# National Transportation Safety Board

WPR24LA265

## **ONBOARD IMAGE, AUDIO AND DATA RECORDER**

Location: Raft River, Idaho  
Date: August 2, 2024  
Time: 21:07 mountain daylight time (MDT) on August 2, 2024  
03:07 coordinated universal time (UTC) on August 3, 2024  
Helicopter: Bell 407, US Forest Service, N20BH

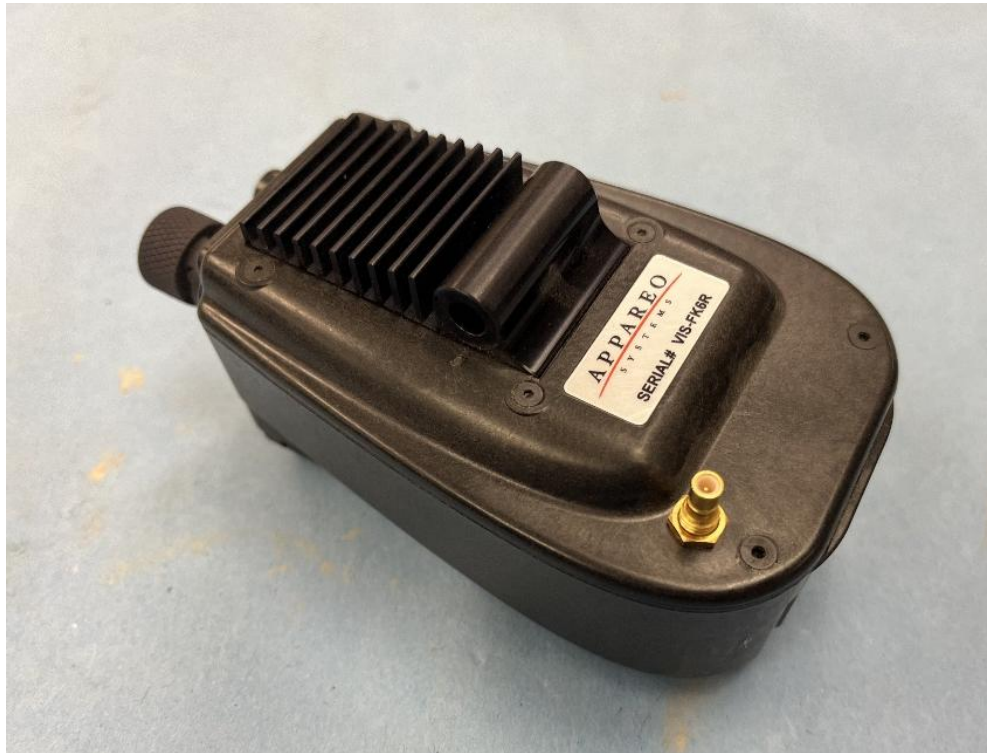
The device was in good condition, as shown in figure 1, and the unit contained a removable Appareo branded SD card. The SD card was removed and downloaded

**Figure 1.** The Appareo Vision 1000 as received.

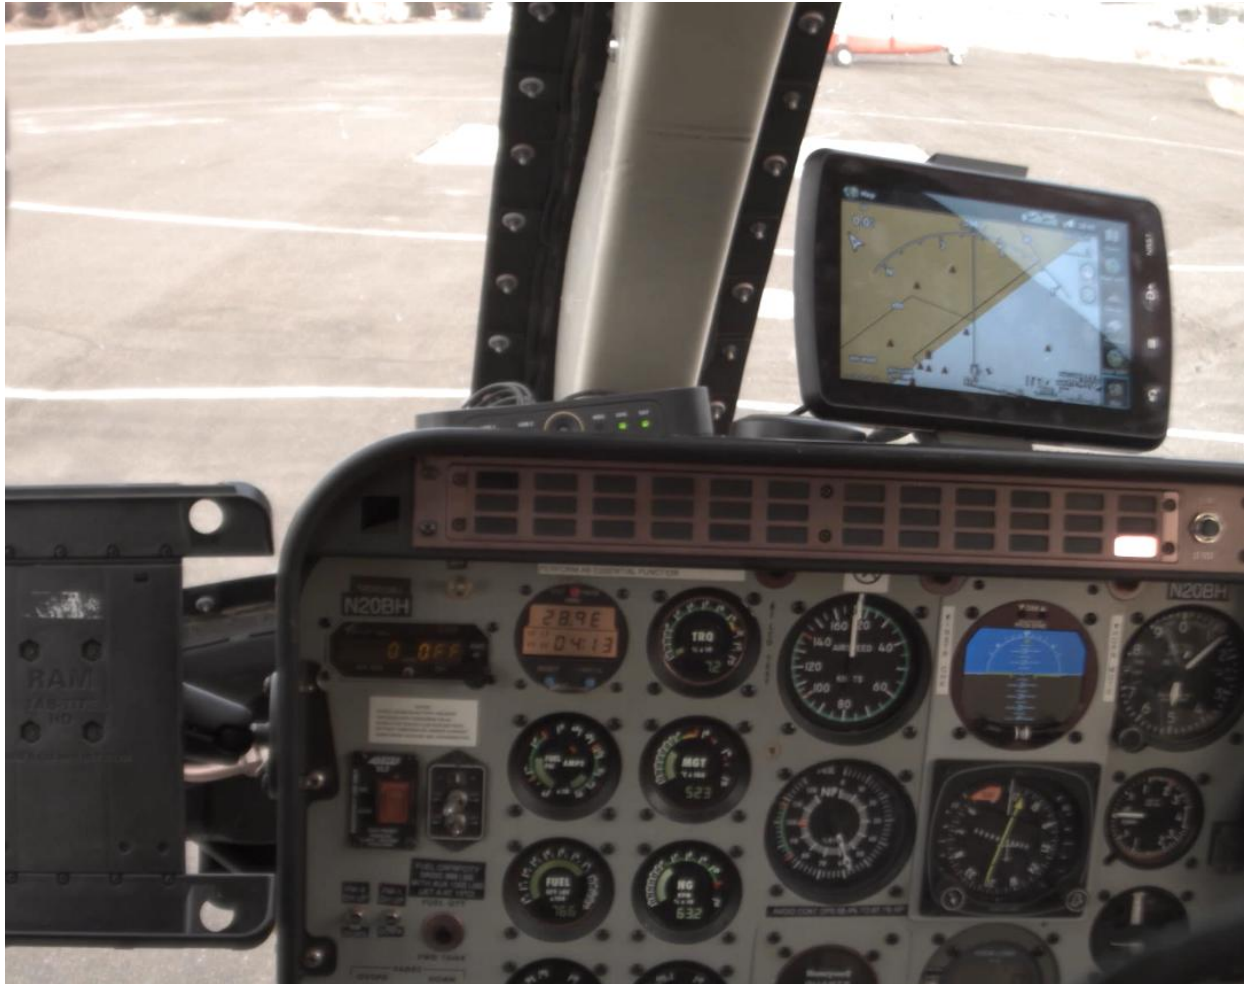
The Appareo Vision 1000 was mounted to the frame of the aircraft and was oriented to show a forward-facing field of view that included a portion of the instrument panel. The field of view of the accident recording is shown in figure 2. The video recording was made at a resolution of 1600x1200 pixels at a frame rate of 4 frames per second (fps). The associated audio track was recorded from the device's internal microphone.

**Figure 2.** Image showing camera field of view.

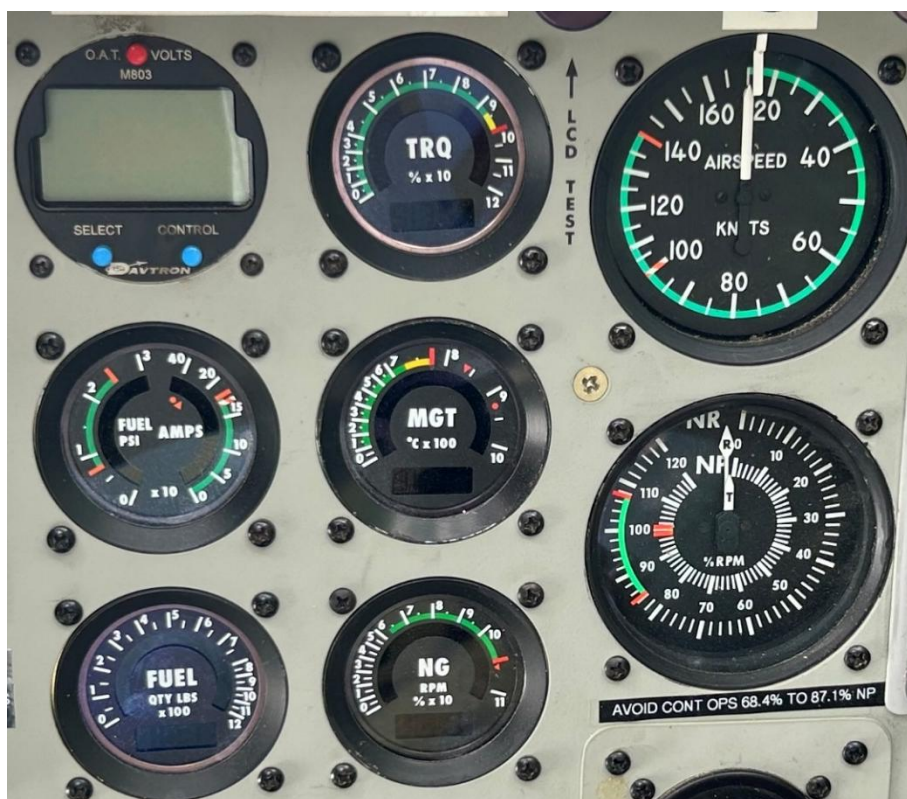
For reference, figure 5 shows the engine instruments in daylight with the helicopter powered off.

**Figure 5.** Engine instruments in daylight with helicopter powered off.
