# National Transportation Safety Board

WPR25LA027

## **RECOVERABLE DATA MODULE**

Specialist's Factual Report

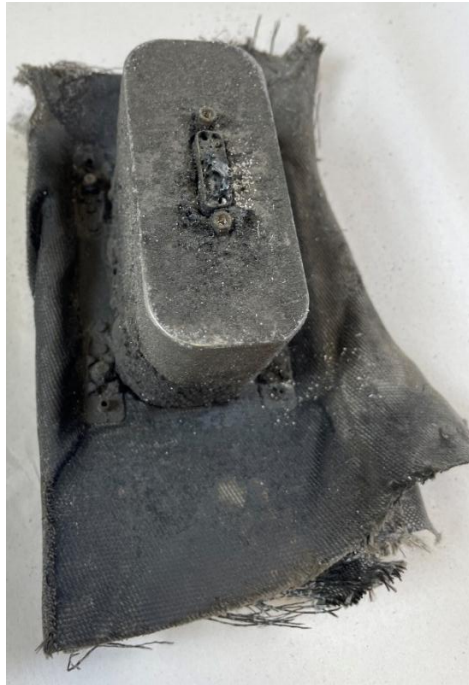
**Figure 1.** RDM as received.

The Appareo RDM-300 sustained severe fire damage from the accident, as shown in Figure 1. Figure 2 shows its internal circuit board and the memory module. The non-reversible temperature indicator had turned dark grey from its original color (white), indicating the circuit board had exposed to temperatures of over 138 degrees Celsius.

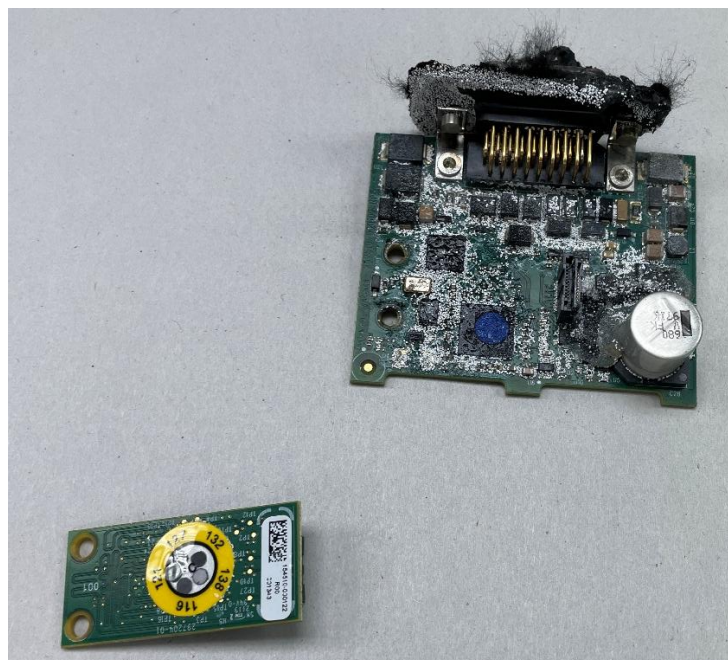
**Figure 2.** Memory module (bottom left) and main circuit board (top right).

The main circuit board and the memory module of the RDM-300 were in fair condition, but the connector port was damaged. Data were downloaded using

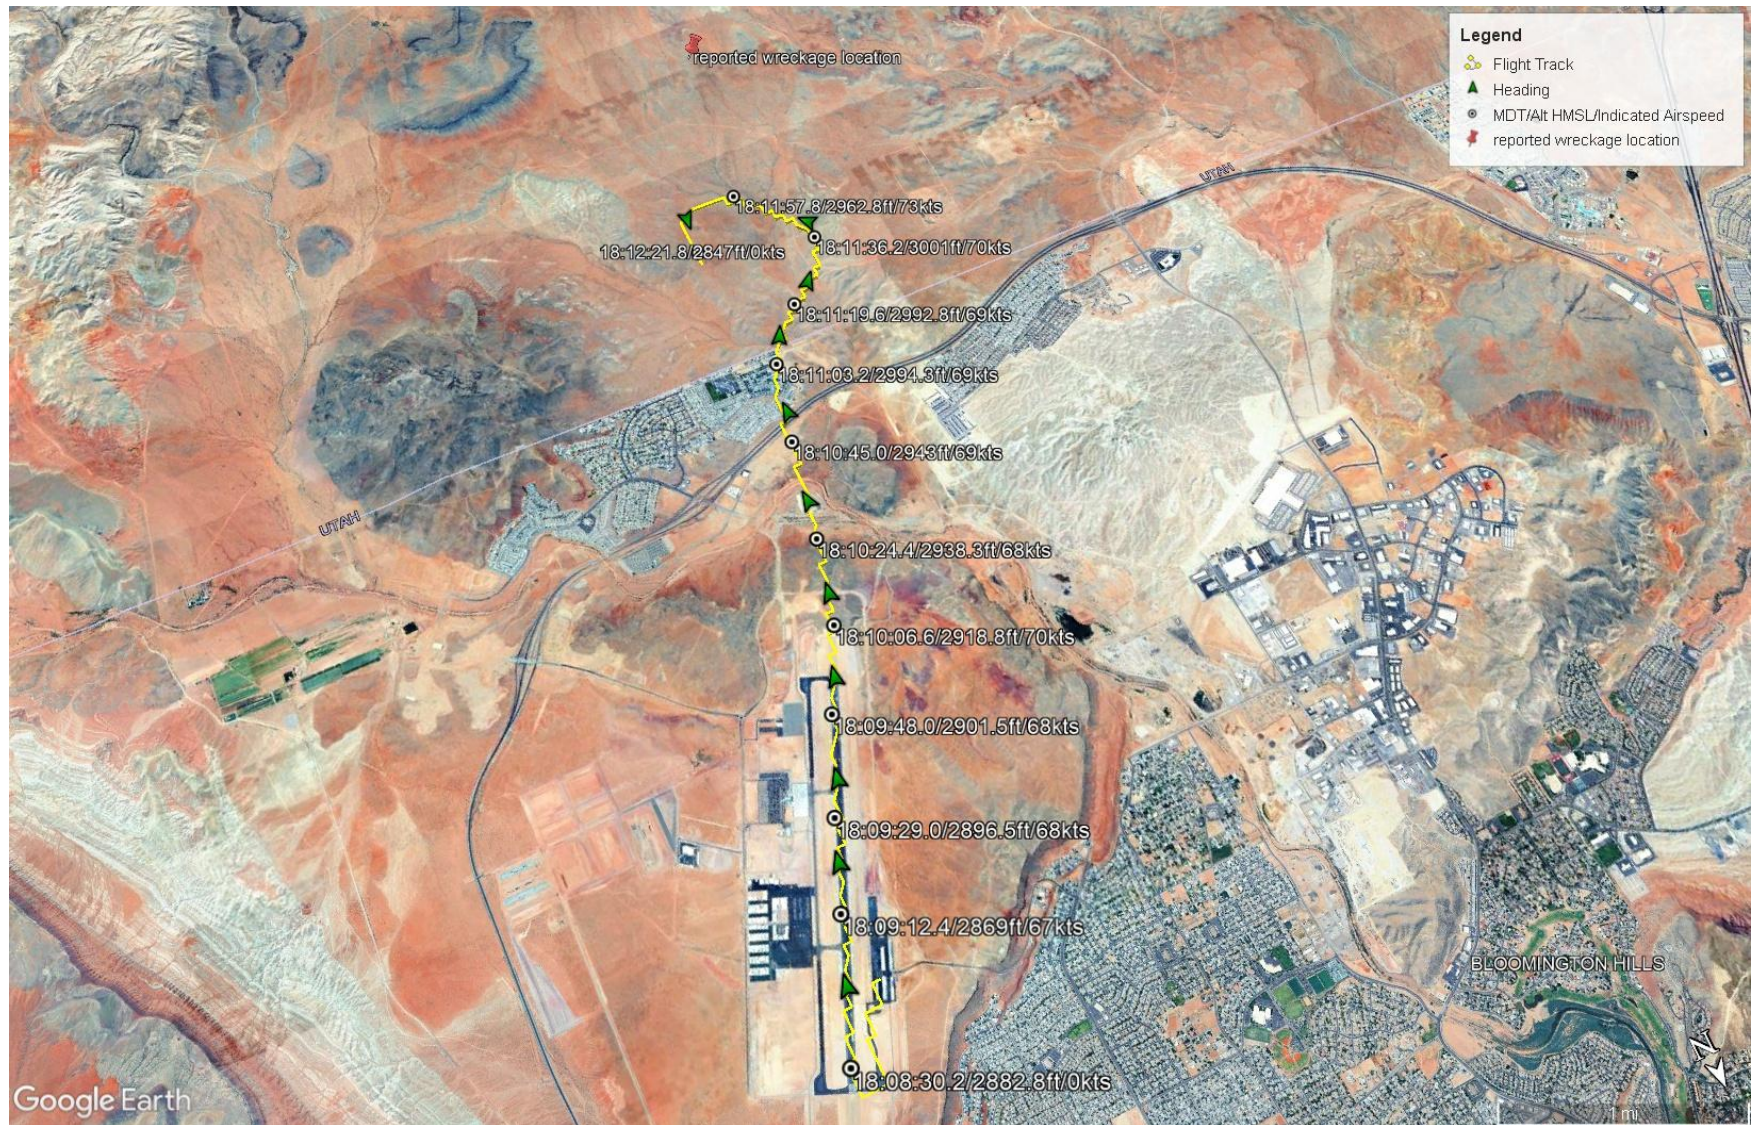
**Figure 7.** Google Earth overlay of the entire accident flight.

Figure 7 is a Google Earth Overlay of the entire accident flight.

The weather and lighting conditions in Google Earth are not necessarily the weather and lighting conditions present at the time of the recording. Note that the entire flight path of the accident flight recorded on the RDM presents in an abnormal zig-zag shape rather than a smooth line. This is a known issue with Appareo RDM in recording GPS location data, and the appearance of the flight track may not be representative of the airplane's actual flight track. This pattern may be attributed to the update rate of GPS parameters as well as the software encoding of the GPS input to the device.
