WPR25LA040

**INVESTIGATION PHOTOGRAPHS-MAT LAB**

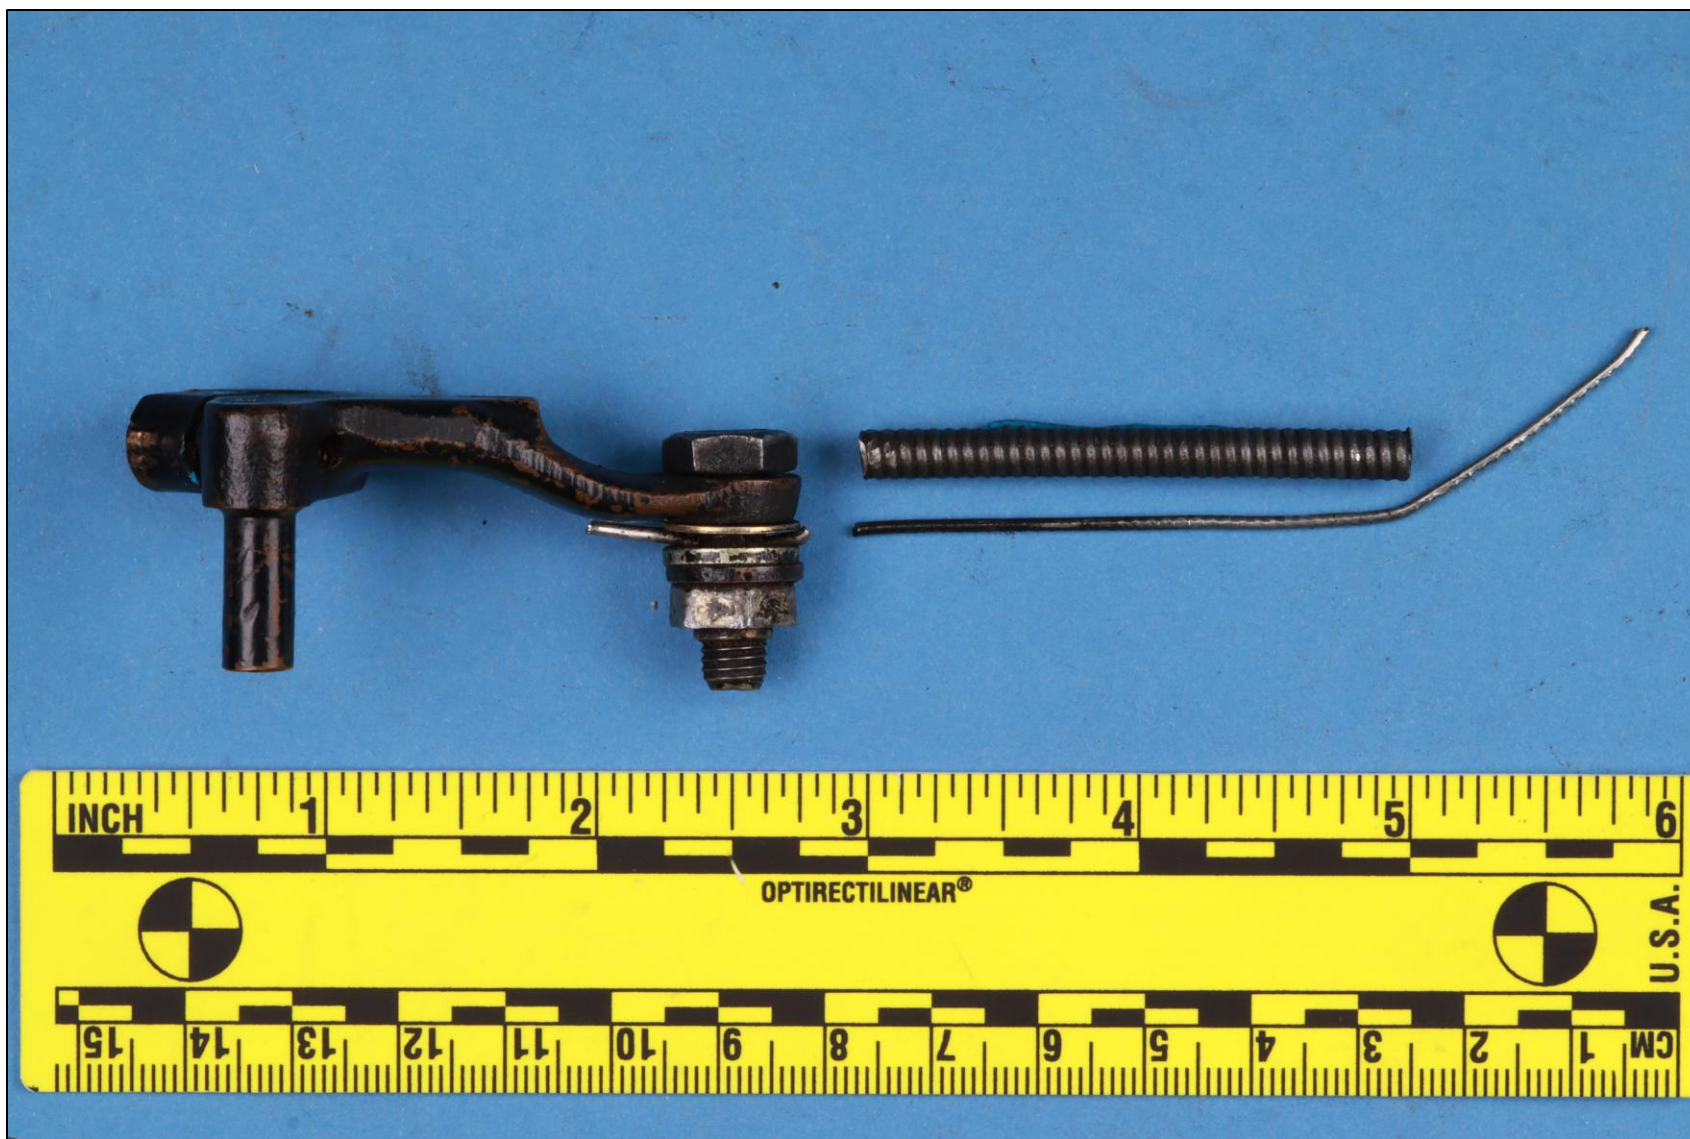
**Photograph 1 - Mixture cable, overall.**

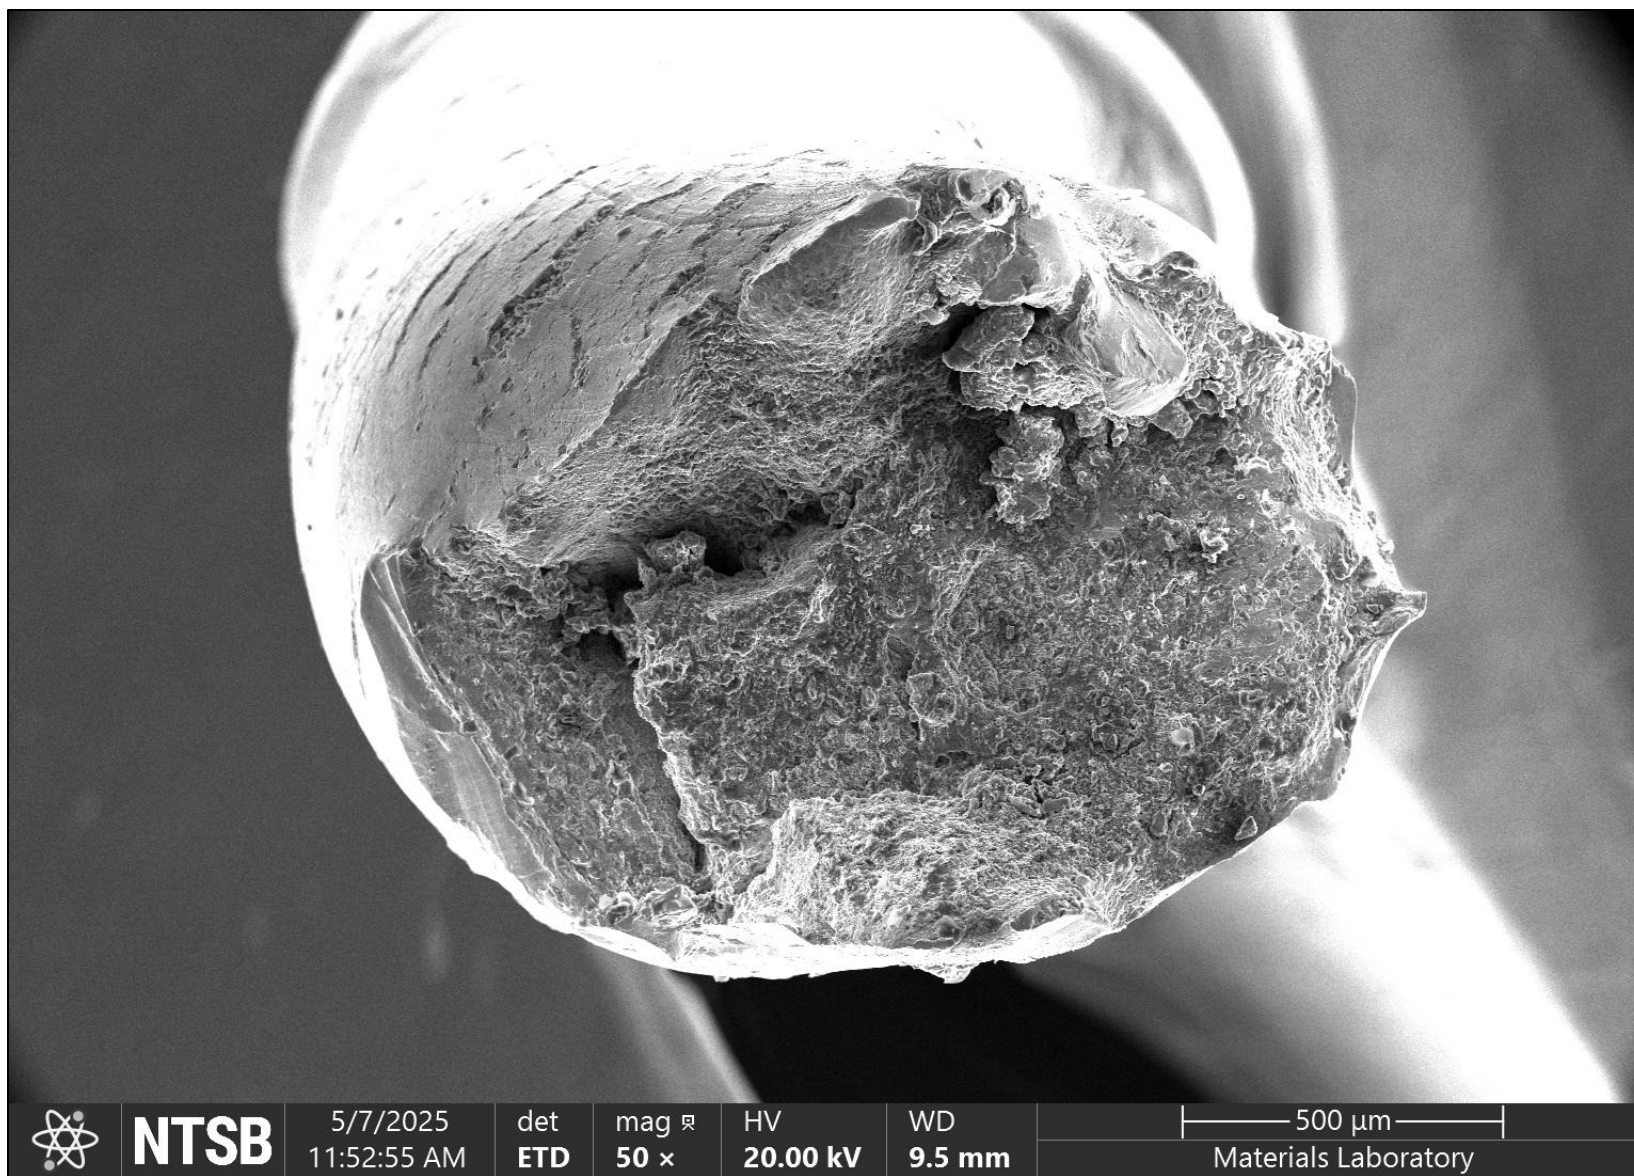
**Photograph 2 - SEM of fracture surface. (50x)**

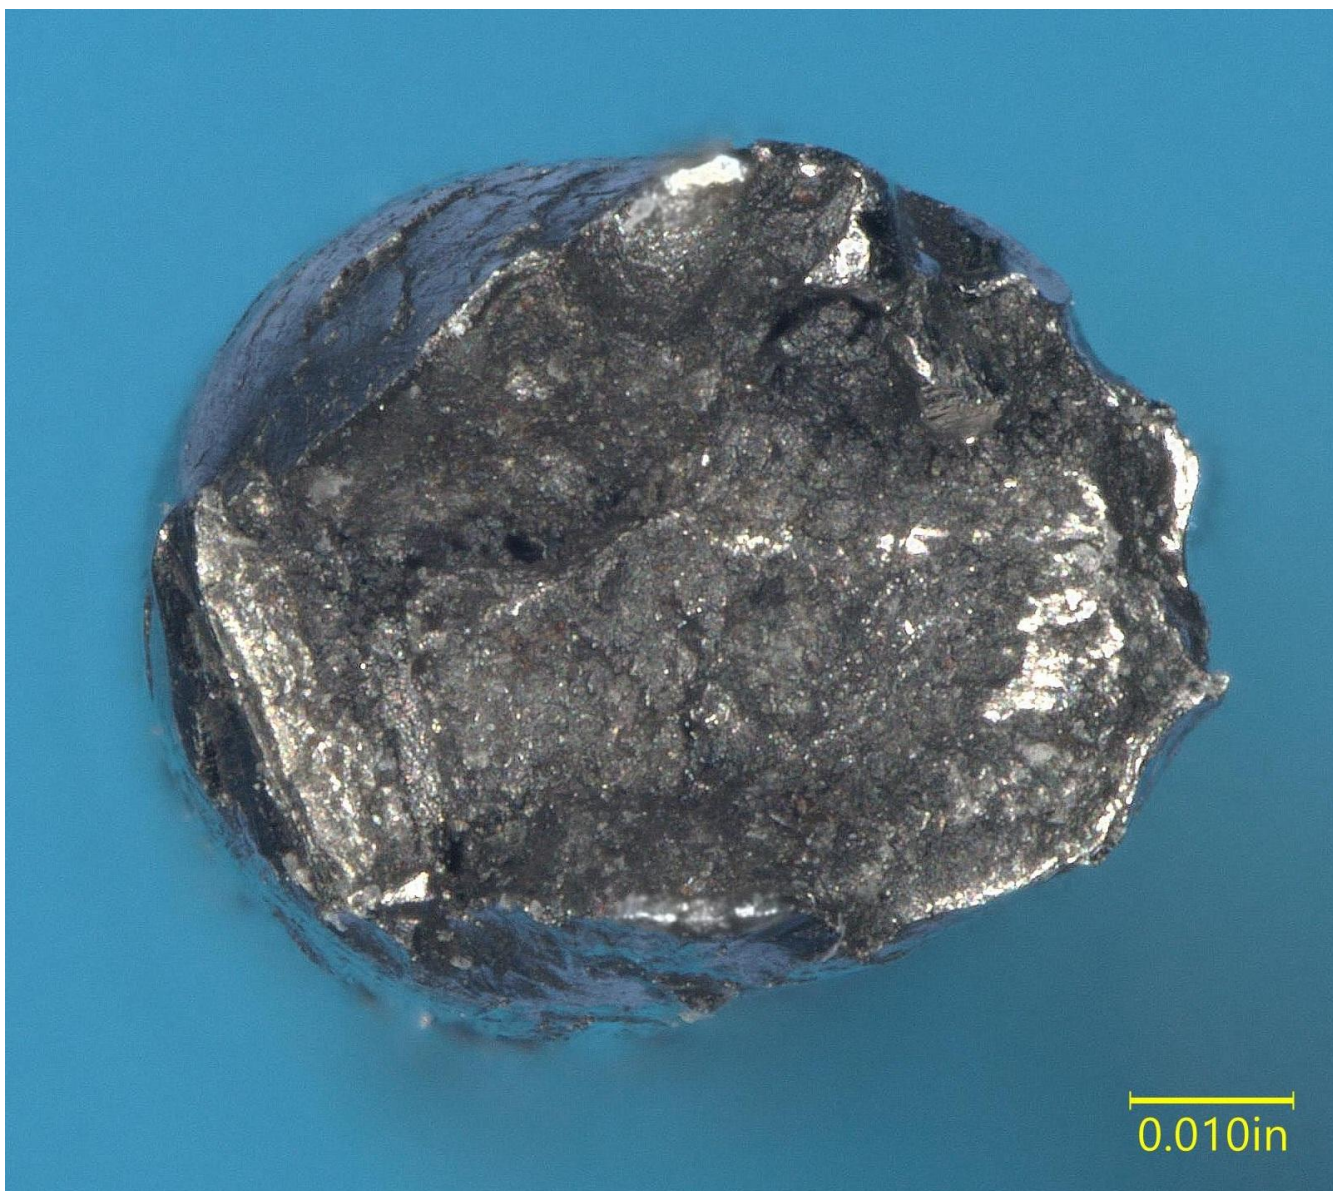
**Photograph 3 - Wire fracture surface (80x)**

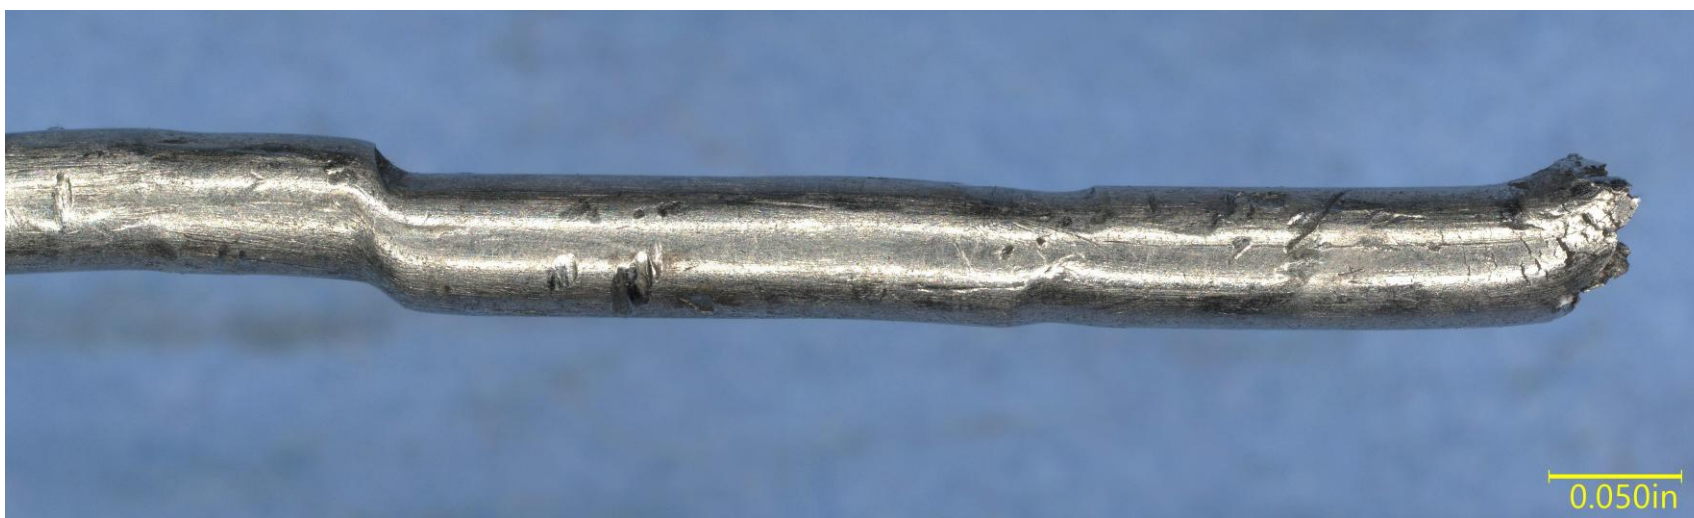
**Photograph 4 - Wire profile. (40x)**
