WPR26LA056

## INVESTIGATION PHOTOGRAPHS

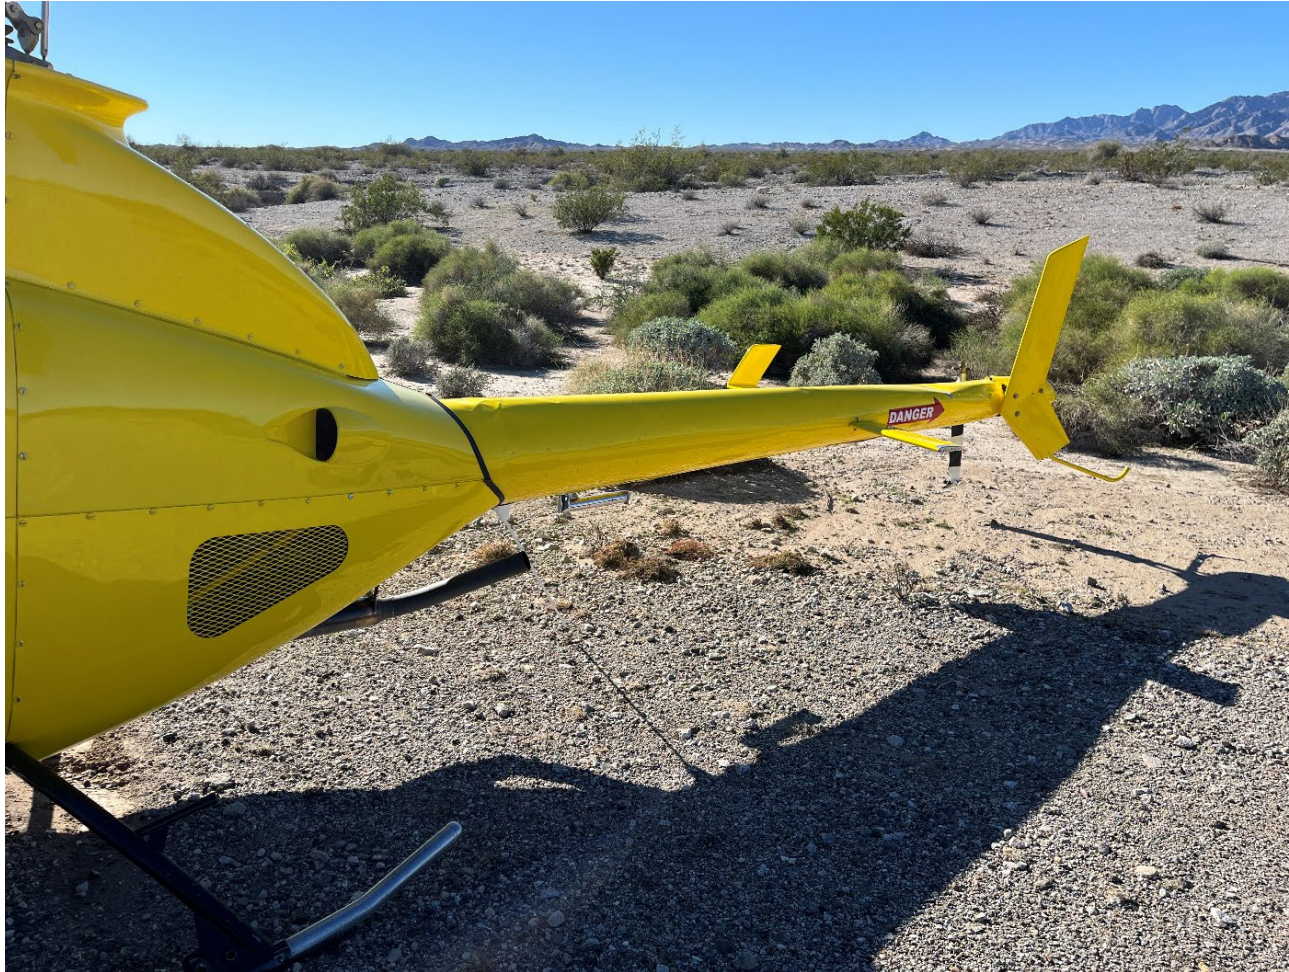
**Photograph 1 - Damage to tailboom (Courtesy of San Bernardino County Sheriff)**

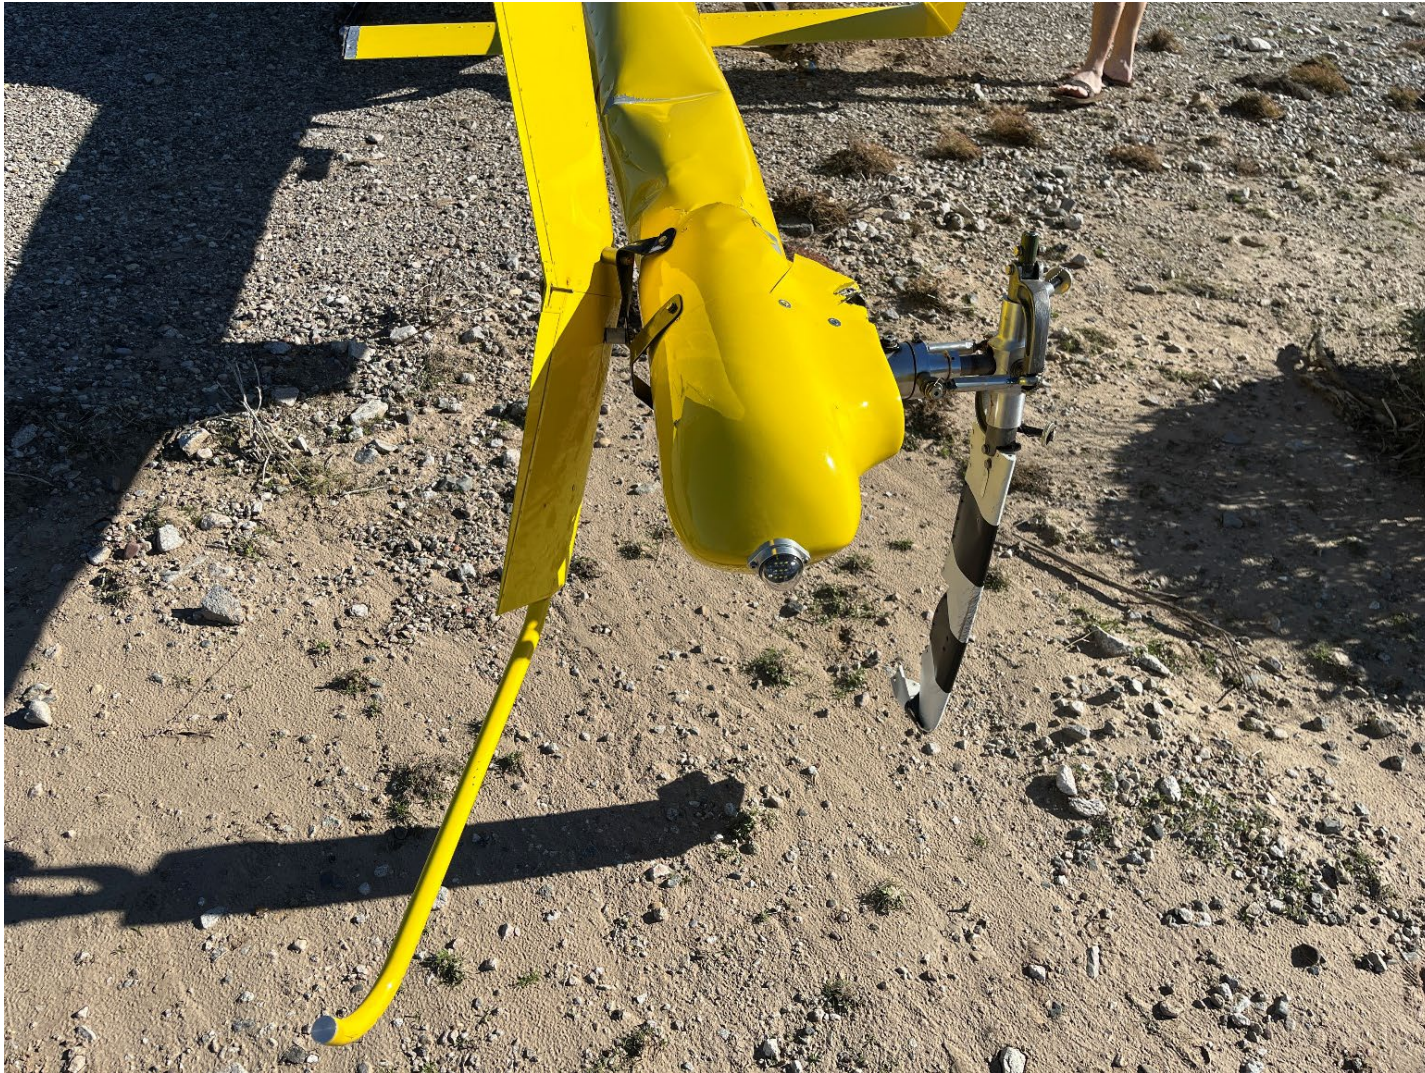
**Photograph 2 - Damage to tail rotor blades (Courtesy of San Bernardino County Sheriff)**

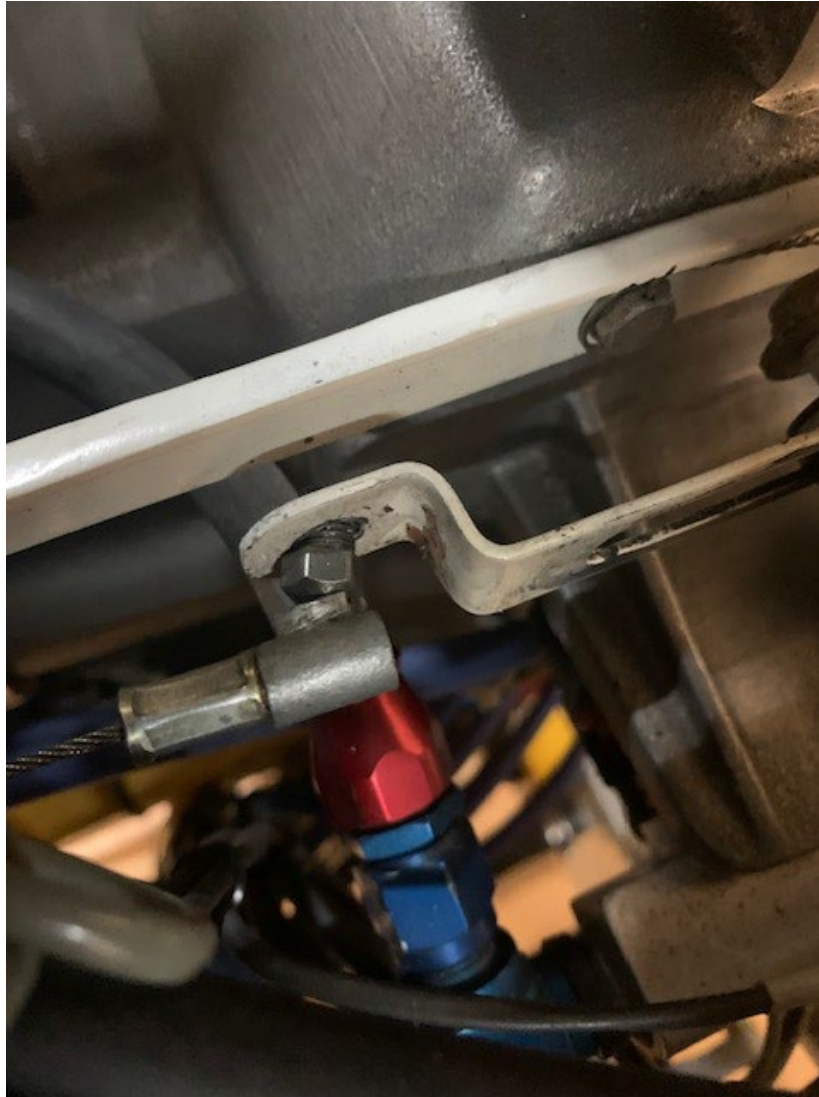
**Photograph 3 - Throttle cable without securing nut (Courtesy of Owner)**

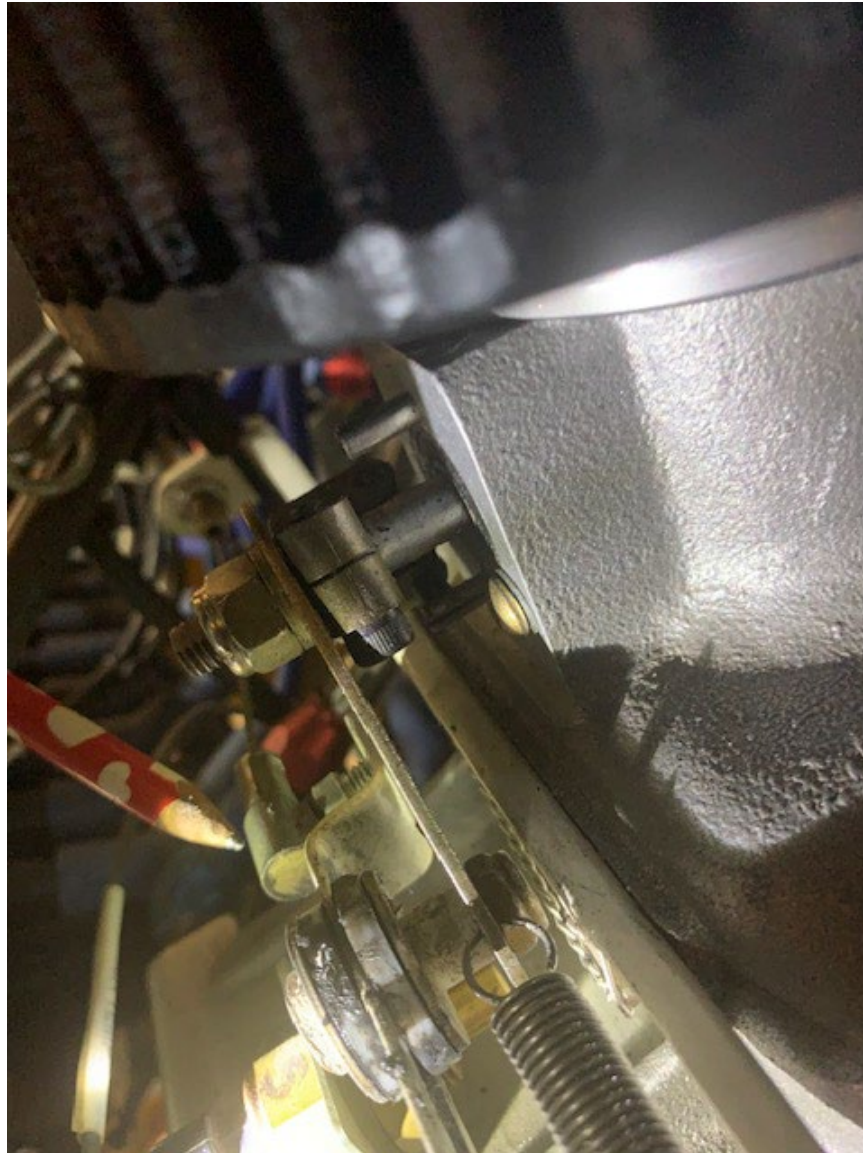
**Photograph 4 - Throttle assembly (Courtesy of Owner)**
