## **NATIONAL TRANSPORTATION SAFETY BOARD**

### **Group Chairman's Weather Study Report**

# **METEOROLOGY**

**ANC15FA049**

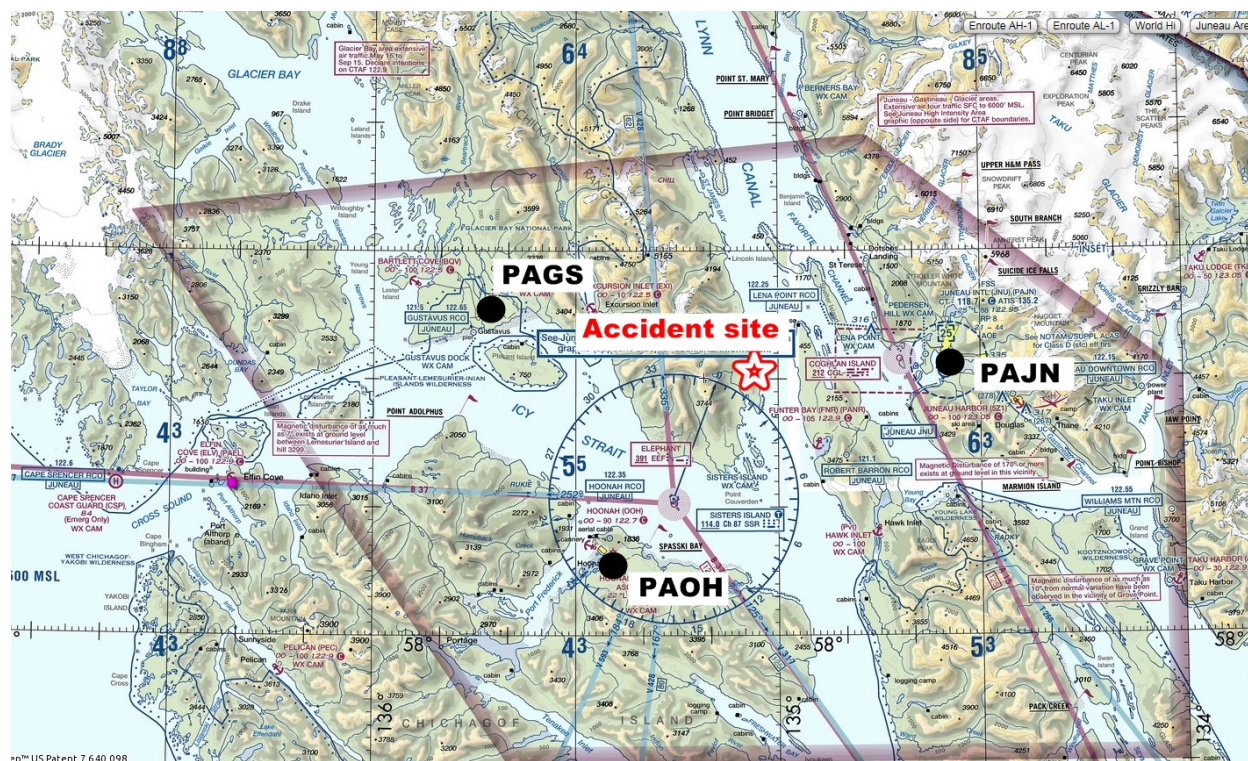
**Figure 2 – Map of Alaska with the location of the accident site and surface observation sites**

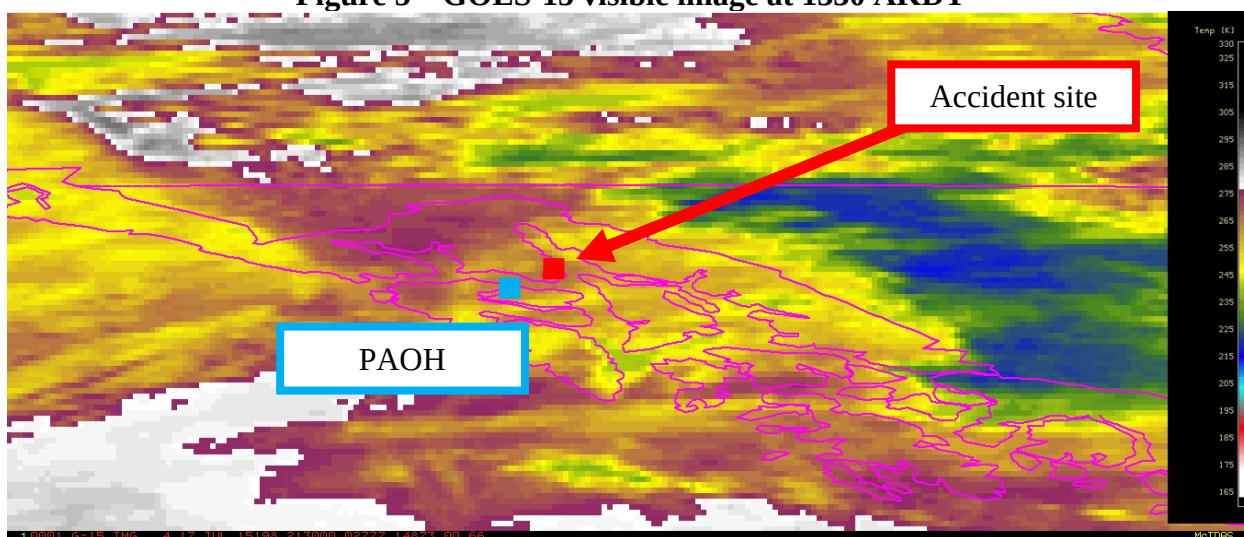
Figures 4 and 5 present the GOES-15 visible imagery from 1300 and 1330 AKDT at 2X magnification with the accident site marked by a red square. The visible imagery indicated abundant cloud cover over and around the accident site at the accident time with that cloud cover moving from west to east. Figure 6 presents the GOES-15 infrared imagery from 1330 AKDT at 6X magnification. Inspection of the infrared imagery indicated the more enhanced bands (yellows and greens, higher cloud tops) were located to the east of the accident site into northern British Columbia. Based on the brightness temperatures above the accident site and the vertical temperature profile provided by the 1300 AKDT GDAS sounding, the approximate cloud-top heights over the accident site were 16,500 feet at 1330 AKDT.

**Figure 6 – GOES-15 infrared image at 1330 AKDT**

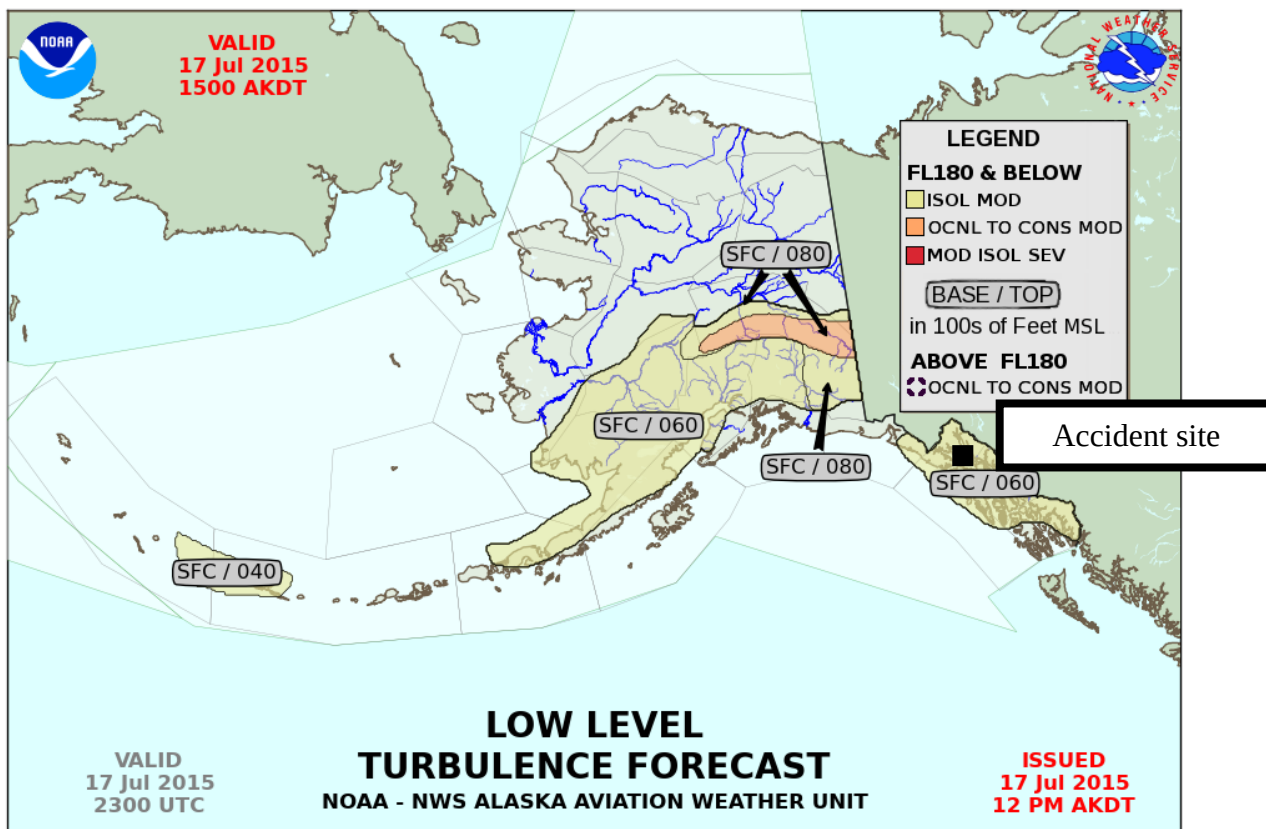
The Area Forecast issued by the NWS Alaska Aviation Weather Unit (AAWU) at 1210 AKDT included an AIRMET for mountain obscuration due to clouds and precipitation and the AIRMET was valid at the accident site at the accident time. The Area Forecast mentioned scattered clouds at 1,200 feet msl with broken to overcast ceiling at 2,000 feet msl with clouds top to FL250<sup>19</sup>, and an occasional broken ceiling at 1,200 feet msl with 5 miles visibility and light rain. Isolated IFR conditions were also forecast with rain and mist. The AAWU weather charts produced at 1200 AKDT indicated the accident site on the boundary of the MVFR to IFR conditions with isolated moderate low-level turbulence between the surface and 6,000 feet msl (figures 8, 9, and 10). Isolated moderate icing conditions were forecast above 16,000 feet msl:

Figure 10 – AAWU low-level turbulence forecast issued at 1200 AKDT valid for 1500 AKDT

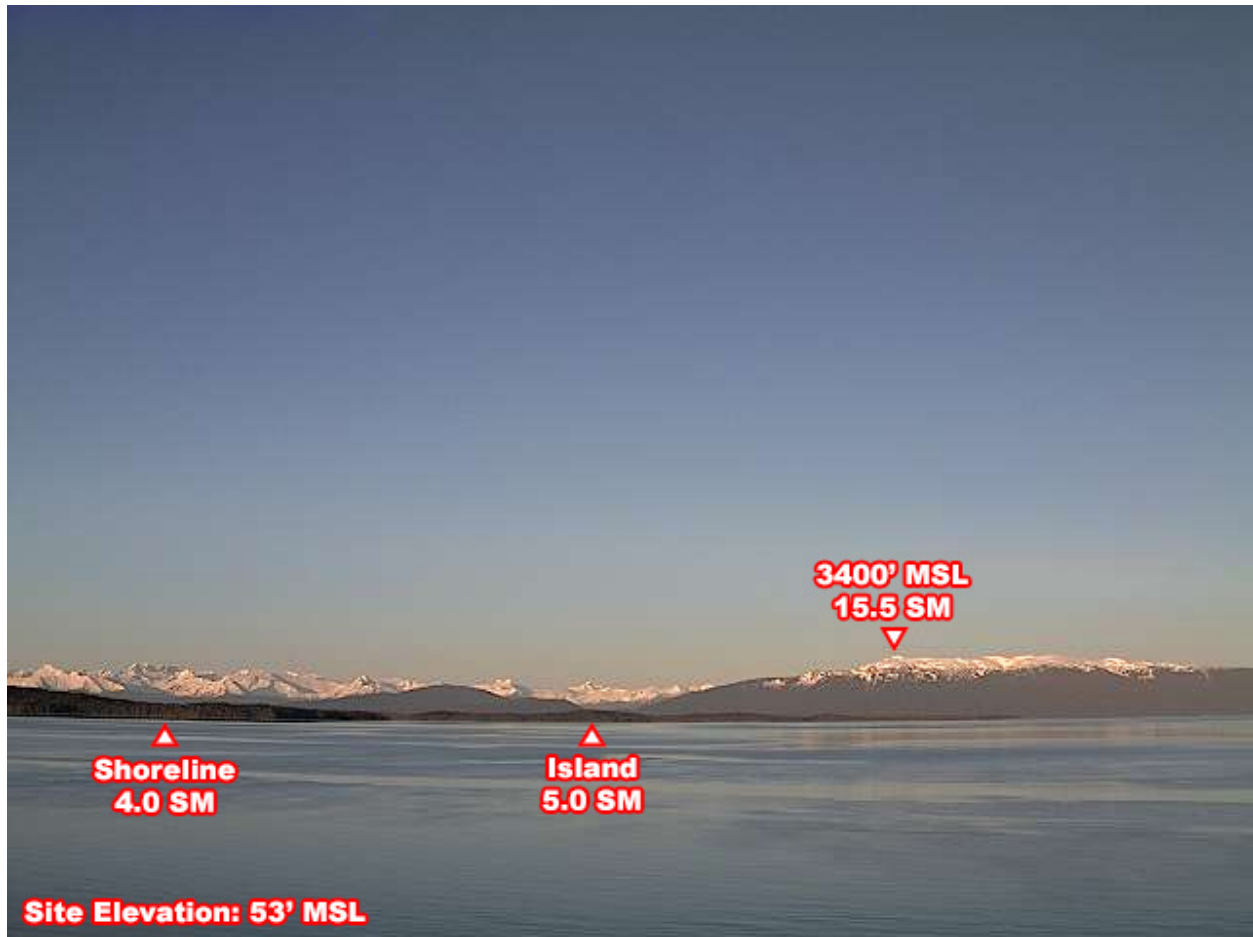
Images from the FAA's Aviation Weather Cameras are shown in figures 11 through 26 along with attachments 3 through 6 providing images of the weather conditions surrounding the accident site at the accident time. The weather camera from Sisters Island, 10 miles south-southwest of the accident site, at an elevation of 53 feet showing the northeast facing camera are provided in figures 11 through 17 with times from 1235 AKDT through 1325 AKDT. The ceiling and visibility conditions are relatively high from 1235 through 1305 AKDT with visibilities above 5 miles. From 1305 through 1325 AKDT the visibilities drop below 5 miles with a lower ceiling as the island in the foreground disappears from view (figures 11, 15, 16, and 17). Attachment 3 provides an animation of the Sisters Island northeasterly view camera from 1105 to 1405 AKDT with the worst visibility and ceiling conditions between 1305 and 1335 AKDT. The weather camera images from Lena Point located 14 miles east-northeast of the accident site at an elevation of 170 feet southwest and west facing views are provided in figures 18 through 26. The west facing camera from Lena Point showed the top of Shelter Island (2 miles west of the camera site) obscured by clouds between 1306 and 1326 AKDT (figures 20, 21, and 22). The hilly terrain on Shelter Island ranged in height from 700 to 1,100 feet msl, with the terrain height portion of Shelter Island directly across from the Lena Point west facing camera between 700 and 800 feet msl. The southwest facing camera view showed similar conditions (figures 24, 25, and 26) with the visibility below 6.5 miles between 1307 and 1327 AKDT and visibility and ceiling restrictions in, around, and south of Shelter Island. Attachments 4 and 5 provide animations of the weather camera images from the west facing Lena Point camera (attachment 4) and from the southwest facing Lena Point camera (attachment 5) between 1106 and 1407 AKDT. The ceilings and visibilities remain restricted throughout the entire timeframe between 1106 and 1407 AKDT with the worst conditions between 1200 and 1230 AKDT and 1306 and 1345 AKDT. Finally, the animated images from the Pederson Hill web camera west facing camera are provided in attachment 6 from 1102 to 1402 AKDT, with the Pederson Hill web camera located 17 miles east of the accident site at an elevation of 476 feet. The Pederson Hill west facing web camera indicated less than 2 miles visibility between 1242 and 1402 AKDT with ceilings at or below 700 feet msl. The FAA's Aviation Weather Cameras surrounding the accident site show MVFR to IFR conditions with the worst conditions along and near the terrain at the accident time. There was more variability to the ceiling and visibility conditions south and west of the accident site as indicated on the northeast facing camera from Sisters Island (attachment 3 and figures 11 through 17).

**Figure 11 – FAA weather camera from Sisters Island northeast looking view from a standard clear sky weather day**

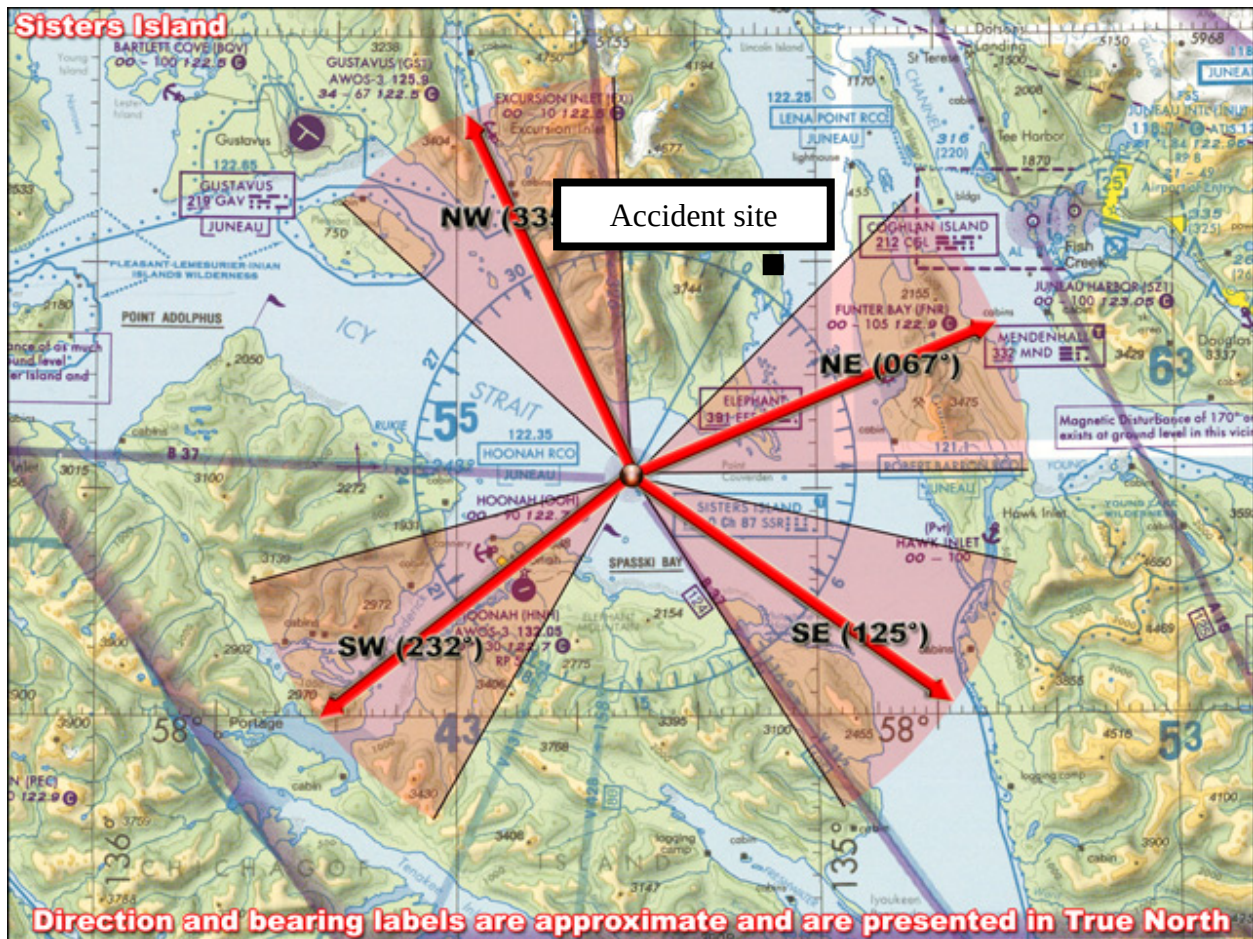
Figure 12 – FAA weather camera Sisters Island location on sectional chart with the direction the different camera angles face with the accident site marked

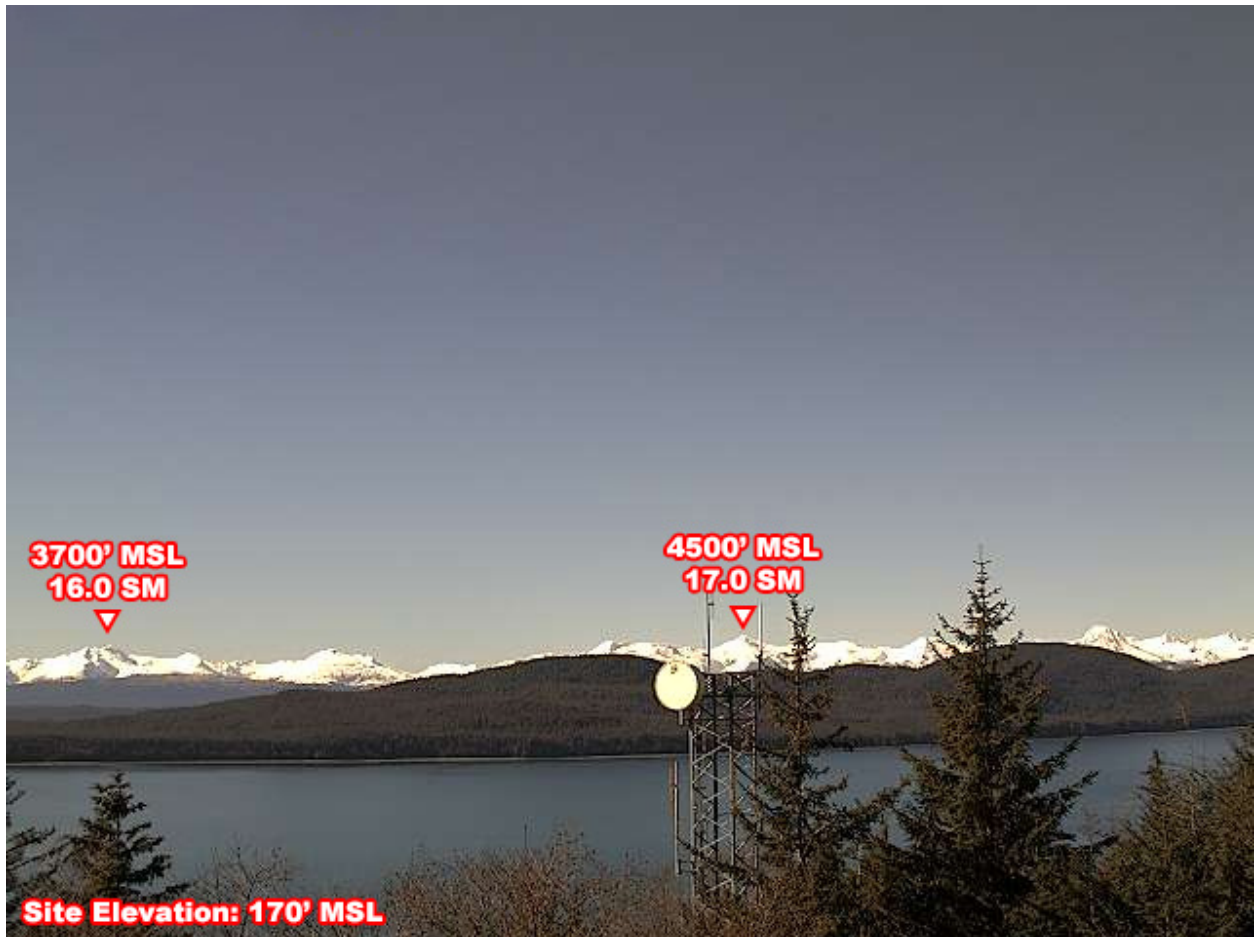
**Figure 18 – FAA weather camera from Lena Point west looking view from a standard clear sky weather day**

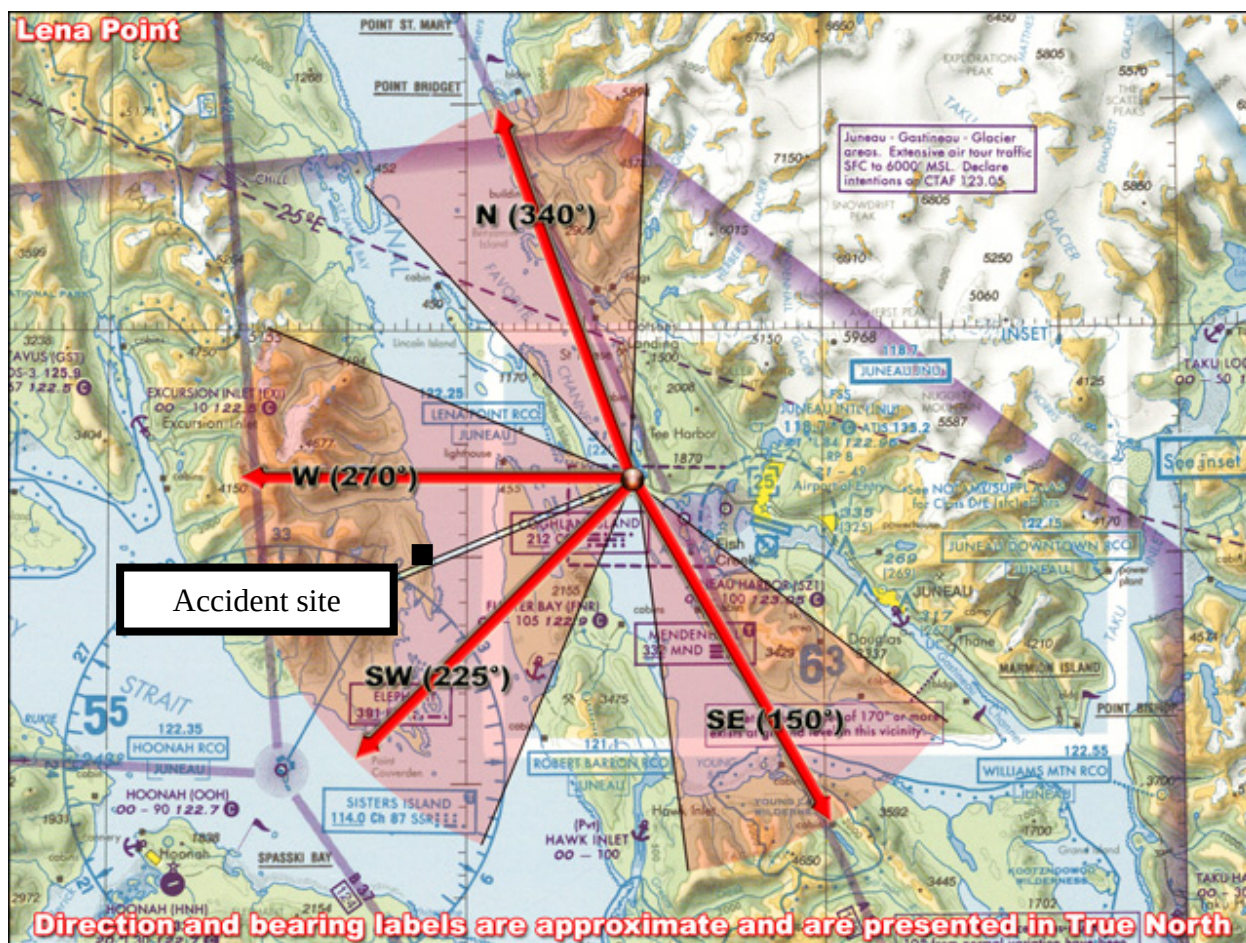
Figure 19 – FAA weather camera Lena Point location on sectional chart with the direction the different camera angles face with the accident site marked

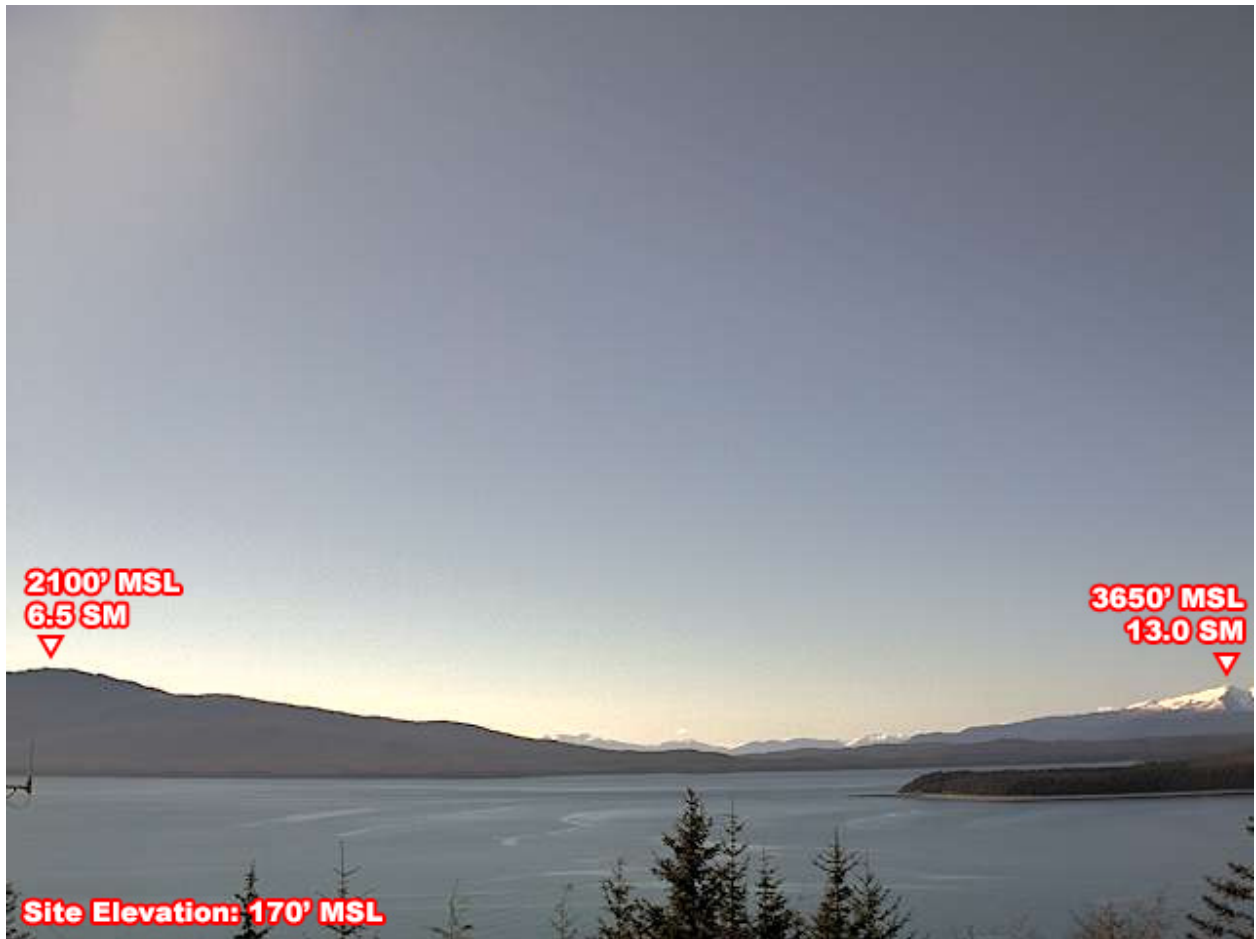
Figure 23 – FAA weather camera from Lena Point southwest looking view from a standard clear sky weather day
