## **NATIONAL TRANSPORTATION SAFETY BOARD**

### **Group Chairman's Weather Study Report**

# **METEOROLOGY**

**ANC16LA012**

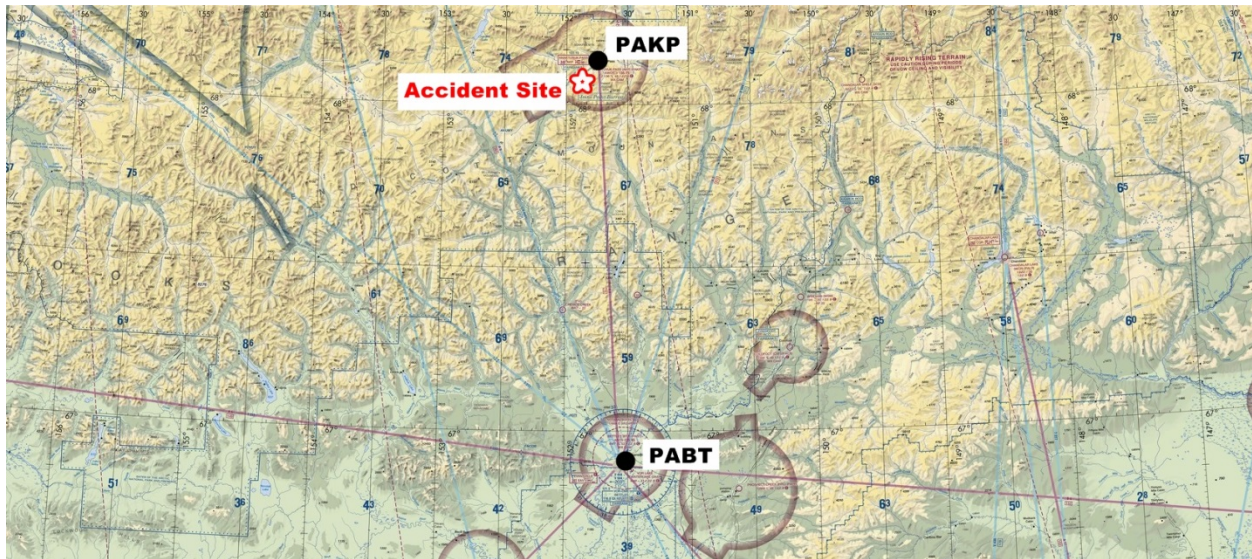
**Figure 2 – Map of Alaska with the location of the accident site and surface observation sites**

Anaktuvuk Pass Airport (PAKP) was the closest official weather station to the accident site along with being the destination airport. PAKP had an Automated Weather Observing System (AWOS<sup>2</sup>) whose reports were not supplemented. PAKP was located 5 miles northeast of the accident site, at an elevation of 2,106 feet, and had a 21° easterly magnetic variation<sup>3</sup> (figure 2). The following observations were taken and disseminated during the times surrounding the accident:<sup>4</sup>

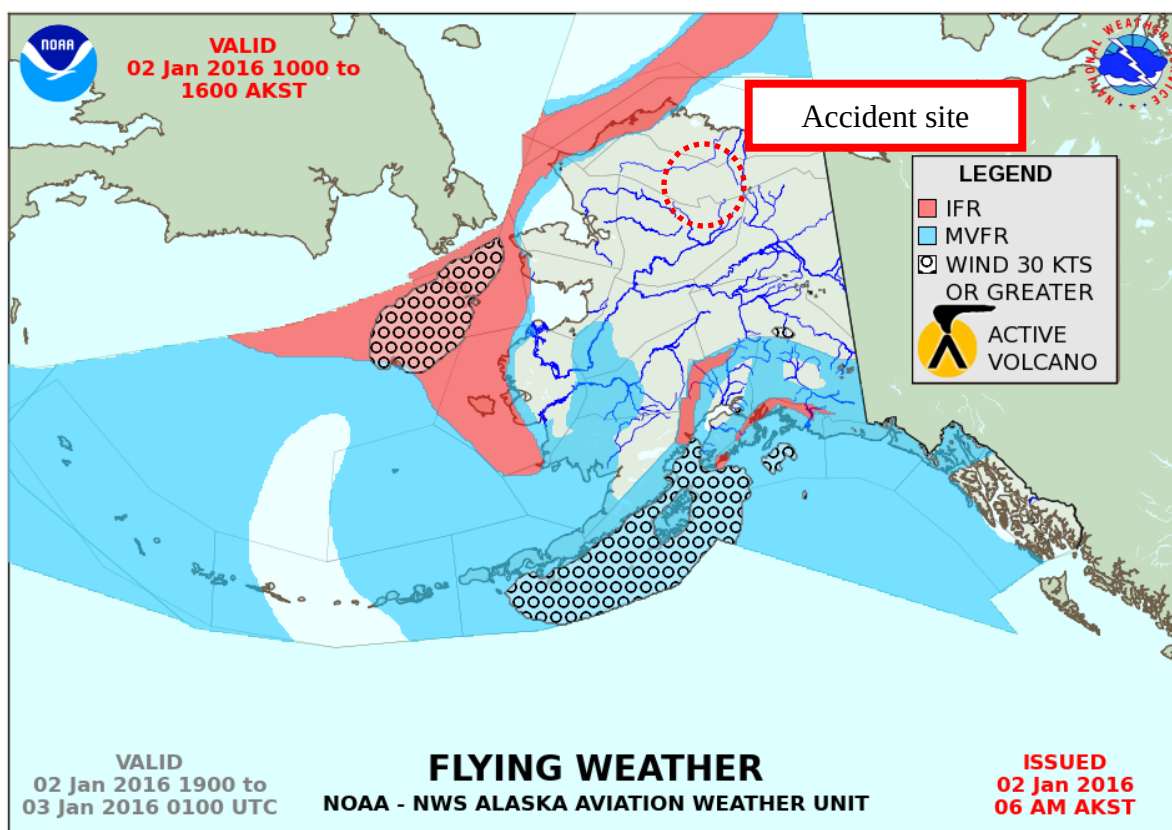
Figure 7 – AAWU IFR and MVFR weather chart issued at 0600 AKST valid from 1000 through 1600 AKST

The Area Forecast issued by the NWS Alaska Aviation Weather Unit (AAWU) at 0648 AKST for the north slopes of the Brooks Range, including the accident site forecasted scattered clouds at 6,000 feet msl with a broken ceiling at 8,000 feet and tops to FL200 with cirrus above. Occasional broken ceiling to 6,000 feet msl was forecast with light snow as well (figures 7, 9, and 11). No significant turbulence or icing was forecast for the accident site with Anaktuvuk Pass forecast to be VFR until 1600 AKST:
