# National Transportation Safety Board

ANC17FA009

## **AIRPLANE PERFORMANCE STUDY**

Location: Fairbanks, Alaska  
Date: December 7, 2016  
Time: 1043 AST  
1943 GMT  
Airplane: Bellanca 7GCBC, N88452

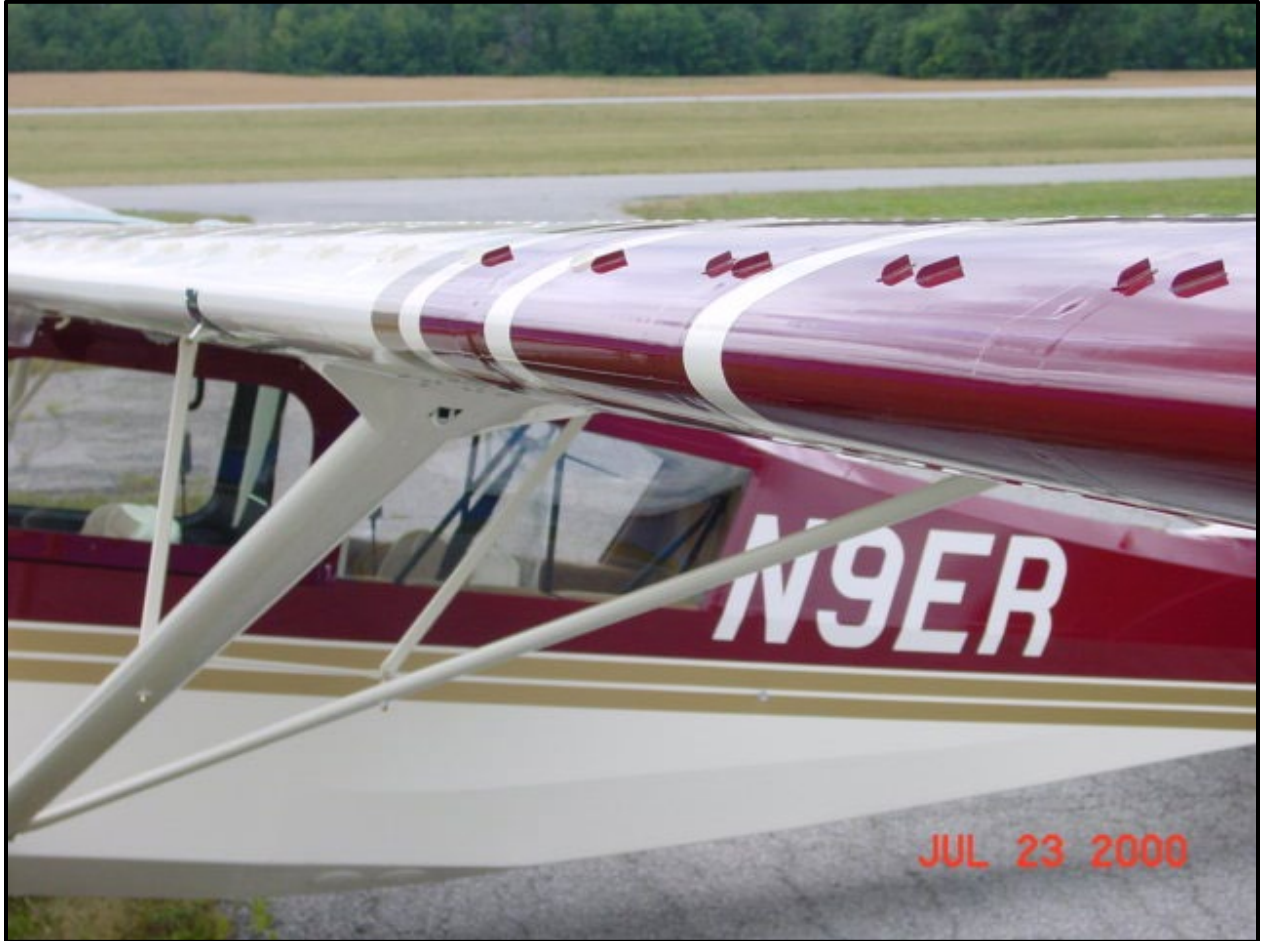
### 1.0 Micro AeroDynamics, Inc, VG Installation on a Comparable Airplane

The accident airplane was equipped with Micro AeroDynamics’s micro vortex generators (VG). Micro claims that the VG’s lower stall speeds, improve controllability, and improve stall characteristics. See Figures 1 and 2.
