# Continental Motors

## ENGINE FIELD INSPECTION REPORT

| ENGINE MODEL | O470R |
| FILE NUMBER | 16-551 |

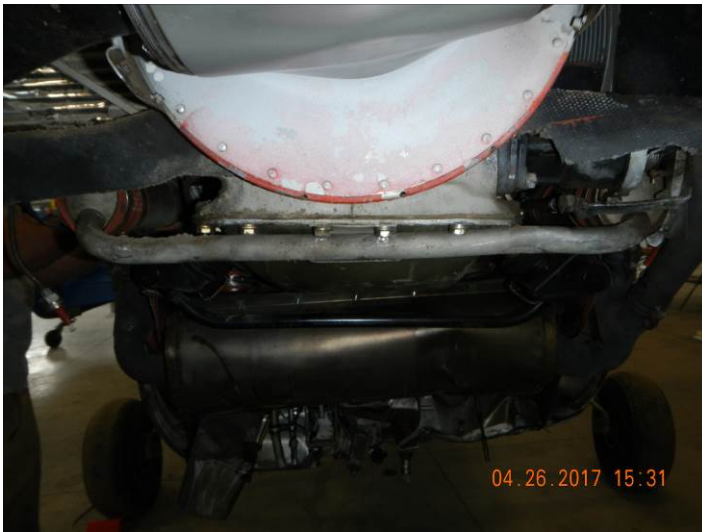
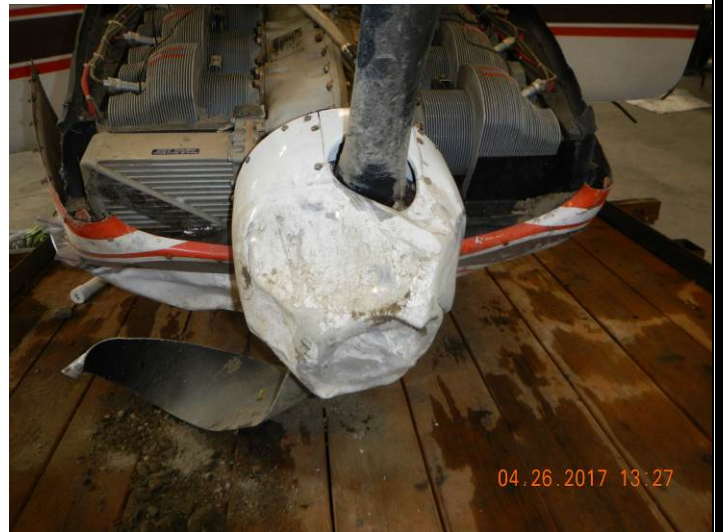
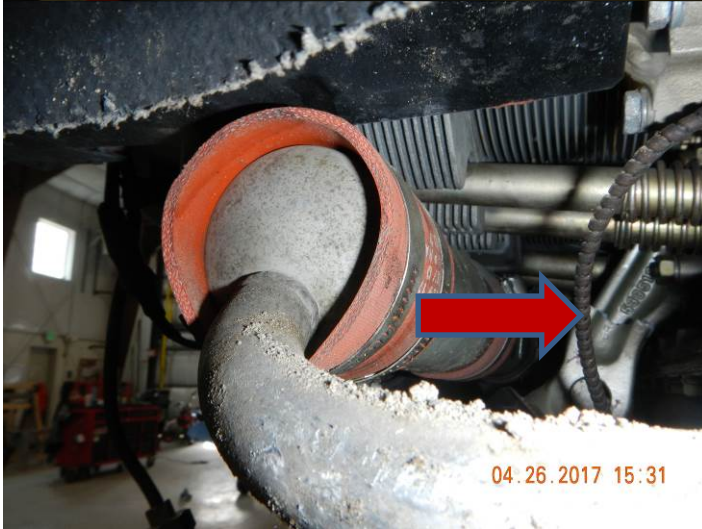
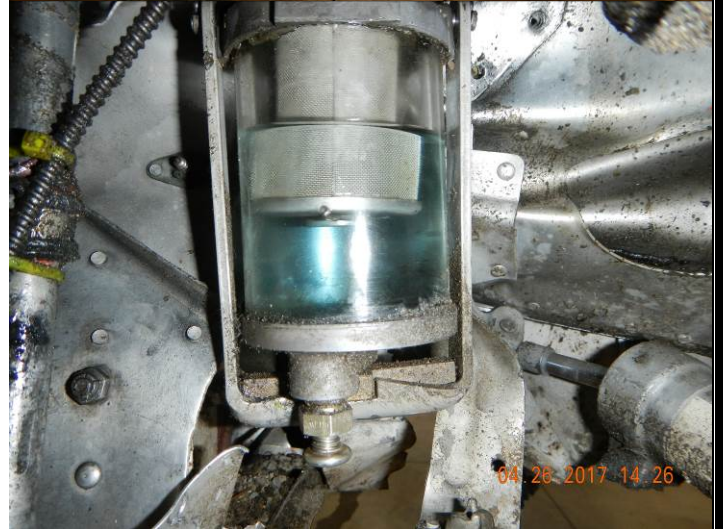
The exhaust collectors exhibited upward bending damage due to impact forces which forced the muffler upward. The muffler was disassembled and no internal failure was evident. Red arrows point to collector outlet area where bending was evident. The muffler heat shield was removed and the muffler inspected. No defects were found. The flame cone was intact and the exhaust path was open. The tail pipe was impact damaged.

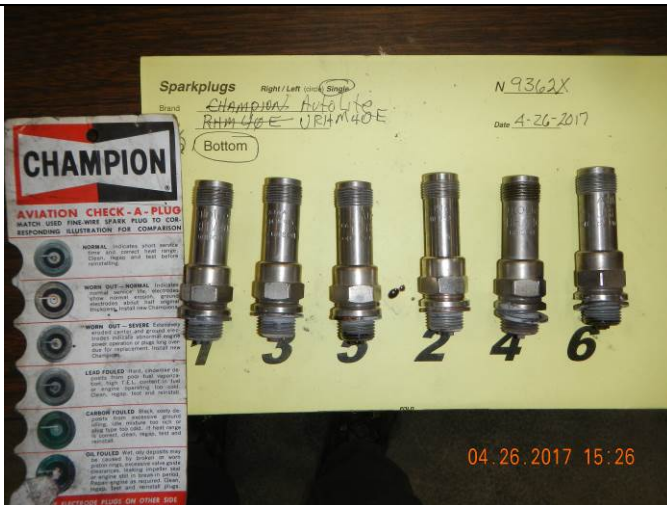
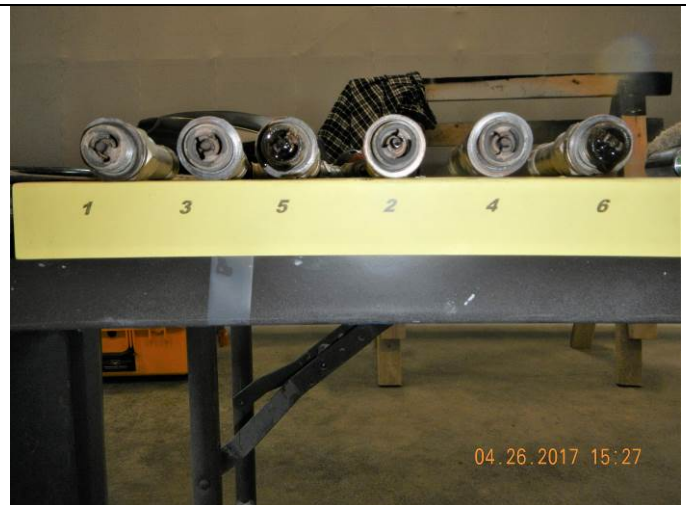
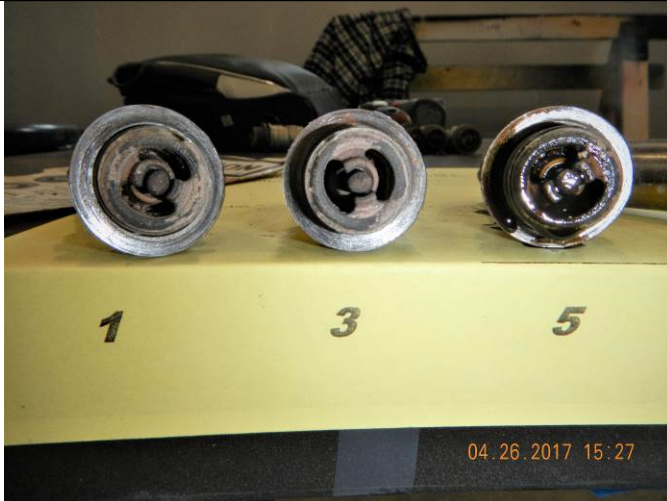
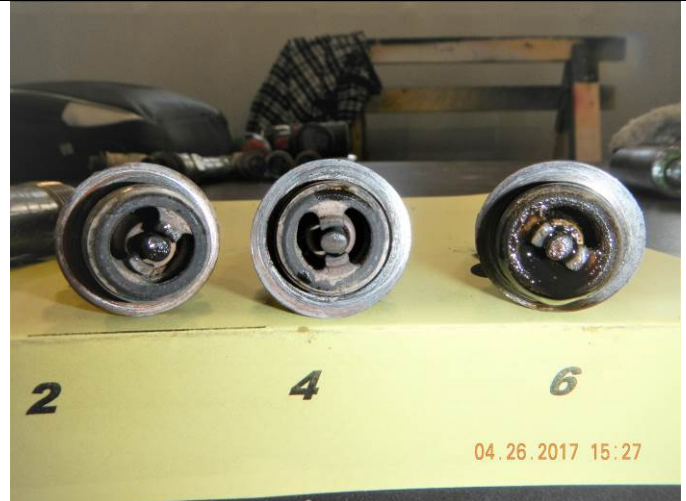
The top sparkplugs were removed and examined. When compared to a Champion Aviation "Check A Plug" chart, each sparkplug condition resembled "normal worn out" with normal coloration. The bottom sparkplugs were removed and examined. All bottom sparkplugs appeared "normal" in wear and coloration except for the sparkplugs removed from cylinders 5 and 6 which were oil contaminated.

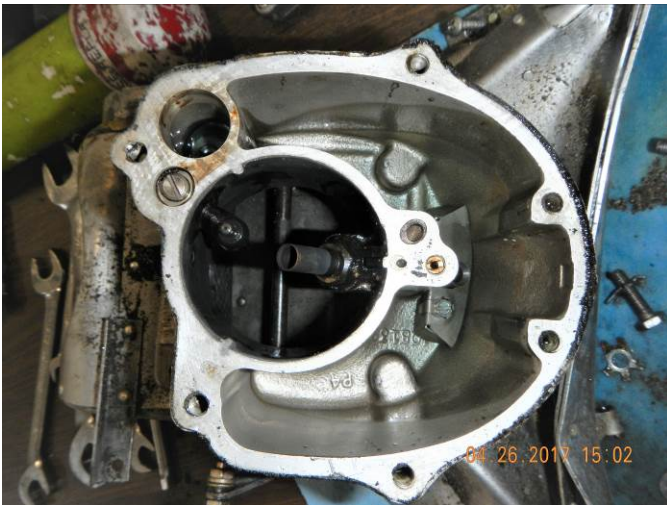
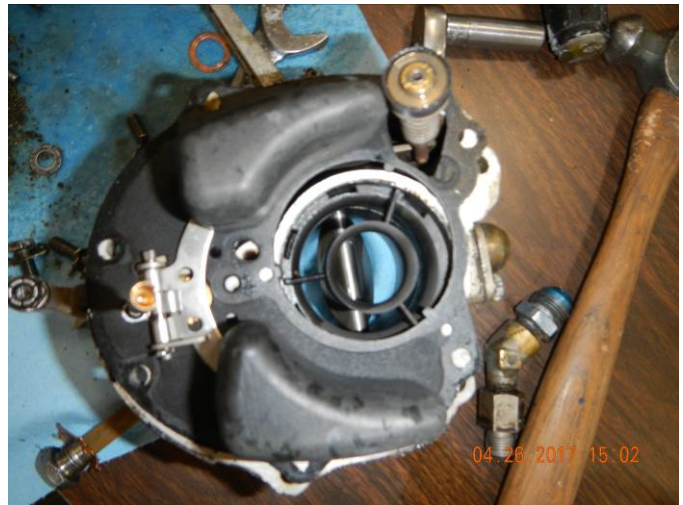
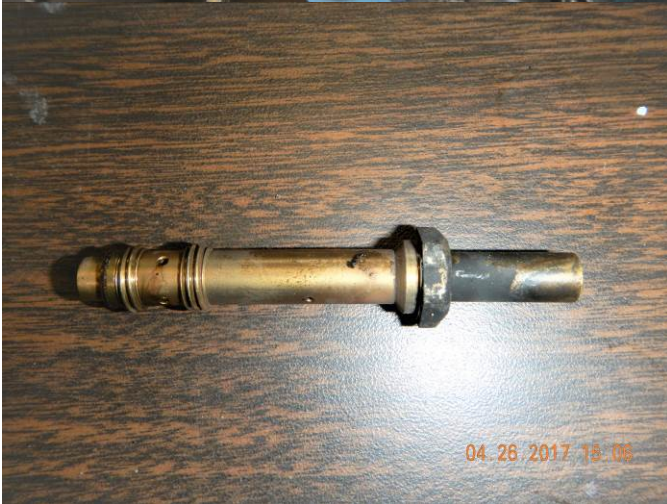
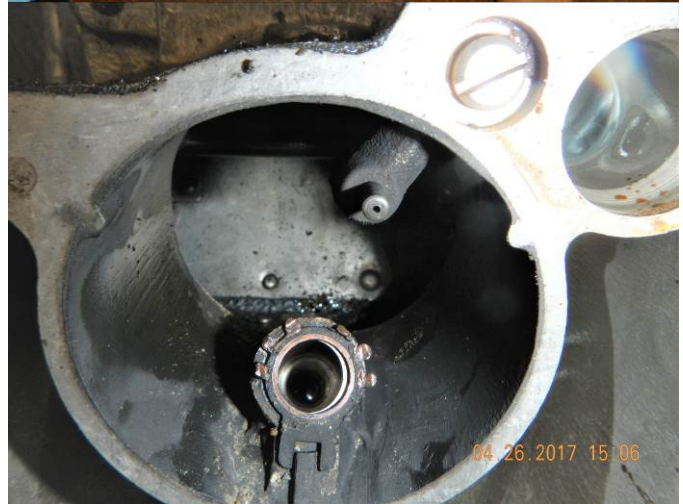
| Condition: | The carburetor exhibited no damage. All engine controls operated normally and control attachments for throttle and mixture were secured correctly. The fuel inlet finger screen was uncontaminated. The accelerator pump operated normally when the throttle arm was manually actuated. The carburetor was disassembled and examined. The plastic float assembly appeared normal and operated the needle correctly. No contamination was discovered inside the float chamber. The main jet and master orifice was removed and found to be uncontaminated. | | |
