## **NATIONAL TRANSPORTATION SAFETY BOARD**

### **Weather Study**

# **METEOROLOGY**

ANC17LA025

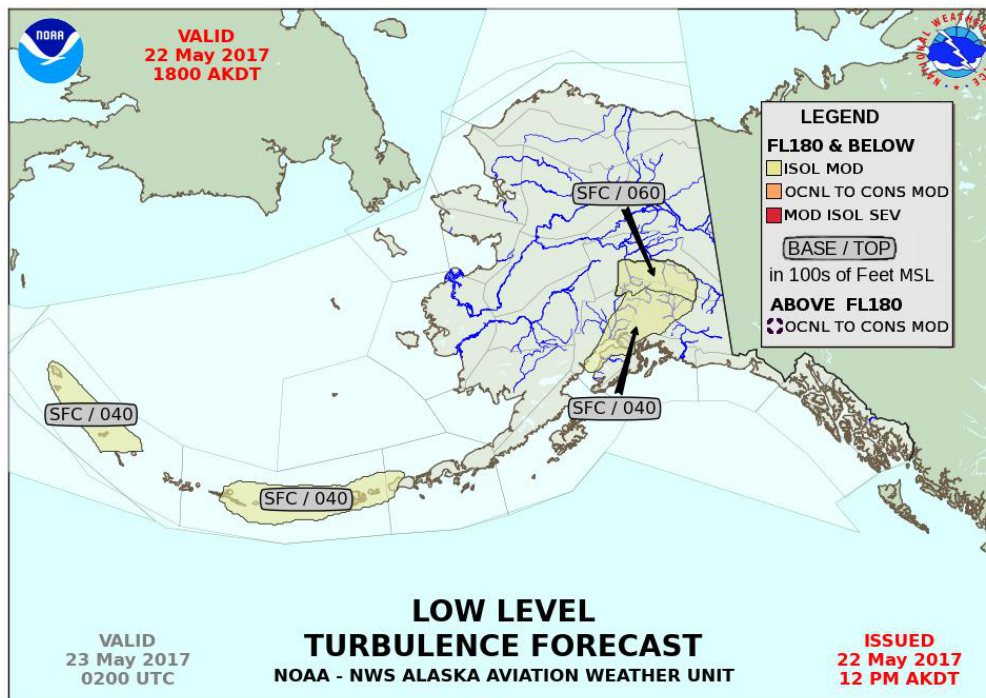
Figure 5 - NWS AAWU Low-Level Turbulence Forecast

and Glacier Bay areas, with marginal flight rule (MVFR) conditions<sup>4</sup> to the west and south, with no large areas of instrument flight rule (IFR) conditions<sup>5</sup> over land. The chart also depicts areas where wind of 30 knots or greater are expected and volcanic activity in which none were expected for the region. The Low-Level Turbulence (figure 5) and Icing Forecast (figure 6) depicted no significant areas of turbulence or icing over the region, with the freezing level depicted at about 4,000 ft over the region.

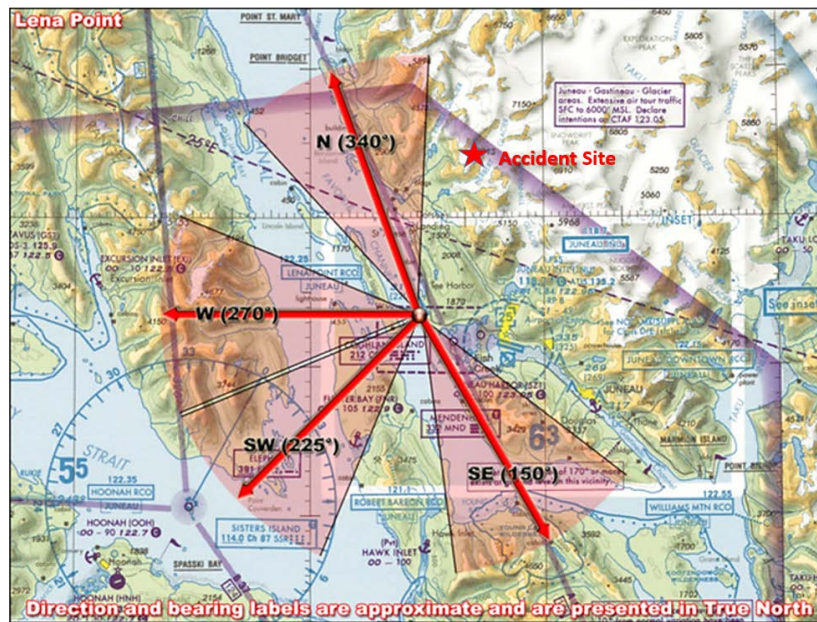
Figure 7 - Lena Point Weather Camera

The FAA had a weather camera at Lena Point, identifier QLT, located about 12.5 miles south or at an 198° azimuth from the accident site, at an elevation of 170 ft. Figure 7 is a depiction of the Lena Point camera views with the approximate location of the accident site marked. The north camera was centered on 340° azimuth and viewed the conditions over the Favorite Channel out to the Lynn Channel area west of the Glacier. A depiction of the visibility references for the North camera from Lena Point on a clear day is included as figure 8. The terrain at 2,800 ft located 13.5 statute miles north was located immediately west near the base of the glacier with the accident site off to the right of the image. Figure 9 is the southeast camera reference markers looking towards the PAJN and the Lynn Channel.

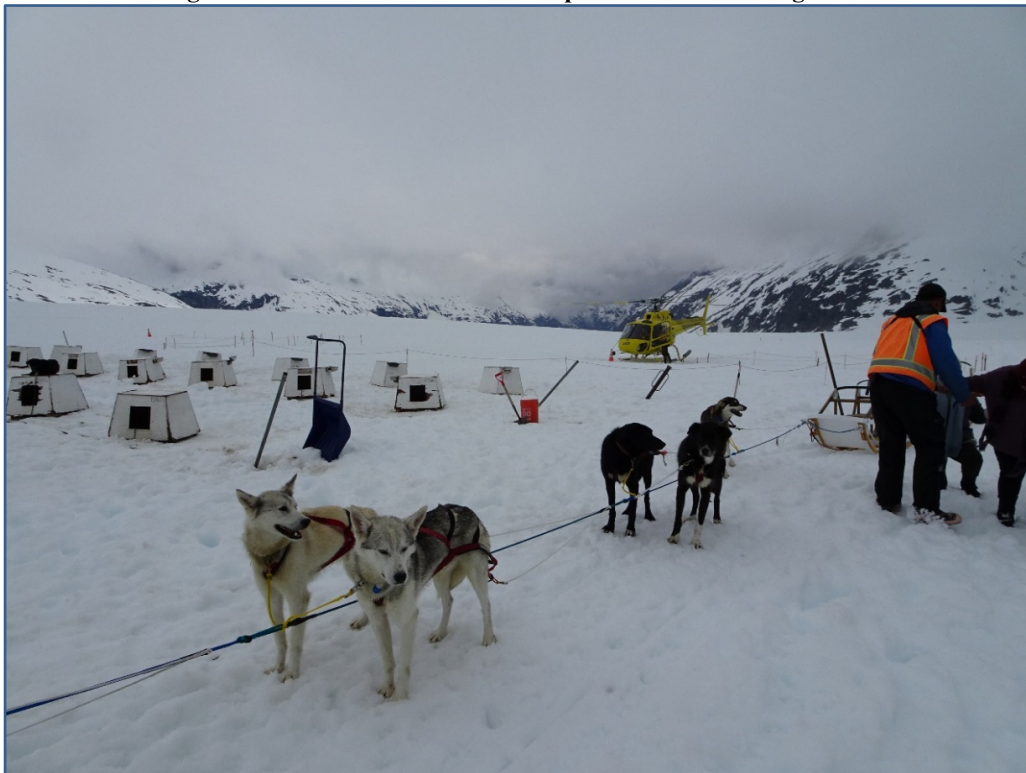
Upon reaching the Glacier at 1525 AKDT the couple indicated that the helicopter was scheduled to come back and pick them up after the dog sled camp and take to another glacier later that day, but due to worsening weather conditions, that portion of the trip was cancelled. They further indicated that intermittent rain was occurring during the entire period at the dog camp and while dog sledding. Figure 27 is a picture of the couple and the low clouds looking back towards the departure route from the glacier, with figure 28 one of the helicopters looking back towards the way they flew in and the low clouds.

**Figure 28 - Dog sled camp looking back towards the way they flew in**

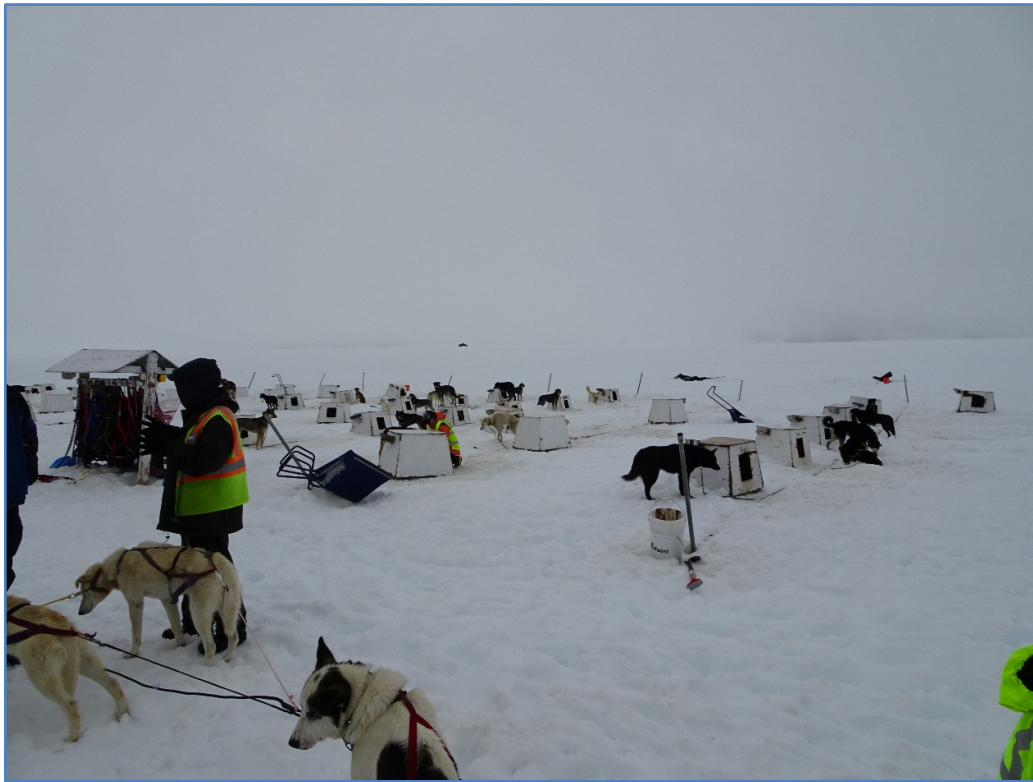
When their dog sled ride was completed and they waited back at camp for the helicopter to return. As they waited, they saw a helicopter break out of the clouds, and then immediately turn around and they assumed headed back to the Juneau Airport. According to the passengers, they were advised that the pilot was more of a visual flyer and because of the worsening weather he was called back and another more instrument rated pilot would return. Figure 31 is the image immediately prior to the helicopter breaking out of the clouds and returning to Juneau at approximately 1740 AKDT.

**Figure 31 - Back at dog camp prior to their return to Juneau**
