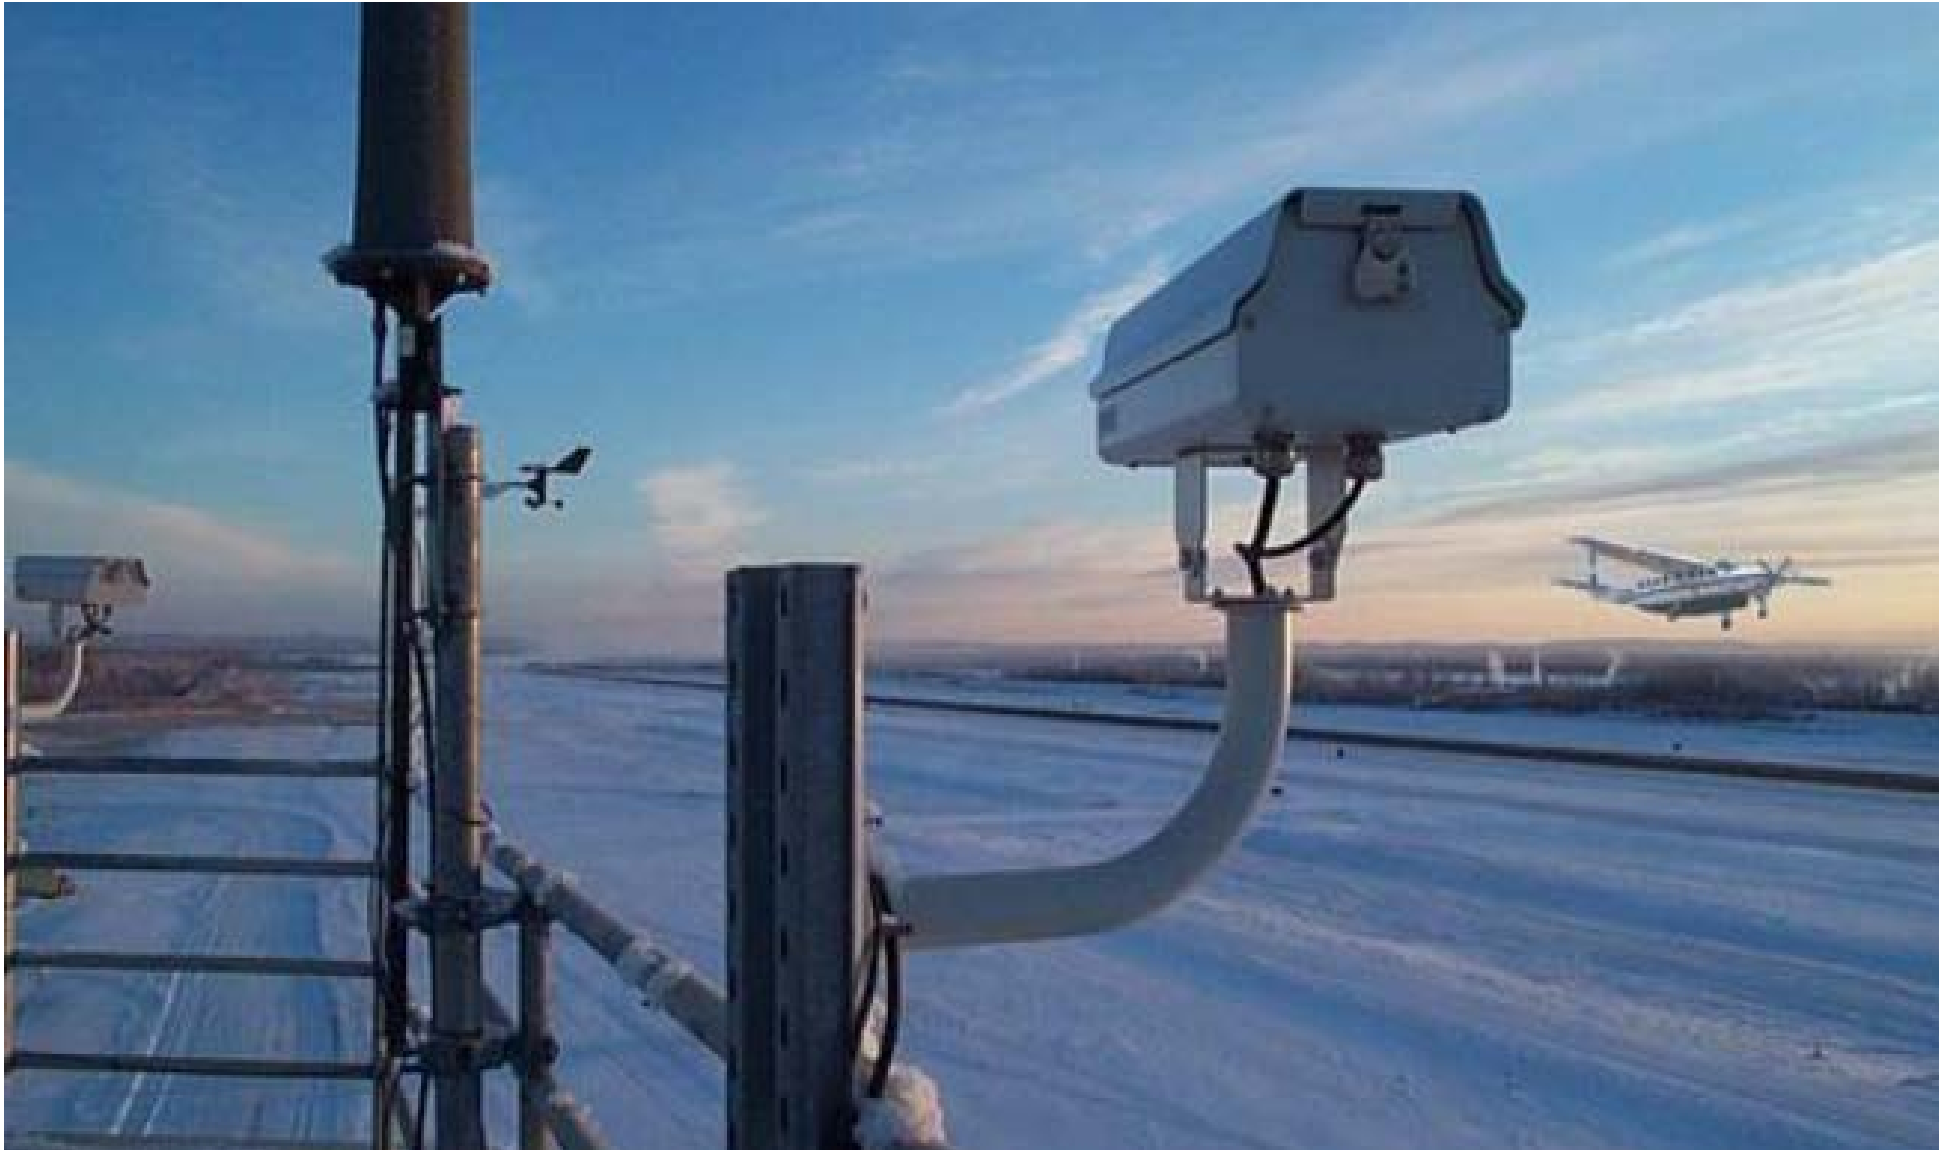
**Photo 8 – Exemplar: FAA aviation weather camera in Alaska (courtesy of the FAA).**

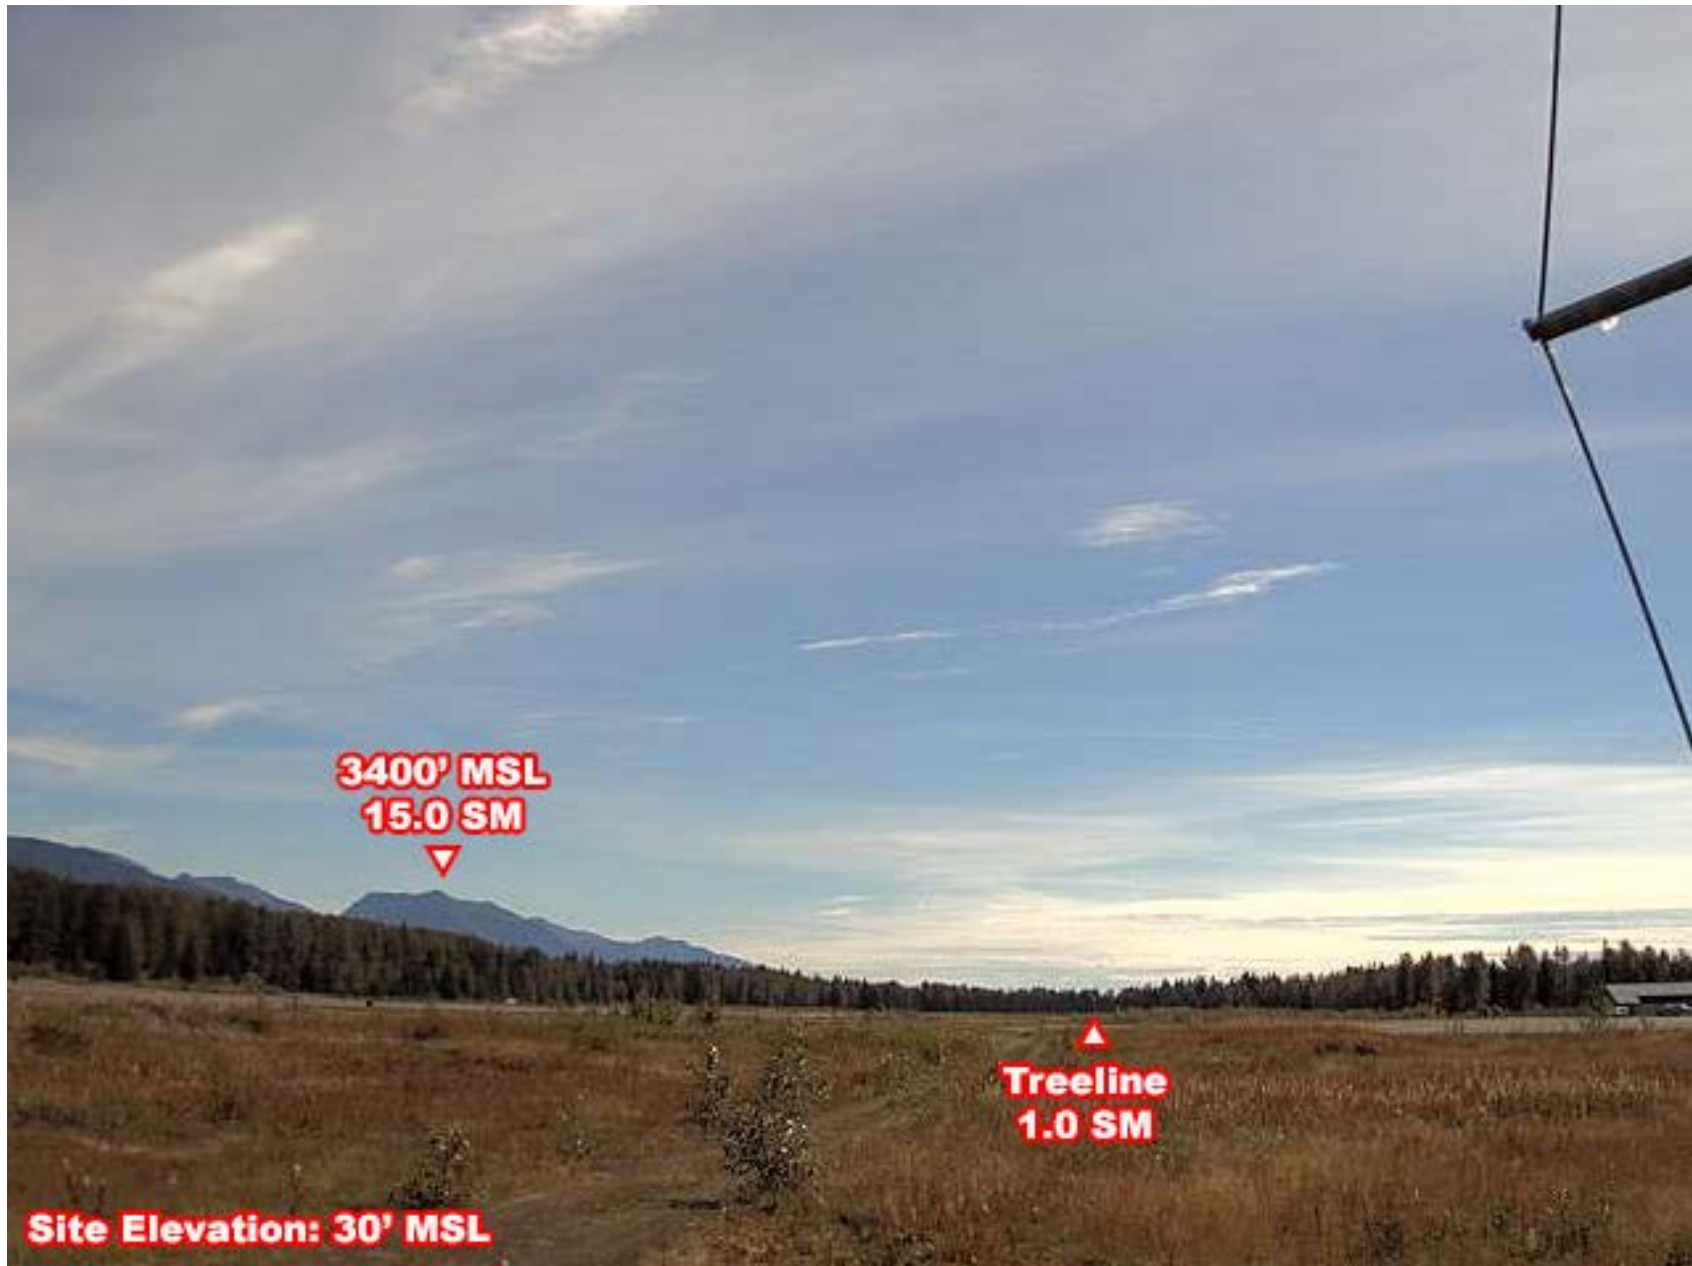
**Photo 10 – Exemplar: Gustavus Airport (GST), Gustavus, Alaska, FAA aviation weather camera (southeast) clear day reference image (courtesy of the FAA).**

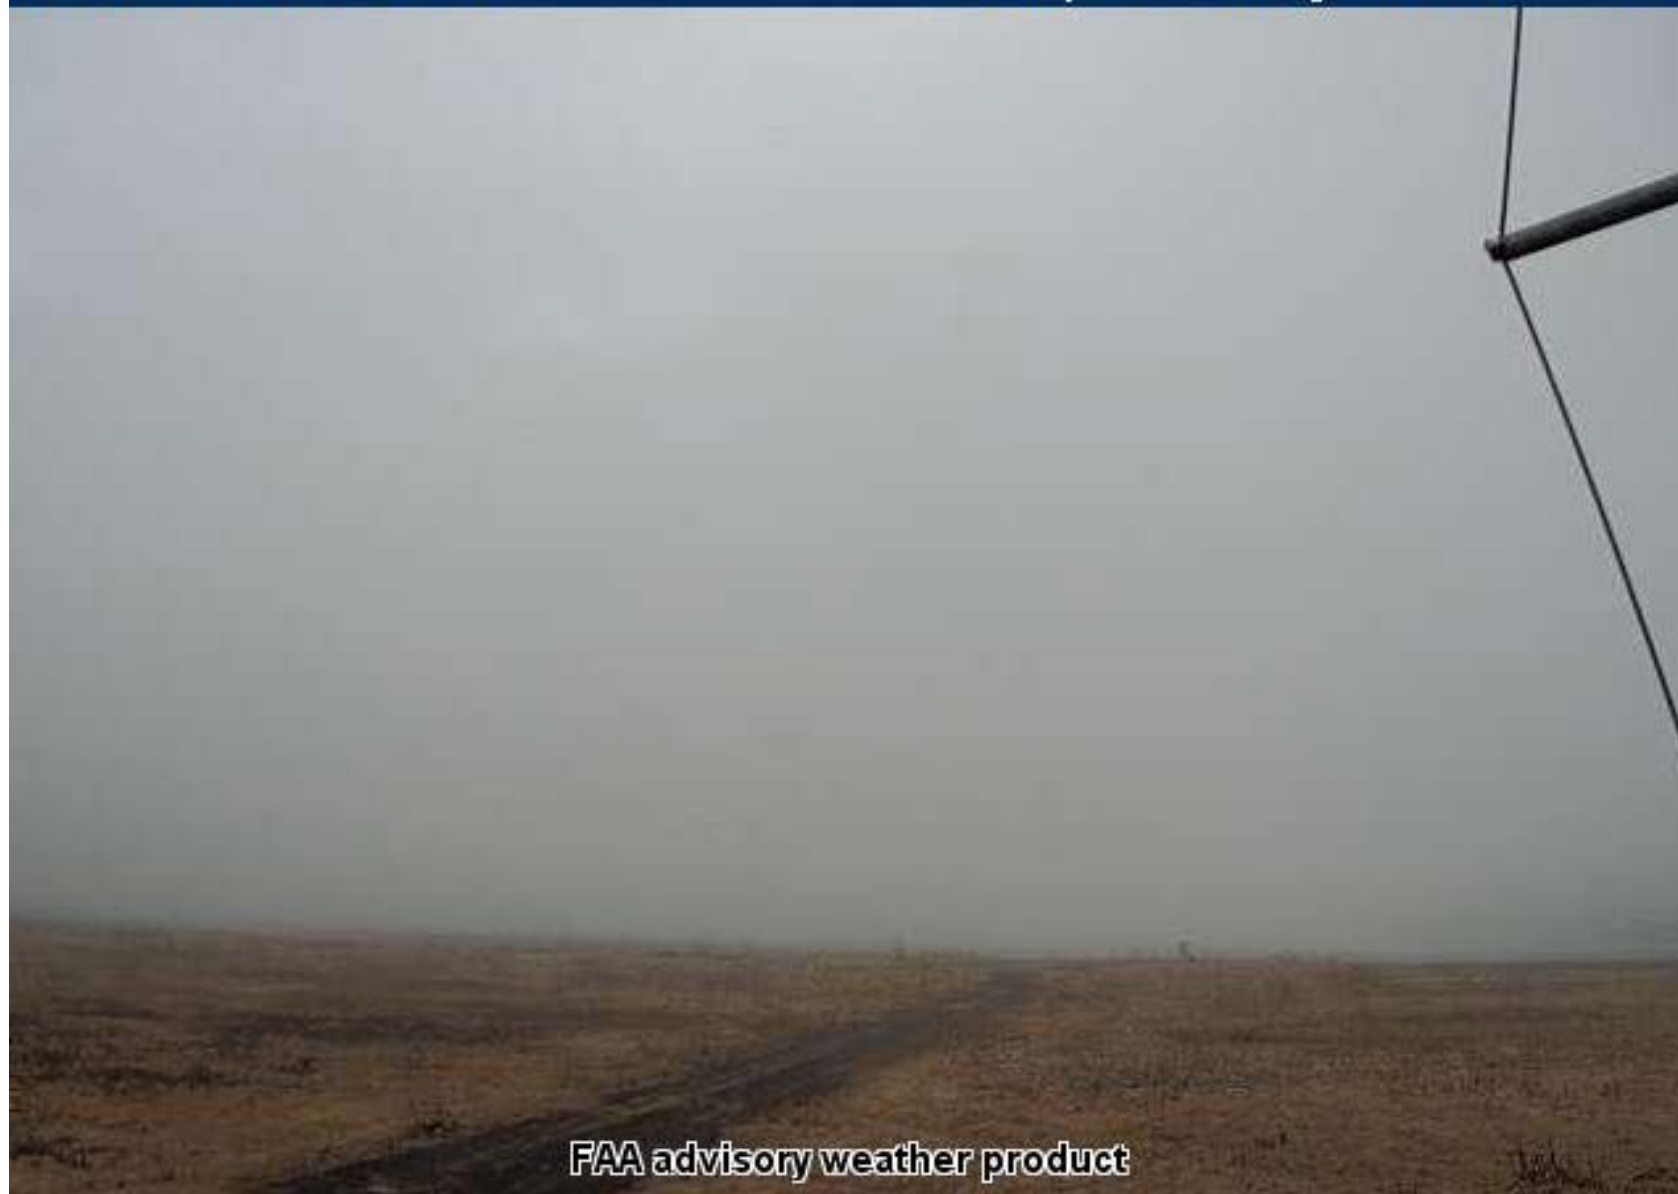
**Photo 11 – Exemplar: Gustavus Airport (GST), Gustavus, Alaska, FAA aviation weather camera (southeast) instrument meteorological conditions image (courtesy of the FAA).**

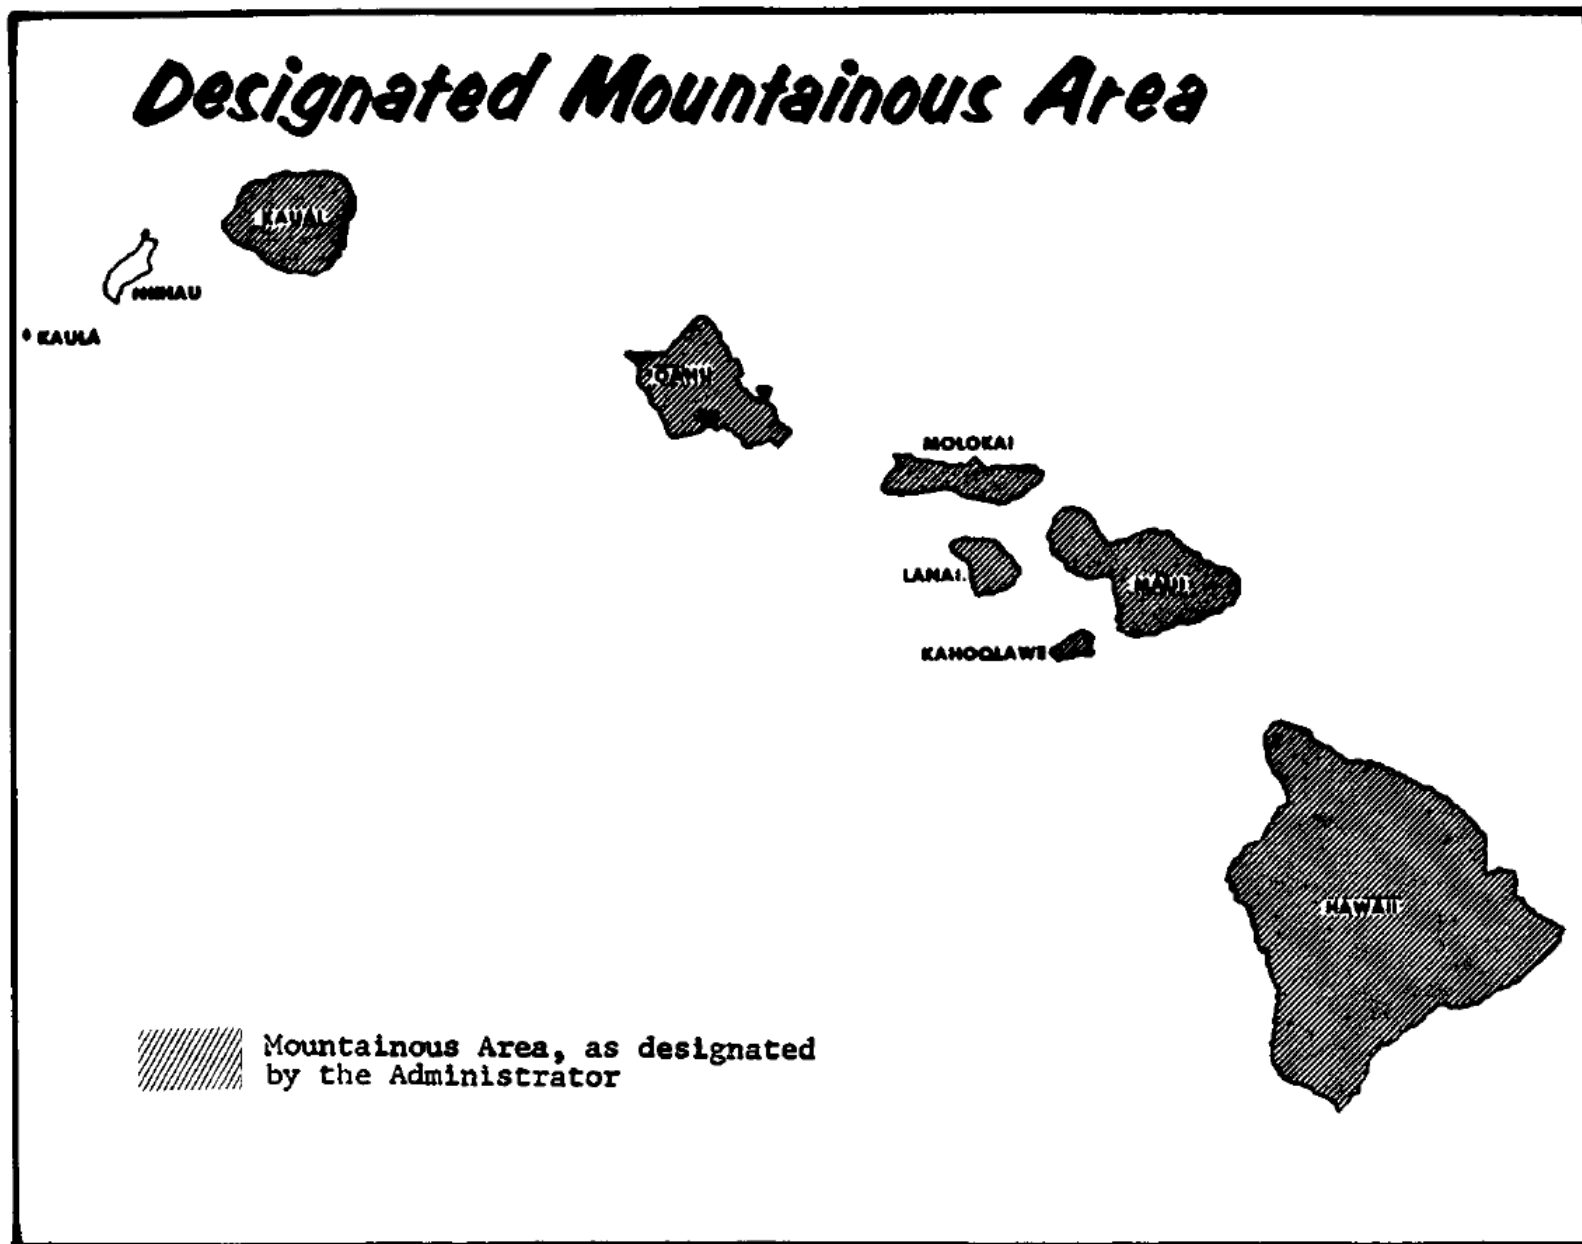
Photo 12 – Designated mountainous terrain in Hawaii (courtesy of the Electronic Code of Federal Regulations).
