## ENGINE EXAMINATION REPORT

| ENGINE MODEL | IO-470-J1B |
| AIRCRAFT REGISTRATION | N9378Y |
| FILE NUMBER | 17-404 |

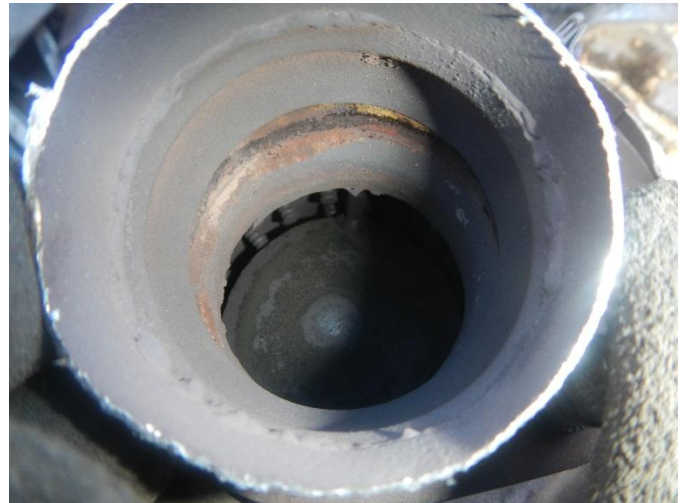
Left

Condition: The exhaust system remained attached to the engine. The left side exhaust system remained intact, but the left muffler/tailpipe was cut away from the exhaust manifold and remained with the aircraft. No pre-accident anomalies were noted with the left side system. The right muffler remained attached to the exhaust system and the right tailpipe was removed from the muffler. No pre-accident anomalies were noted with the right side system.

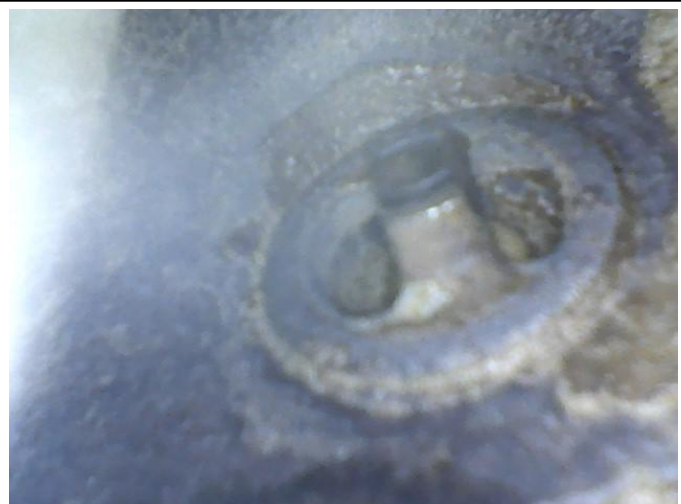
1B

All of the sparkplugs remained secured in place. The top sparkplugs were removed and all displayed a normal worn condition with lean mixture signatures (no signs of lead or carbon fouling). The bottom sparkplugs were examined/documentated with a lighted borescope.
