## MEMORANDUM

**NTSB Accident Number: ANC18FA036 N7061W PA-28**  
**Subject: Investigative Weather Information**

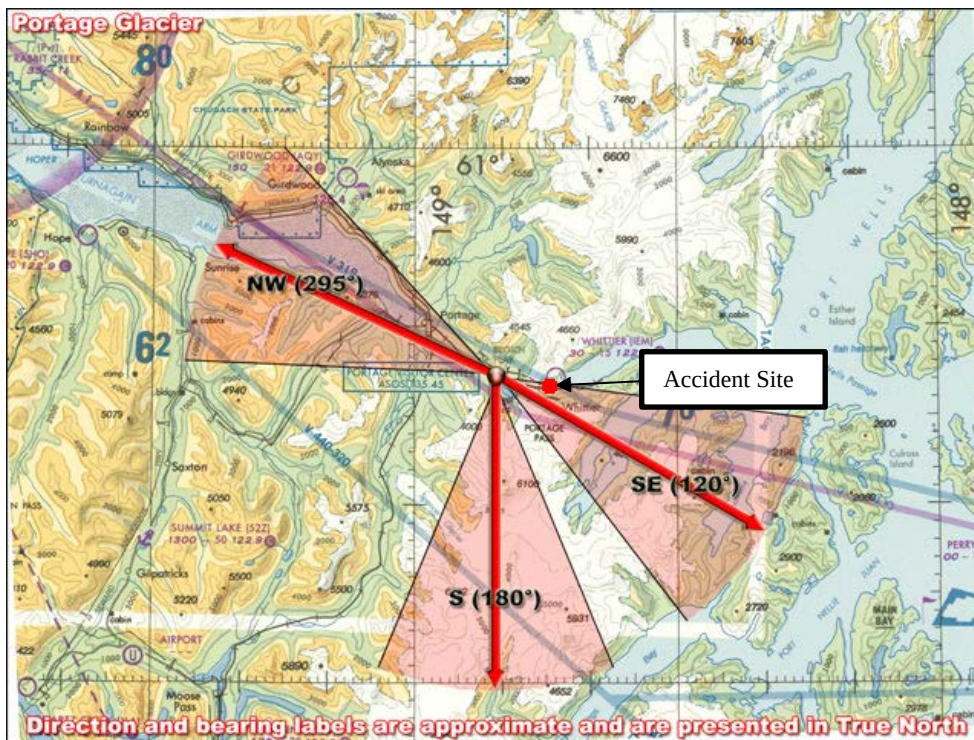
Figure 1. Portage Glacier Camera views.

Portage Glacier Camera views are depicted on the Anchorage VFR Sectional in figure 1. The Southeast (SE) views and visibility on a clear day are depicted in figure 2 and the actual camera image from the time surrounding the accident (0937 local) is depicted in figure 3. The visibility is about 2 statute miles (sm) and the mountains are obscured.

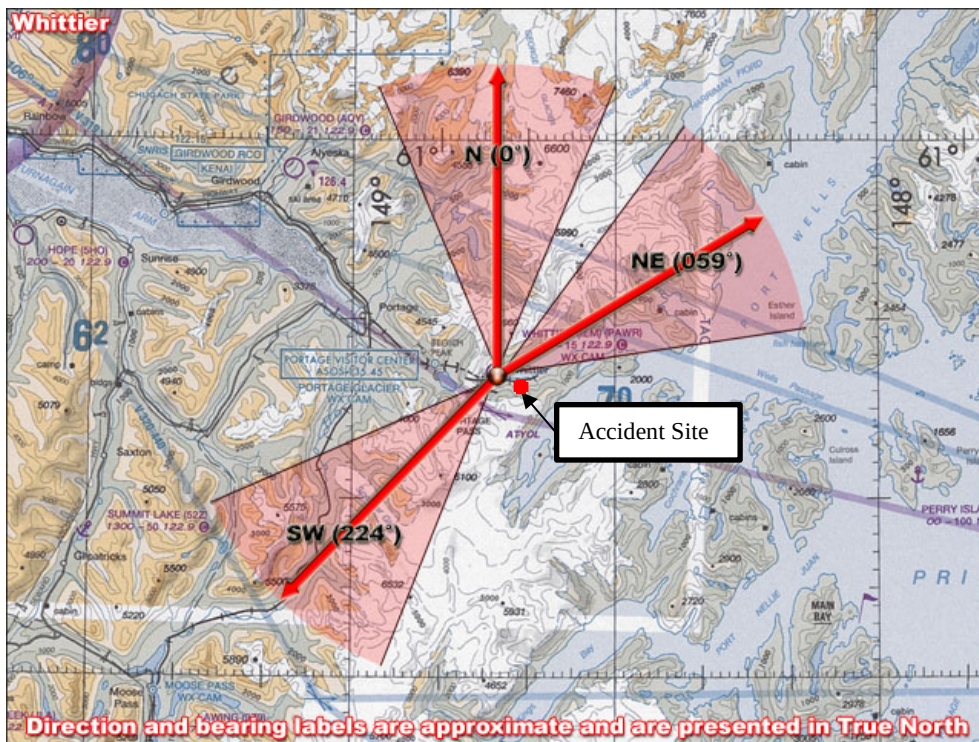
Figure 4. Whittier Weather camera views on VFR sectional chart.

Whittier camera views are depicted in figure 4 and the southwest view on a clear day is depicted in figure 5. The actual southwest camera image at 0941 on May 12 is depicted in figure 6. It indicates that there was a broken to overcast ceiling slightly above 800 ft mean sea level (msl) and the visibility was between 1 and 5 sm. The Whittier northeast view is depicted in figures 7 and 8. Figure 8 indicates that the lowest cloud layer to the north was below 3,100 ft msl and visibility was between 7.5 and 10 sm.
