**From:** Fox Matthew  
**Sent:** Thursday, July 19, 2018 1:34 PM  
**To:** Williams Shaun  
**Subject:** ANC18LA048 - Fairbanks, Alaska - Brake line examination  
**Attachments:** IMG\_1545.JPG; IMG\_1546.JPG; IMG\_1549.JPG; IMG\_1553.JPG

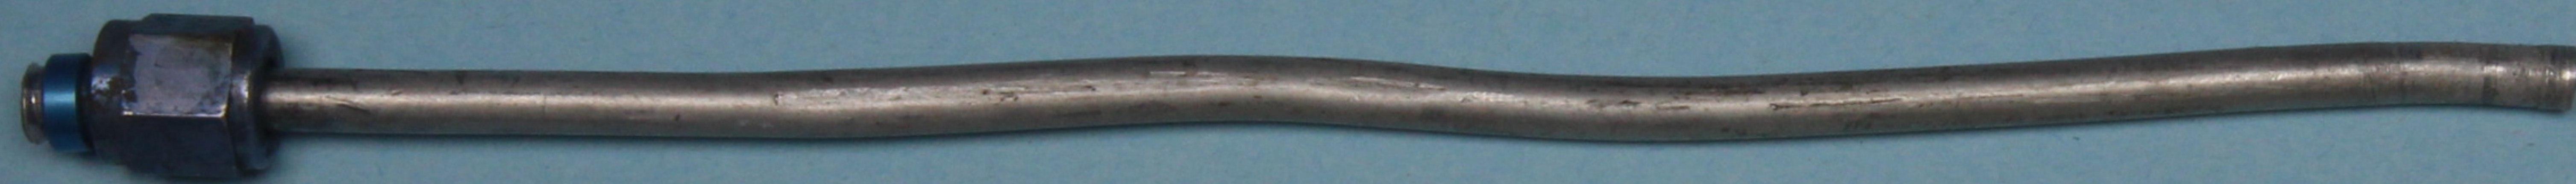
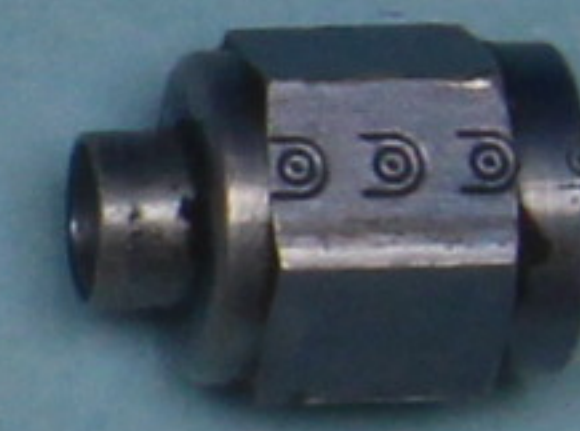
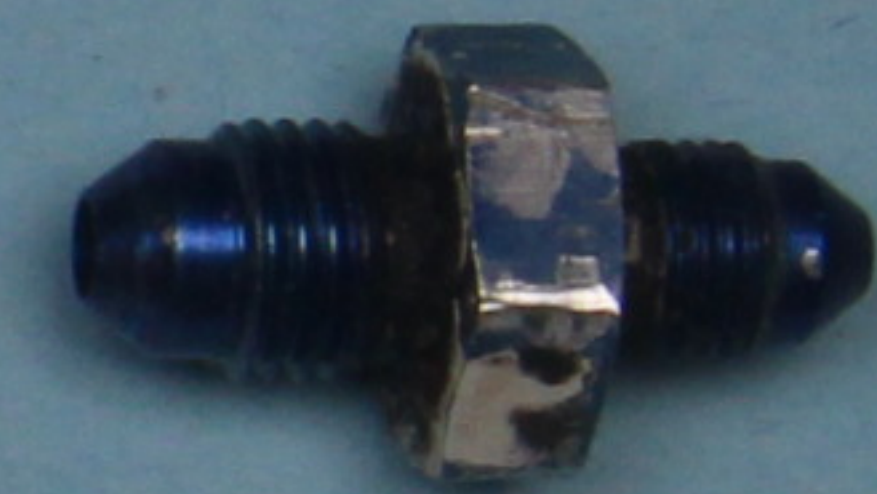
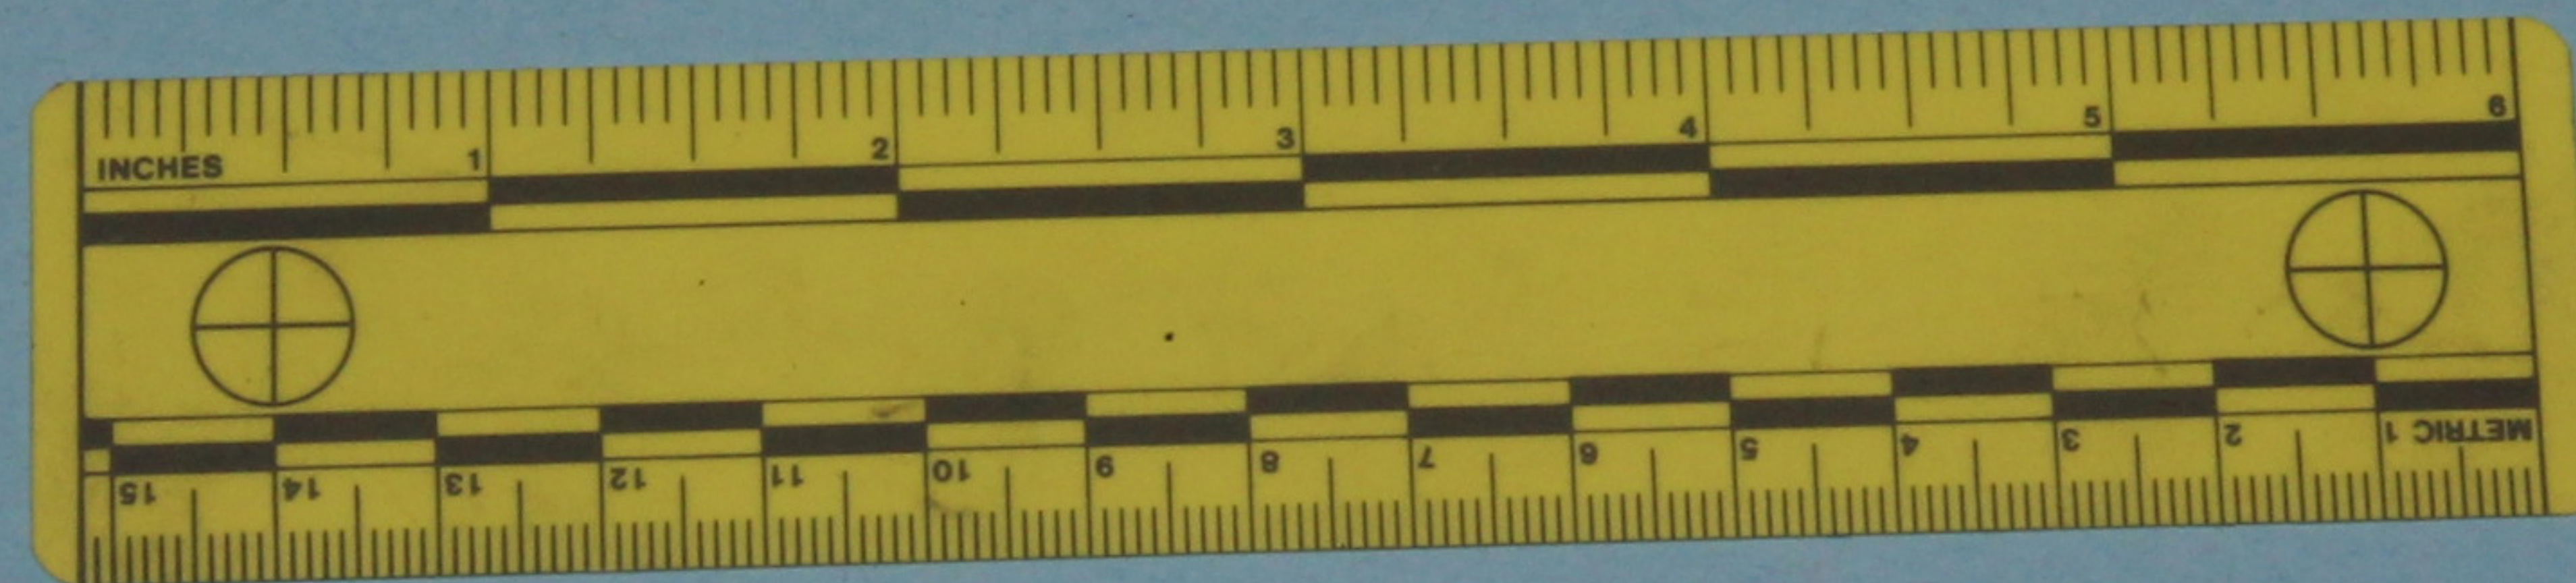
The submitted brake line tube and fitting hardware from the subject investigation were examined at the NTSB Materials Laboratory (see attached photos). At the failed end, the outer diameter of the tube approximately matched the nominal outer diameter of the ¼-inch diameter aluminum tube. The interior surface of the failed end had circumferential marks up to 0.136 inch from the end consistent with formation of a flared end with a flaring tool. The sleeve was trapped within the nut from the failed end, and deposits of gray metal appearing consistent with deformed brake tube material was observed deposited on internal threads of the nut up to 3 threads from the end of the sleeve.

An intact flare with a nut and sleeve was present at the opposite end of the tube. When assembled with the sleeve in place on the intact flared end, the end of the tube was approximately flush with the end of the sleeve. The length of the flared end measured along the interior surface was 0.109 inch.

According to Federal Aviation Administration Advisory Circular AC 43-13-1B, *Acceptable Methods, Techniques, and Practices – Aircraft Inspection and Repair*, a double flare is used on soft aluminum tubing having a 3/8-inch outside diameter or less. No evidence of folded walls consistent with a double flare was noted at either end of the submitted brake line tube.
