## **Wreckage Examination Summary**

NTSB ACCIDENT NUMBER: ANC18LA069

AIRCRAFT REGISTRATION/AIRCRAFT TYPE: N3957X, Piper PA-32

ACCIDENT LOCATION: Wrangell, Alaska

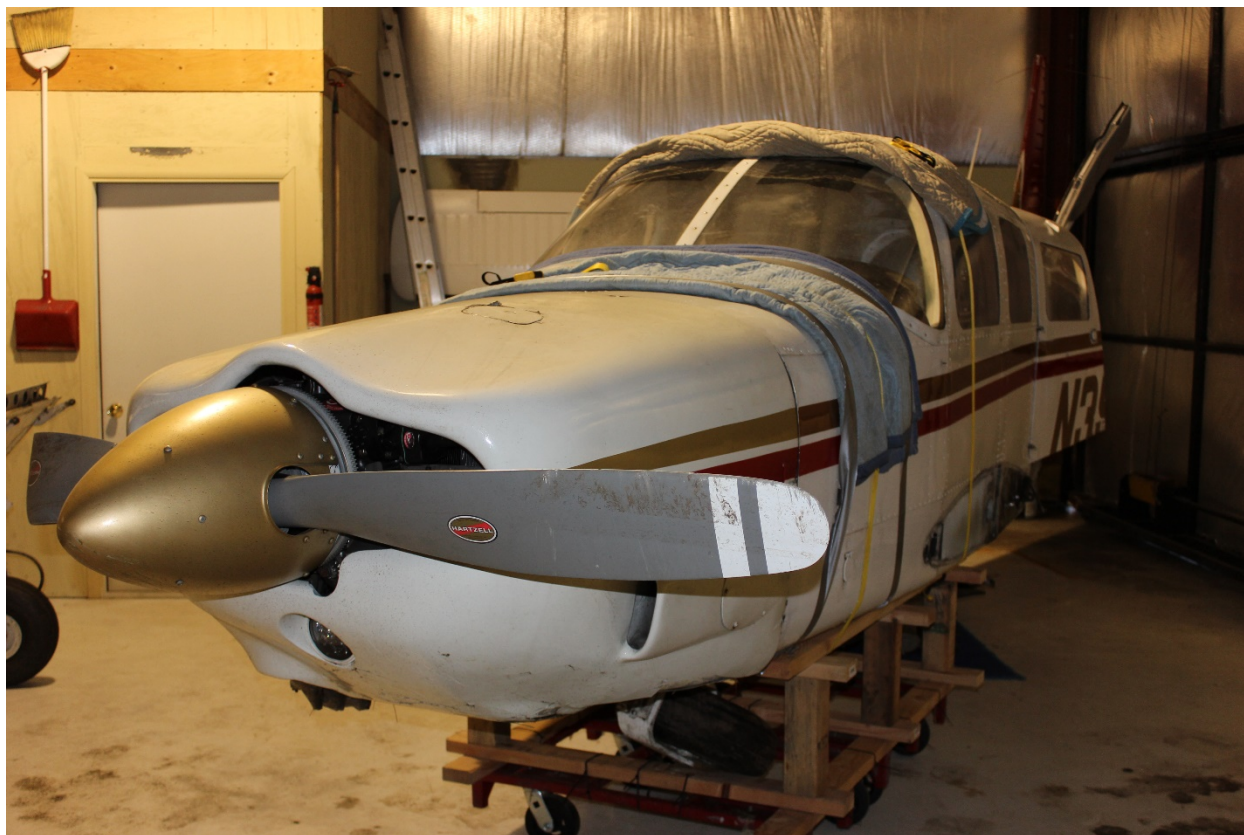
**ANC18LA069 N3957X Piper PA-32**

According to the pilot, while in level cruise flight, the engine rpm increased to 3000. In an effort to correct for the high rpm the pilot reduced manifold pressure to 17 inches of mercury. Shortly thereafter, he noticed the engine oil pressure drop with oil visible on the airplane's windscreen, followed by a total loss of engine power. He performed an emergency landing near the high tide line in an area of seagrass. During the emergency landing the airplane sustained substantial damage to the left wing.
