## **NATIONAL TRANSPORTATION SAFETY BOARD**

### **Group Chairman's Factual Report**

# **AIR TRAFFIC CONTROL**

ANC19LA031

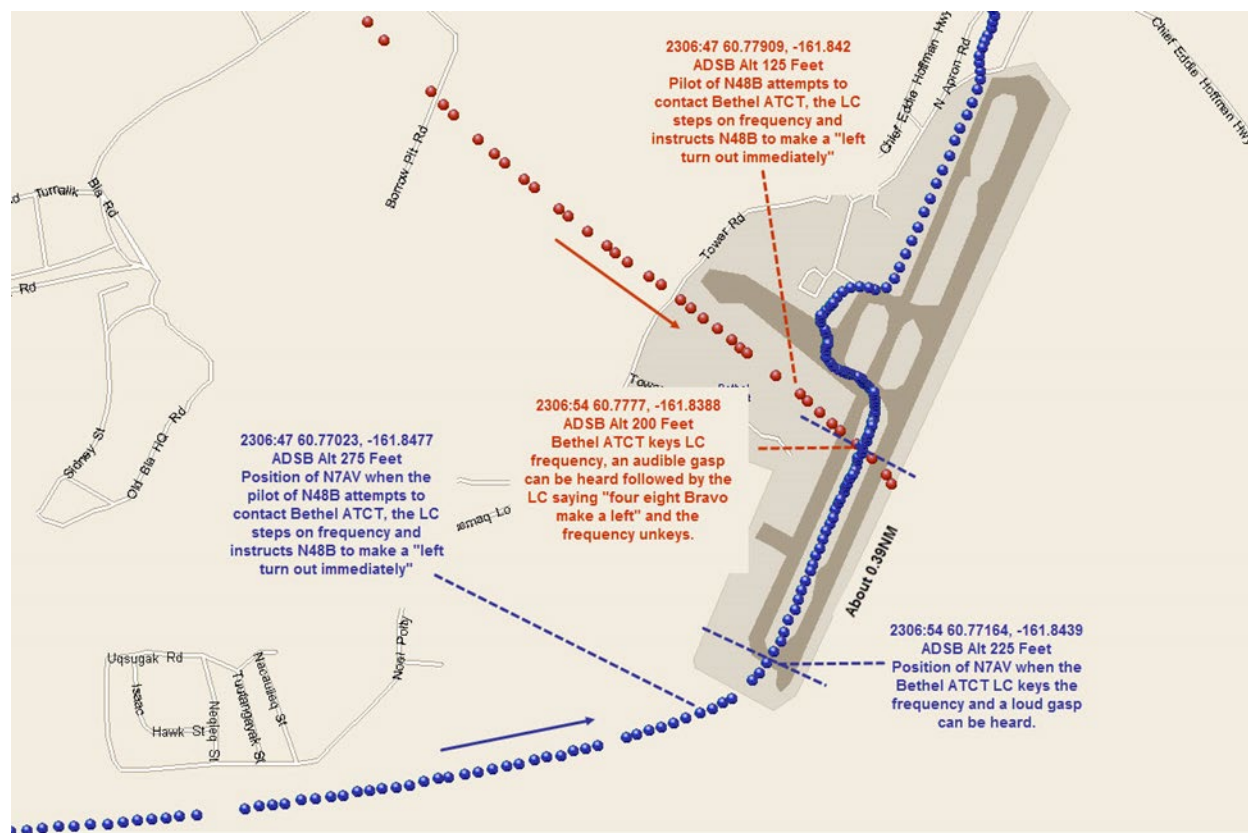
Automatic Dependent Surveillance-Broadcast (ADS-B)<sup>5</sup> surveillance data used for the investigation was provided by the FAA. ADS-B is a performance-based surveillance technology that is more precise than radar. The accident aircraft was equipped with ADSB and the ADSB data was requested from the FAA. The data was of good quality and useable to the investigation. Figure 1 illustrates the track of N9448B when the aircraft was about 4.01 nautical miles from the threshold of runway 12.

Figure 1 - Illustrating the flight path of N9448B when the aircraft was about 4.01 NM from the runway threshold.
