**National Transportation Safety Board**  
Office of Research and Engineering  
Washington, D.C. 20594

## Airplane Performance Study

**Location:** Kapalua, Hawaii  
**Date:** August 18, 2019  
**Time:** 2038 GMT (1038 HST)  
**Airplane:** Cessna 208B Caravan, N879MA  
**NTSB Number:** ANC19LA046

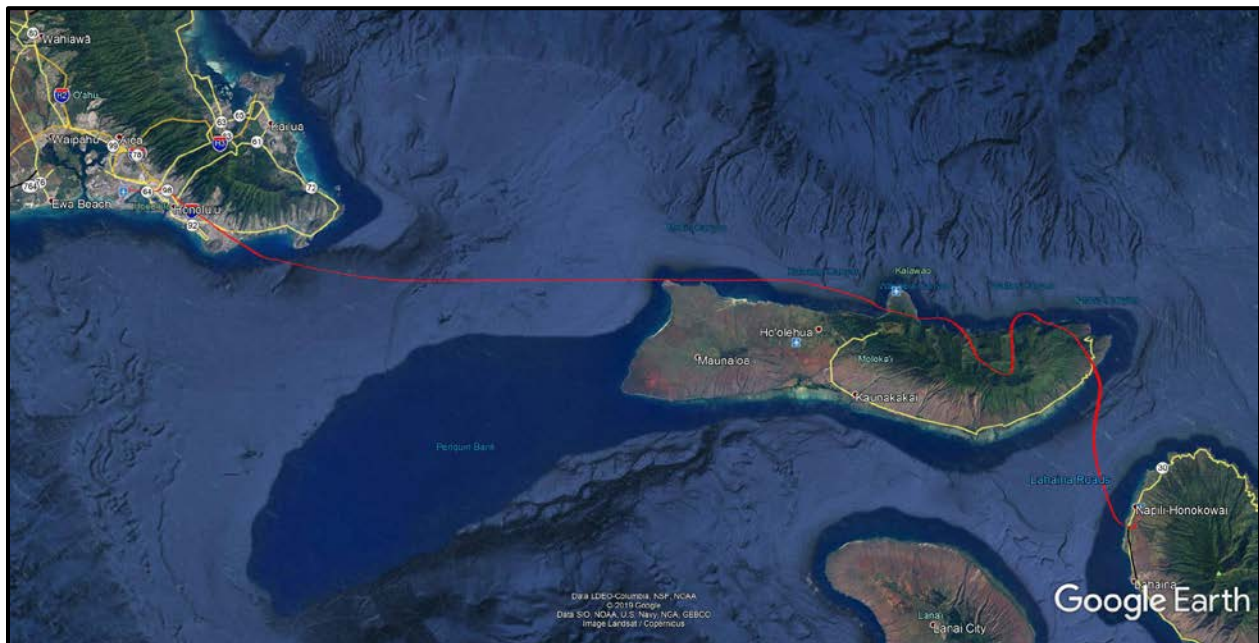
**Figure 2: Mokulele Airlines Flight 504 Ground Track Recorded on Recovered G1000**

The flight originated from the Daniel K Inouye International Airport (HNL) in Honolulu, HI, about 0947 HST. A picture of the direct route is shown in Figure 1. The recorded ground track recovered from the airplane's Garmin G1000 integrated flight instrument system is shown in Figure 2.

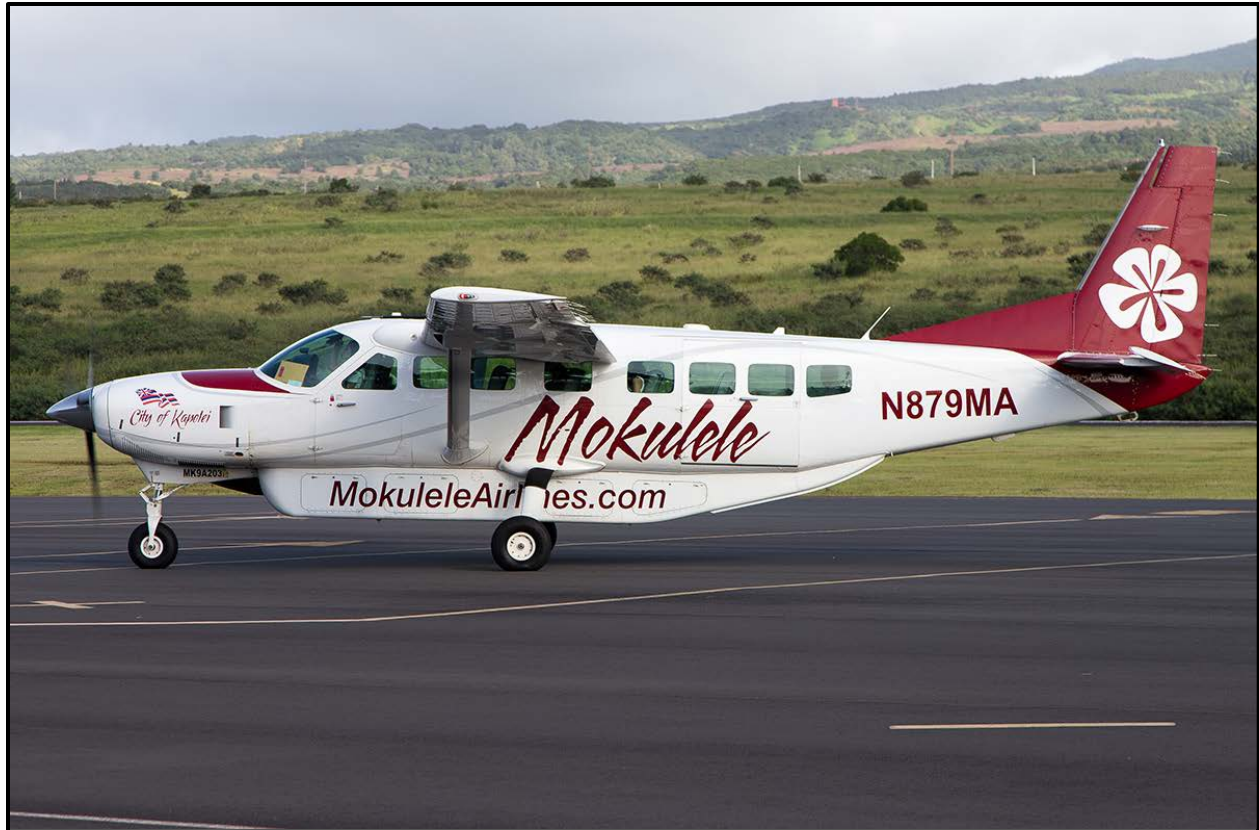
**Figure 3: Accident Airplane, N879MA, a Cessna 208B Grand Caravan EX**

A picture of the accident airplane, a Cessna 208B Grand Caravan EX, is shown in Figure 3. The airplane was manufactured by Cessna in 2013.

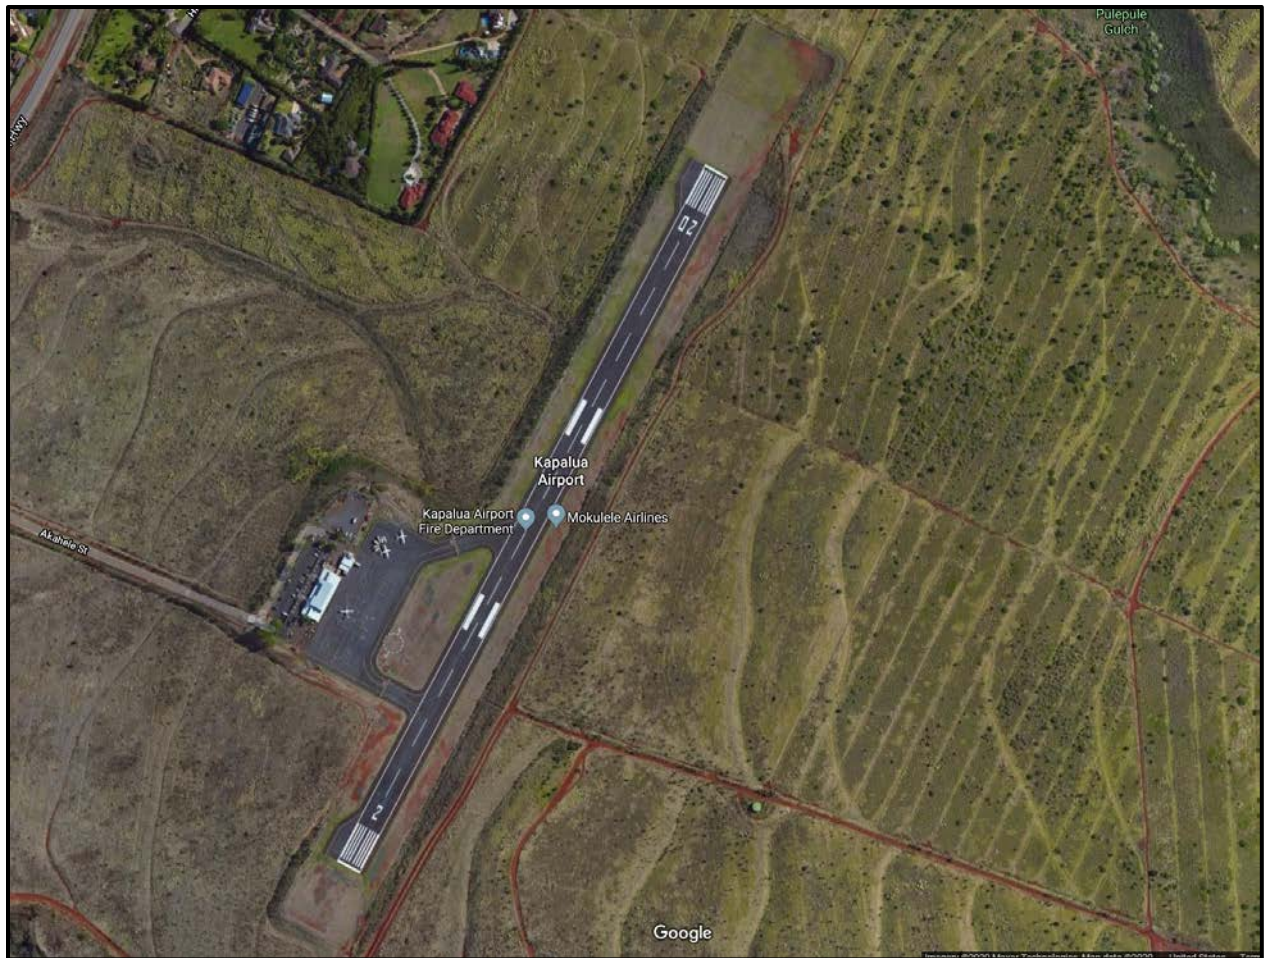
**Figure 4: Kapalua Airport (HJH)**

The runway markings, including the runway threshold, are shown in Figure 4. Figures 5 and 6 show the airplane's ground track recorded on the G1000 during the approach to Kapalua airport's runway 2 as well as the final off-runway resting place of the airplane. A rear view of the airplane in a ditch is shown in Figure 7.

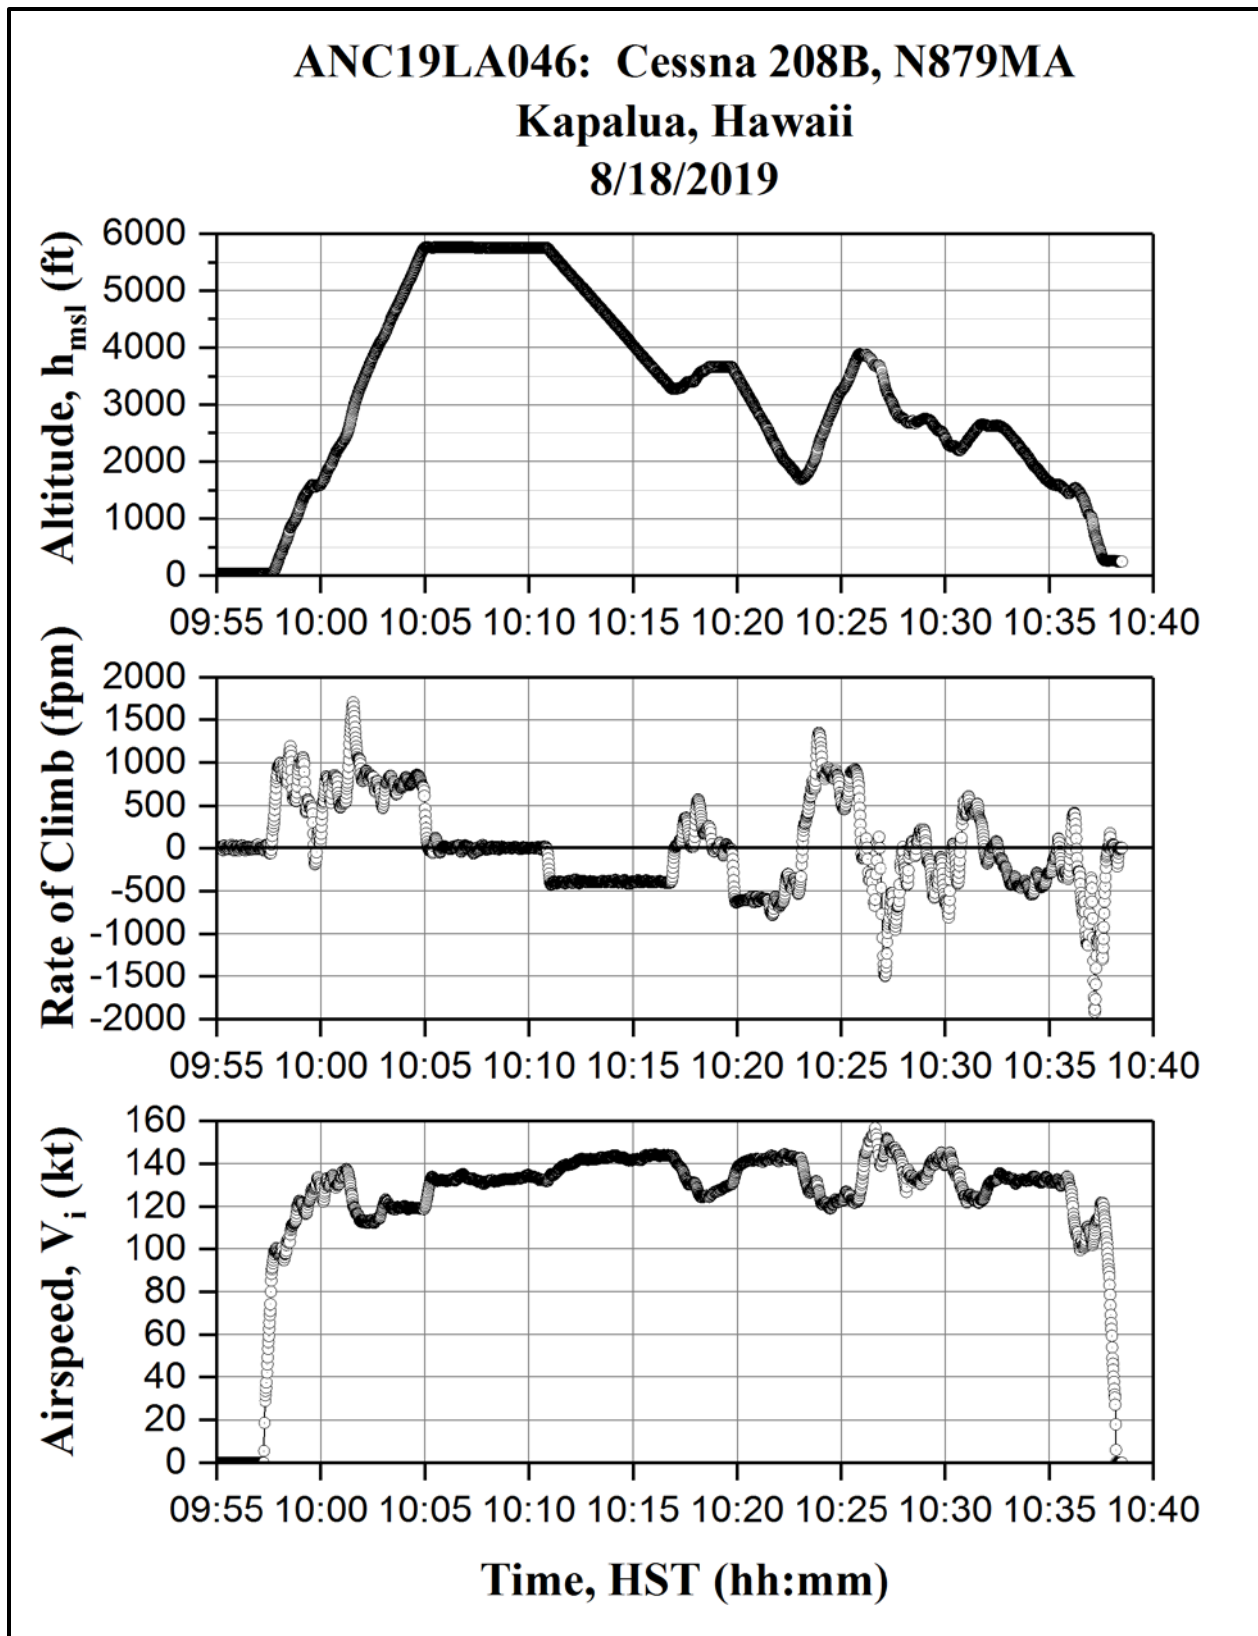
Figure 8: Altitude and Airspeed for Entire Flight Recorded on Recovered G1000

Altitude, airspeed, and airplane attitude for the entire flight are shown in Figures 8 and 9. Flight 504 remained below 6,000 ft altitude most of the time, and the rate of climb varied between +/- 1,500 feet per minute (fpm) until it reached 2,000 fpm in the final descent.
