# NATIONAL TRANSPORTATION SAFETY BOARD

## MATERIALS LABORATORY FACTUAL REPORT

Report No. 20-037

Place : Mokuleia, Hawaii  
Date : February 22, 2020  
Vehicle : Cessna Ector 305A, N65070  
NTSB No. : ANC20FA024  
Investigator : Noreen Price, AS-ANC

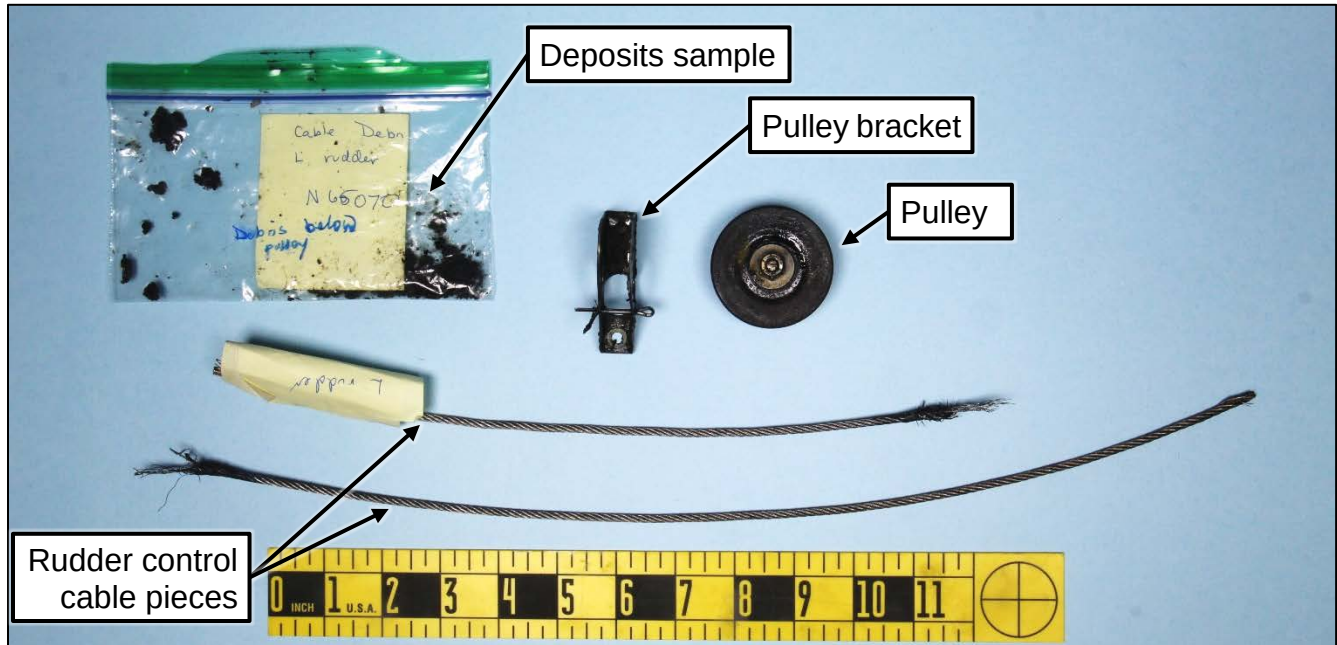
An overall view of the submitted components is shown in figure 1. The rudder control cable was fractured, and the cable had been cut forward and aft of the fracture to facilitate removal from the airplane for laboratory examination. The rudder pulley was received disassembled from its corresponding support bracket as shown in figure 1, and the pulley support bracket had been disassembled from the airplane structure. A plastic bag containing a sample of deposits collected from an area near the rudder pulley was also included with the submitted components.

Figure 1. Overall view of the submitted components.
