# NATIONAL TRANSPORTATION SAFETY BOARD

## MATERIALS LABORATORY FACTUAL REPORT

Report No. 20-028

Place : Kalapana, Hawaii  
Date : March 5, 2020  
Vehicle : Airbus Helicopter EC130-B4, N11QK  
NTSB No. : ANC20LA028  
Investigator : Brice Banning, ASI-ANC

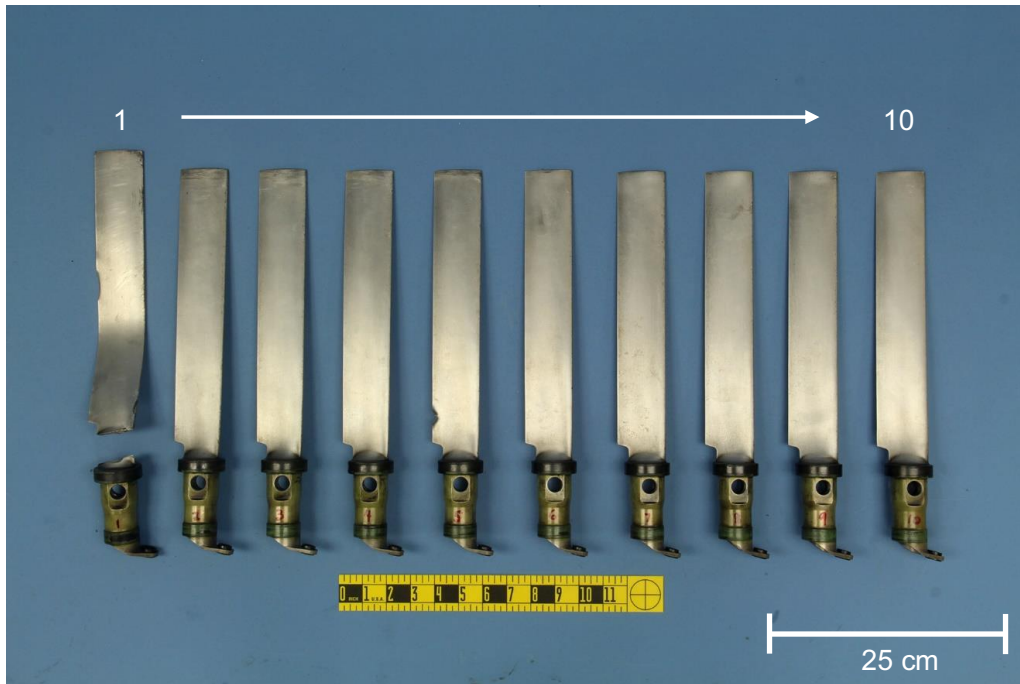
Ten fenestron tail rotor blades were submitted to the NTSB Materials Laboratory for examination as shown below in figure 1. One of the blades was fractured at the root end of the airfoil while the other nine blades were intact. The blades were numbered 1 through 10 with number 1 being the fractured blade. An in-the-field photo of the fenestron is shown in figure 2, with the blades numbered clockwise around the hub as viewed from the left side of the aircraft.

**Figure 1:** Image of the ten fenestron blades as received.

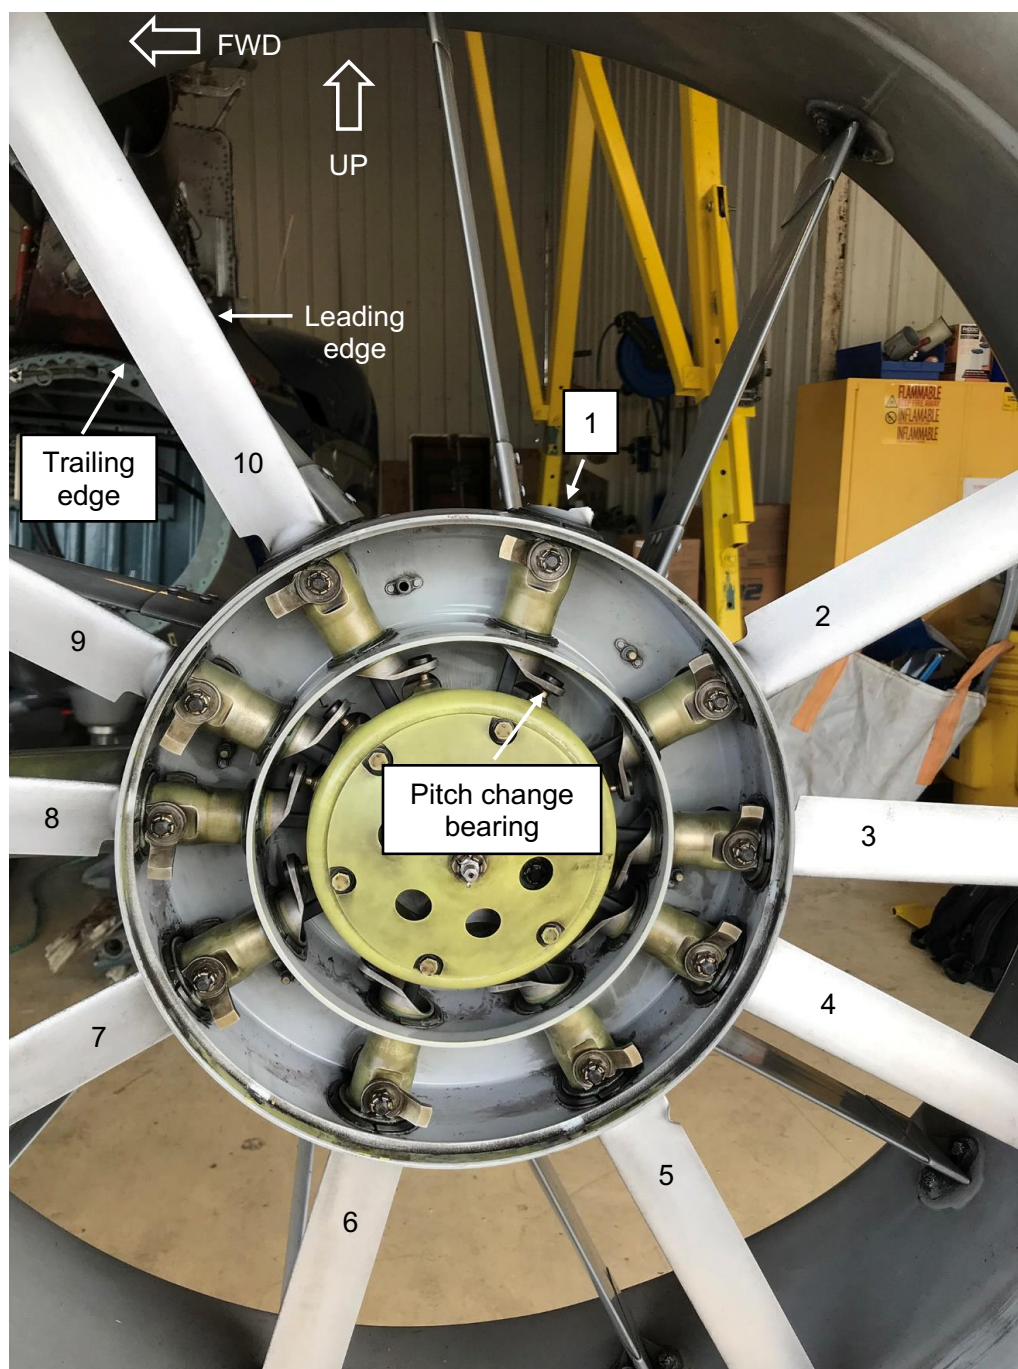
**Figure 2:** Image of the accident helicopter's fenestron showing the blade layout and the location on the hub of the fractured blade.

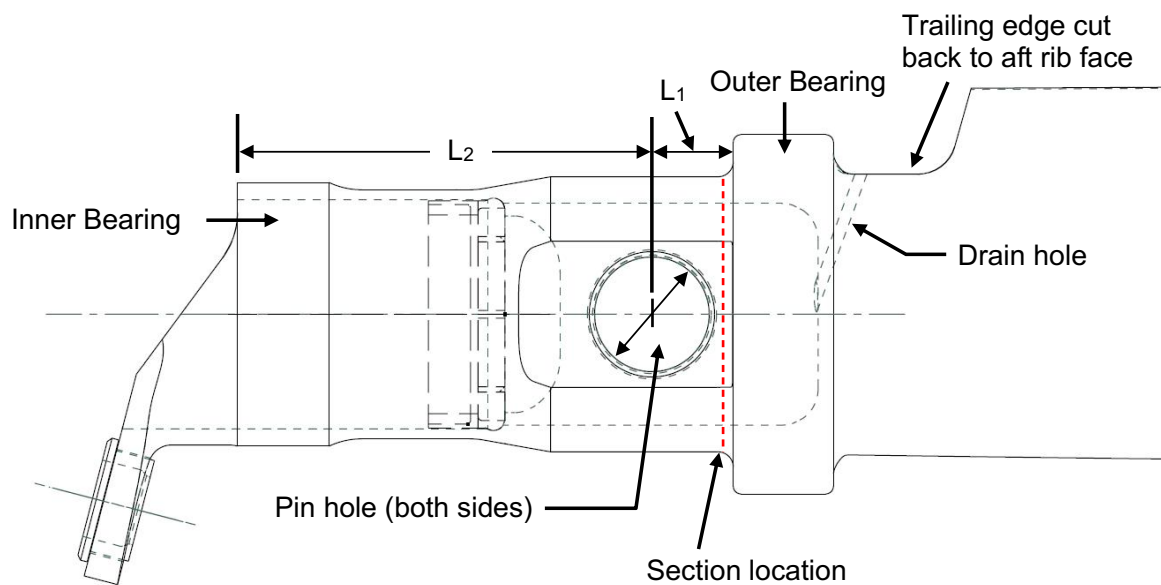
respectively. The longitudinal distance from the center of the pin hole to the underside of the outer bearing, indicated as  $L_1$  in figure 4, was measured on the suction and pressure sides of the blade as 10.59 mm and 10.58 mm. Finally, the longitudinal distance from the center of the pin hole to the underside of the inner bearing, indicated as  $L_2$  in figure 4, was measured once as 54.49 mm. All dimensional attributes were in accordance with the requirements on the engineering drawing.

**Figure 4:** Illustration of the fenestron tail rotor blade root end showing dimensional attributes and features that were measured.

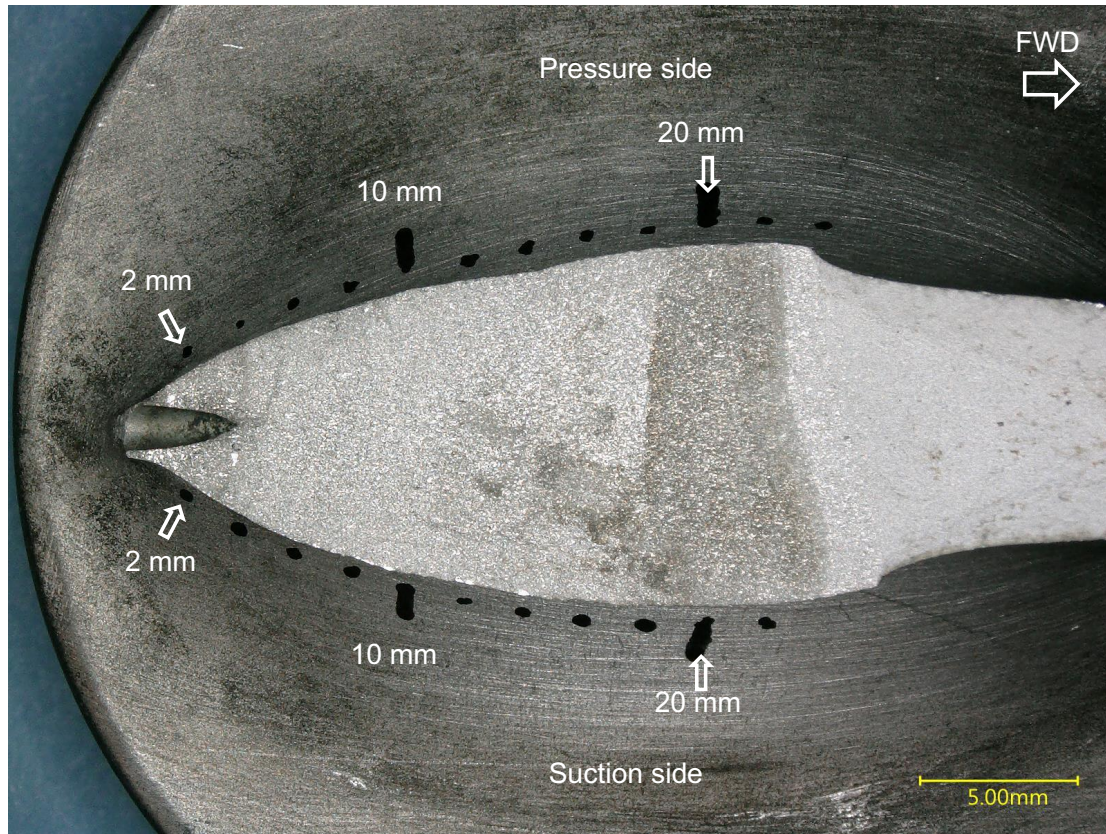
Variations in backscatter images were also observed along the pressure and suction side airfoil surfaces. Both surfaces were examined by SEM just below the fracture starting at the aft rib face and proceeding forward. Pen markings were placed on each surface at 2mm intervals starting at the rib and proceeding forward as shown in figure 17. From the aft rib to approximately 2 mm, the surface exhibited an oxidized/pitted appearance, similar to that noted previously, and backscatter images exhibited both dark and bright regions. Examples for the pressure side and suction side 2 mm forward of the rib face are shown in figures 18a and 19a, respectively. At approximately 4 mm, the surface began to exhibit scratch marks and by 12 mm, the transition to a scratched/abraded texture was nominally complete. Examples for the pressure side and suction side 20 mm forward of the rib face are shown in figures 18b and 19b, respectively.

**Figure 17:** Plan view image of the root-side fracture with marks every two millimeters along each airfoil surface starting from the aft rib face.

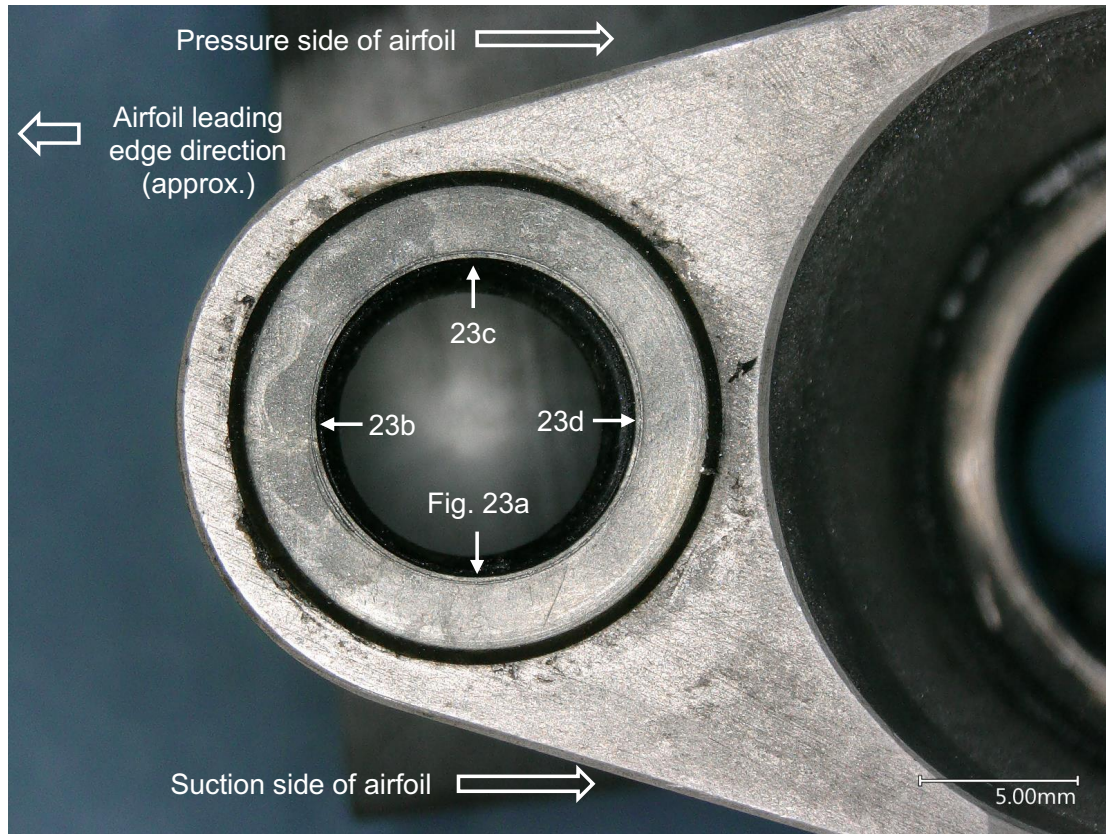
The pitch change bearing (see figures 3 and 22) was examined with the aid of a stereomicroscope and exhibited wear on the bearing face. Images of the wear marks were taken using a digital optical microscope, as shown in figures 23a – d and indicated in figure 22, starting toward the suction side of the airfoil and proceeding clockwise (the blade viewed radially outward as in figure 22).<sup>1</sup> Wear marks were observed toward the suction and pressures sides of the bearing, as seen in figures 23a and c. The two wear marks extended around the bearing face and met near the trailing edge direction as seen in figure 23d.

**Figure 22:** Inward looking radially outward view of the pitch change bearing at the base of the blade root. The bearing flange is rotated relative to the airfoil's chordwise direction. Therefore, labels regarding airfoil orientation are approximate.

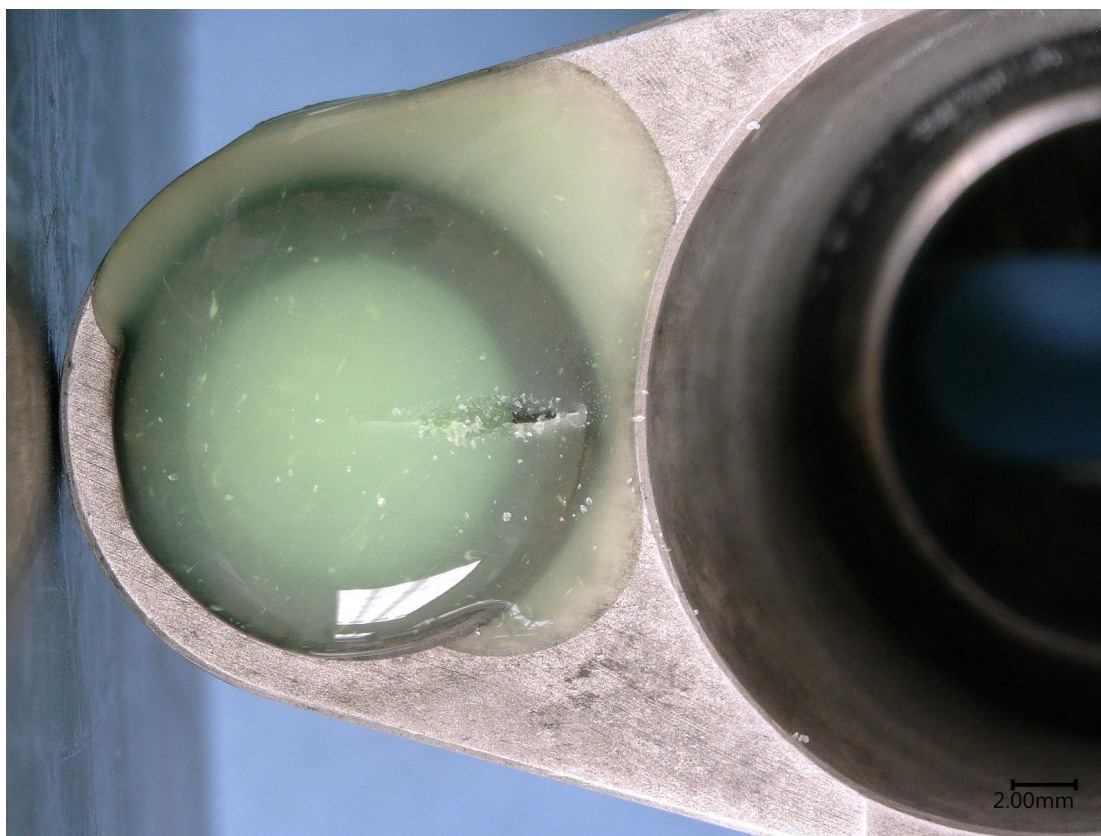
The size and location of the wear marks were measured by making a silicone rubber replica of the pitch change bearing cavity. The replica was scored with a fiduciary mark as shown in figure 24, the excess rubber was cut from the replica, and the replica

**Figure 24:** Silicone rubber mold of pitch change bearing.
