**National Transportation Safety Board**  
Office of Research and Engineering  
Washington, D.C. 20594

## Airplane Performance Study

**Location:** Eagle River, Alaska  
**Date:** April 11, 2020  
**Time:** 2025 Alaska daylight time  
**Airplane:** Cessna A185E, N185RN  
**NTSB Number:** ANC20LA043

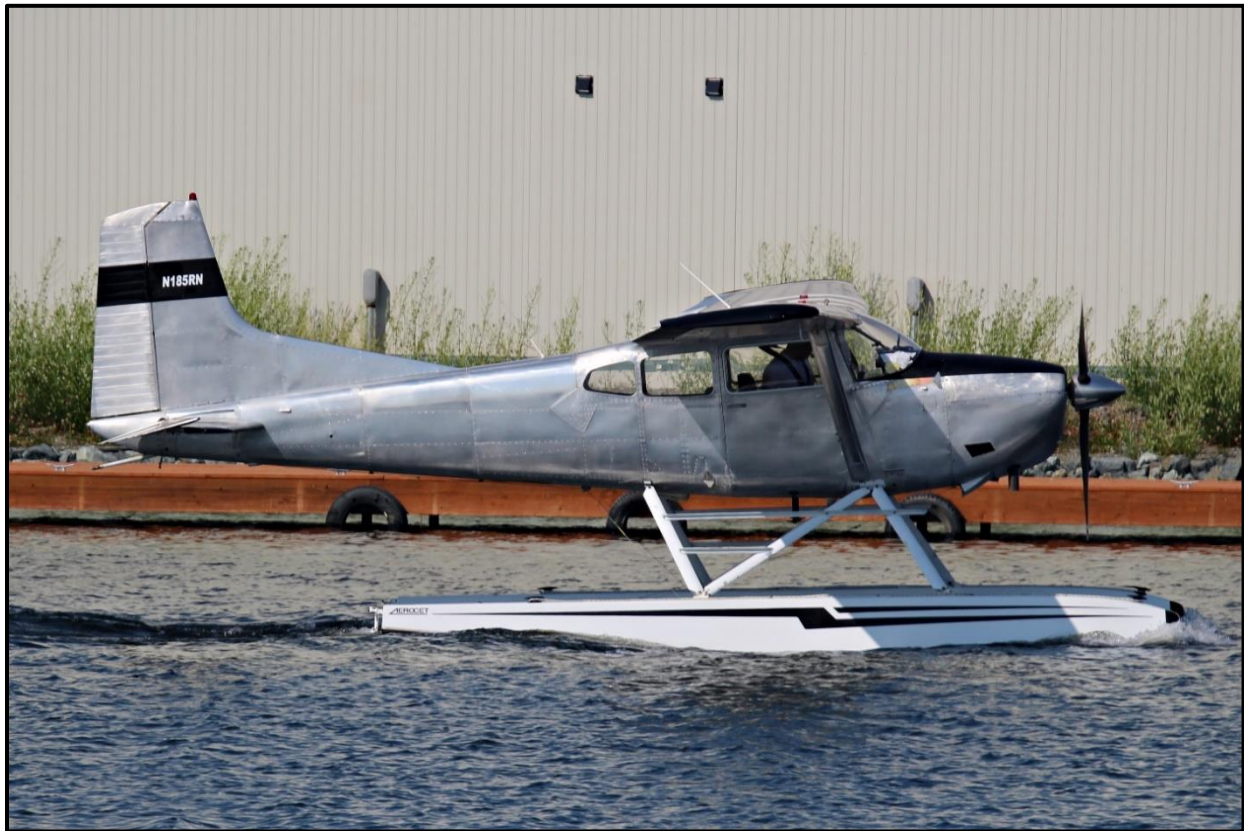
**Figure 1: Accident Airplane, N185RN, a Cessna A185E**

A picture of the accident airplane, a wheel/ski-equipped Cessna A185E, is shown in Figure 1 when it was configured with floats. The airplane was manufactured by Cessna in 1968 and is registered to a private owner. An exemplar wheel/ski-equipped Cessna A185E is shown in Figure 2.

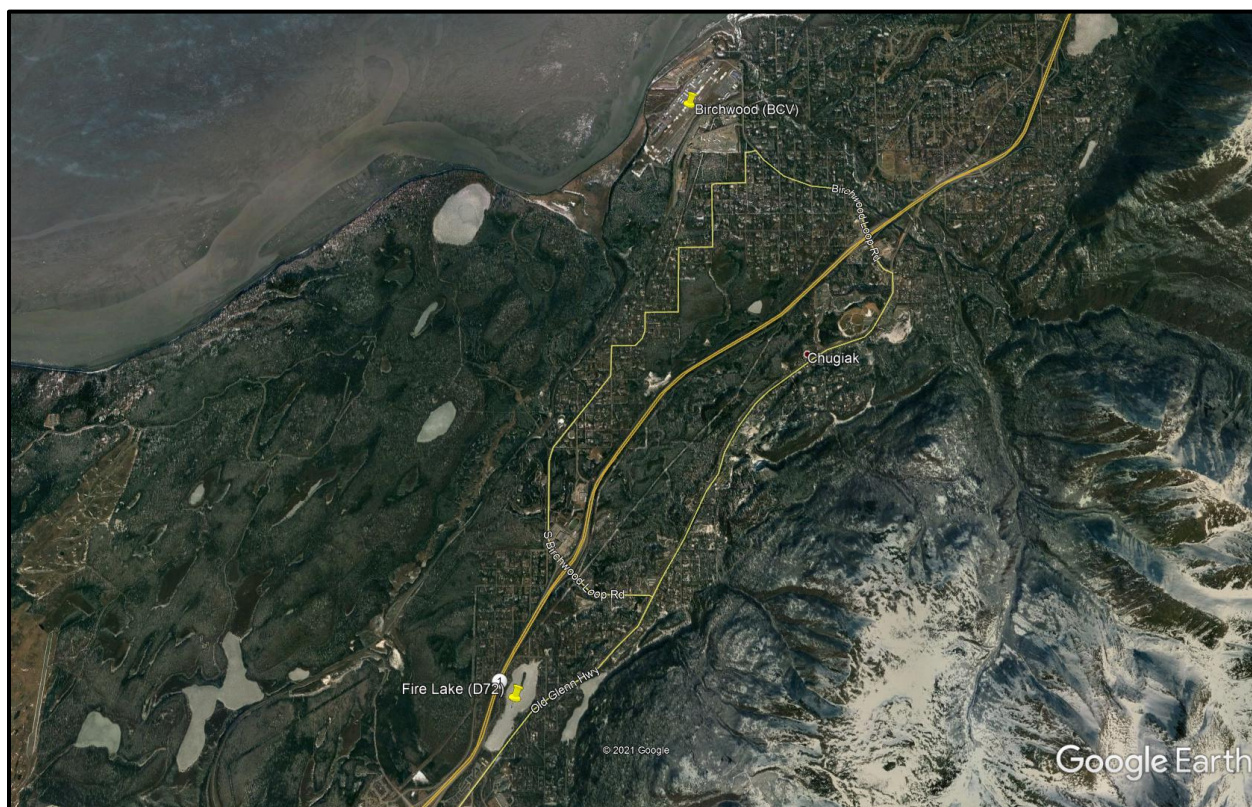
The GPS data were unremarkable and did not indicate any problems. The accident occurred shortly after the end of Airlog 81 as shown in Table 1 as N185RN was returning to Fire Lake from camp, about 75 miles away. Note: the logs start at Birchwood airport (BCV) where N185RN last filled up with fuel. BCV is located approximately 4 NM north of Fire Lake. See Figures 4 thru 7.

**Figure 4: N185RN Re-fueled at Birchwood Airport Located 4 NM North of Fire Lake**

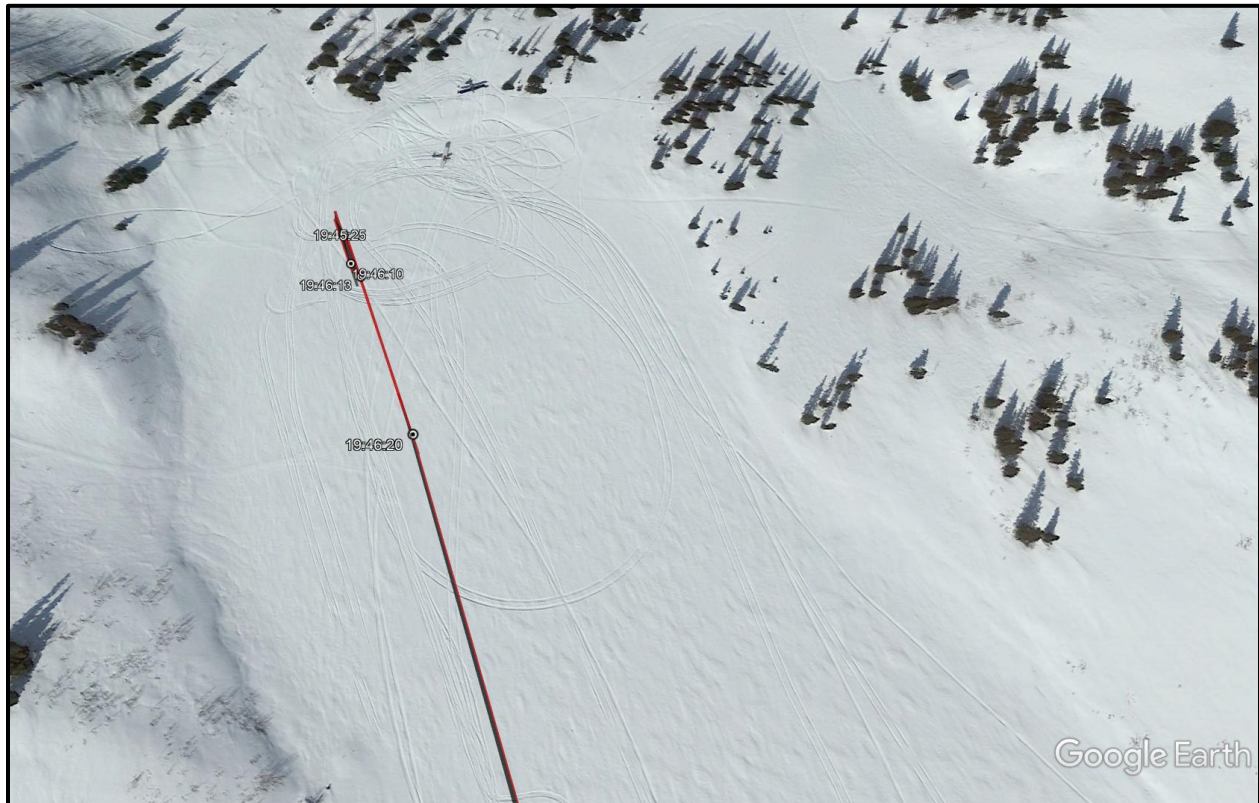
**Figure 5: Camp and Ground Track from Final Take-off, Airlog 81**
