**NATIONAL TRANSPORTATION SAFETY BOARD**  
Office of Aviation Safety

**STRUCTURES GROUP CHAIRMAN'S RUDDER LOADS STUDY**

**ANC20LA059**

Operator: Private  
Location: Anchorage, Alaska  
Date: June 8, 2020  
Time: 0945 Alaska Daylight Time (ADT)  
Aircraft: Piper PA-12  
Registration: N3188M

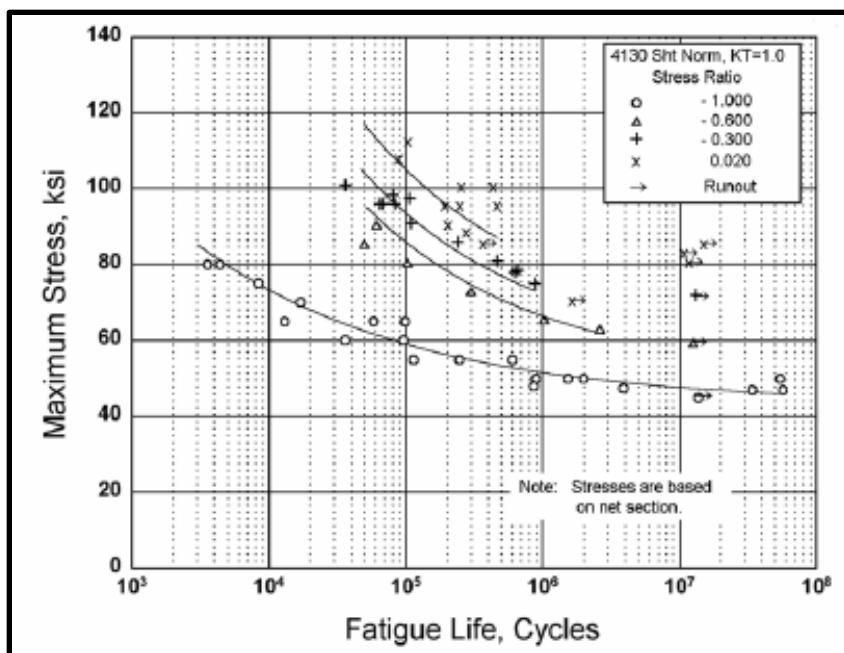
Figure 3-MMPDS-04 Figure 2.3.1.2.8(a) Best fit S-N curves for unnotched AISI 4130N sheet.

The PA-12 and PA-18 airplanes were designed for static load conditions as dictated by the regulations in place at the time. However, in service, the loading conditions on many parts of the structure, including the rudder, are not static and contain dynamic alternating or repeated (fatigue) loads. It is well documented that fatigue failures in metal occur at stress levels well below the static strength stress levels. Aircraft designed in accordance with modern regulations must account for fatigue loads. As part of the modern design process, materials used for aircraft structure must have published fatigue test data in the form of stress-life (S-N) curves. An example of this data is shown in Figure 3 for unnotched AISI 4130N alloy steel sheet from MMPDS-04.

The relationship between ultimate strength and endurance limit is evident in the data of Figure 3, however, it only applies to pristine (or unnotched) material. Localized stress concentrations in the form of holes, changes in cross sectional area, notches, scratches, or corrosion will have a significant effect on the fatigue life of any material resulting in a decrease in fatigue life. In addition, standard industry practice would incorporate a scatter factor on test data such as that in Figure 3 since the data was gathered in controlled tests and is not representative of actual in-service conditions.
