# NATIONAL TRANSPORTATION SAFETY BOARD

## Engine Monitoring Device

**Specialist's Factual Report**  
**By Sean Payne**

Location: Birch Creek, AK  
Date: July 14, 2020  
Aircraft: Air Tractor AT802A  
Registration: N80166  
Operator: Aero Spray Inc  
NTSB Number: ANC20LA069

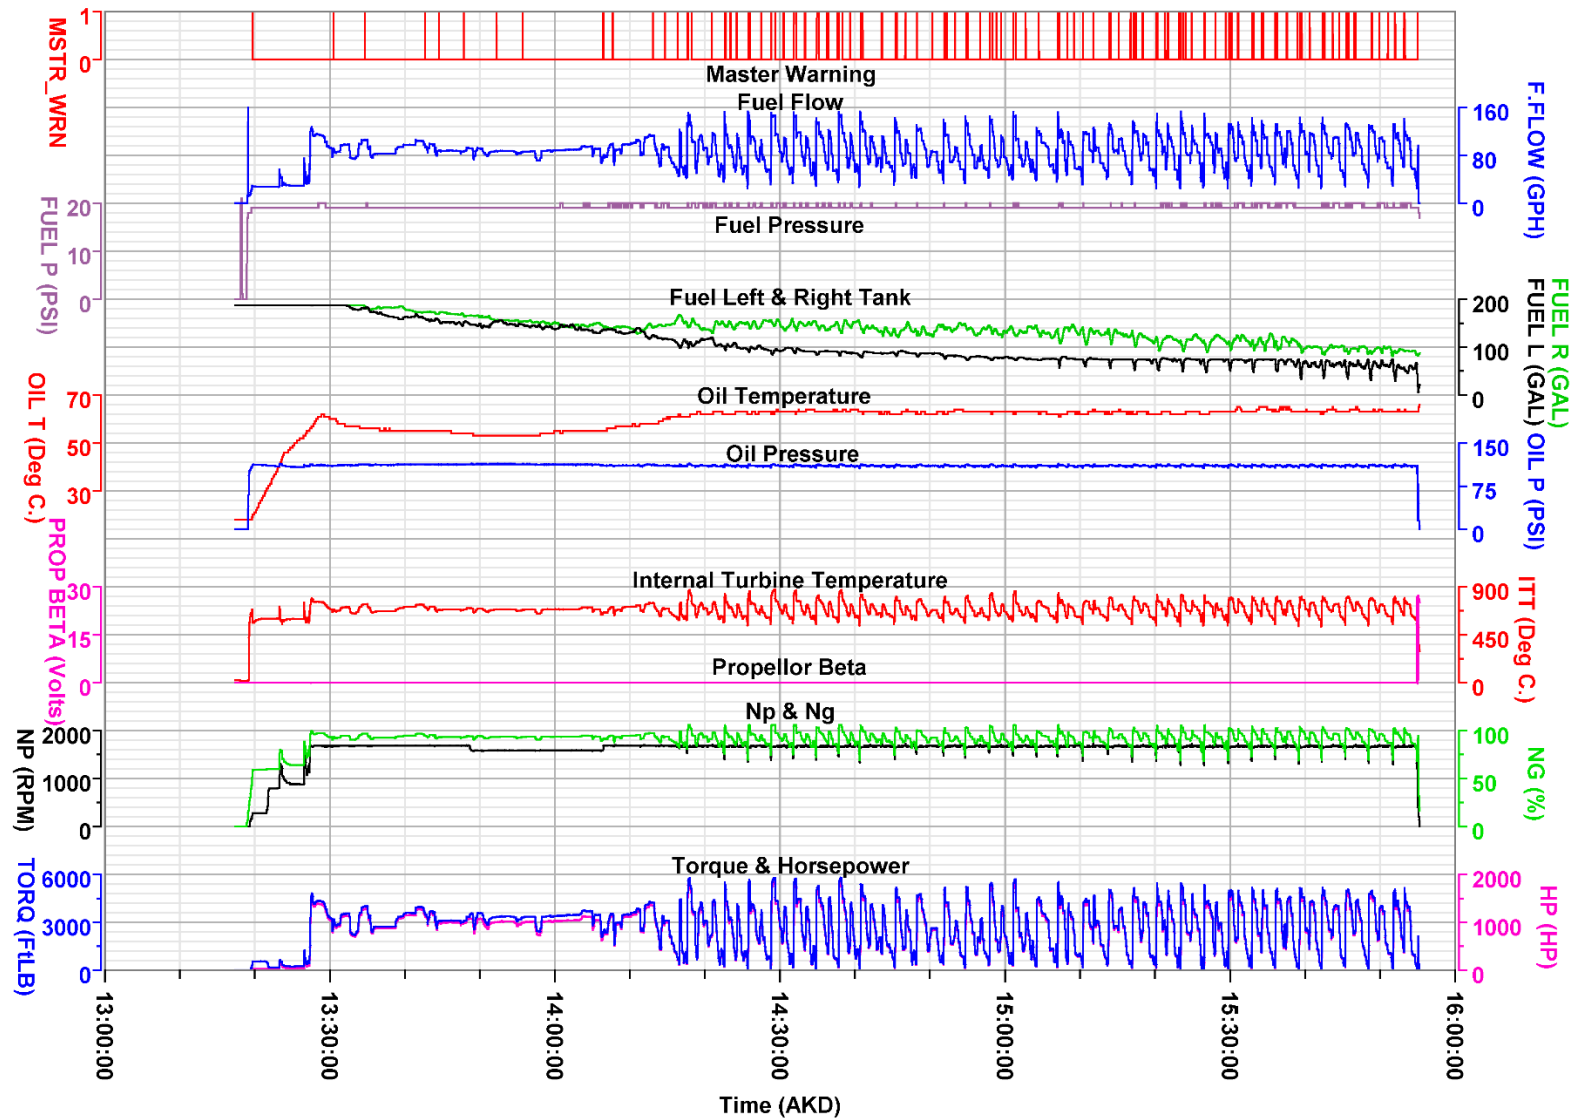
Figure 2 is a plot of the entire accident flight recording from the MVP-50T. The plotted time interval is between 13:00 AKD and 16:00 AKD.

Figure 2. A plot of the entire accident flight recording form the MVP-50T. The plotted time interval is between 13:00 AKD and 16:00 AKD.

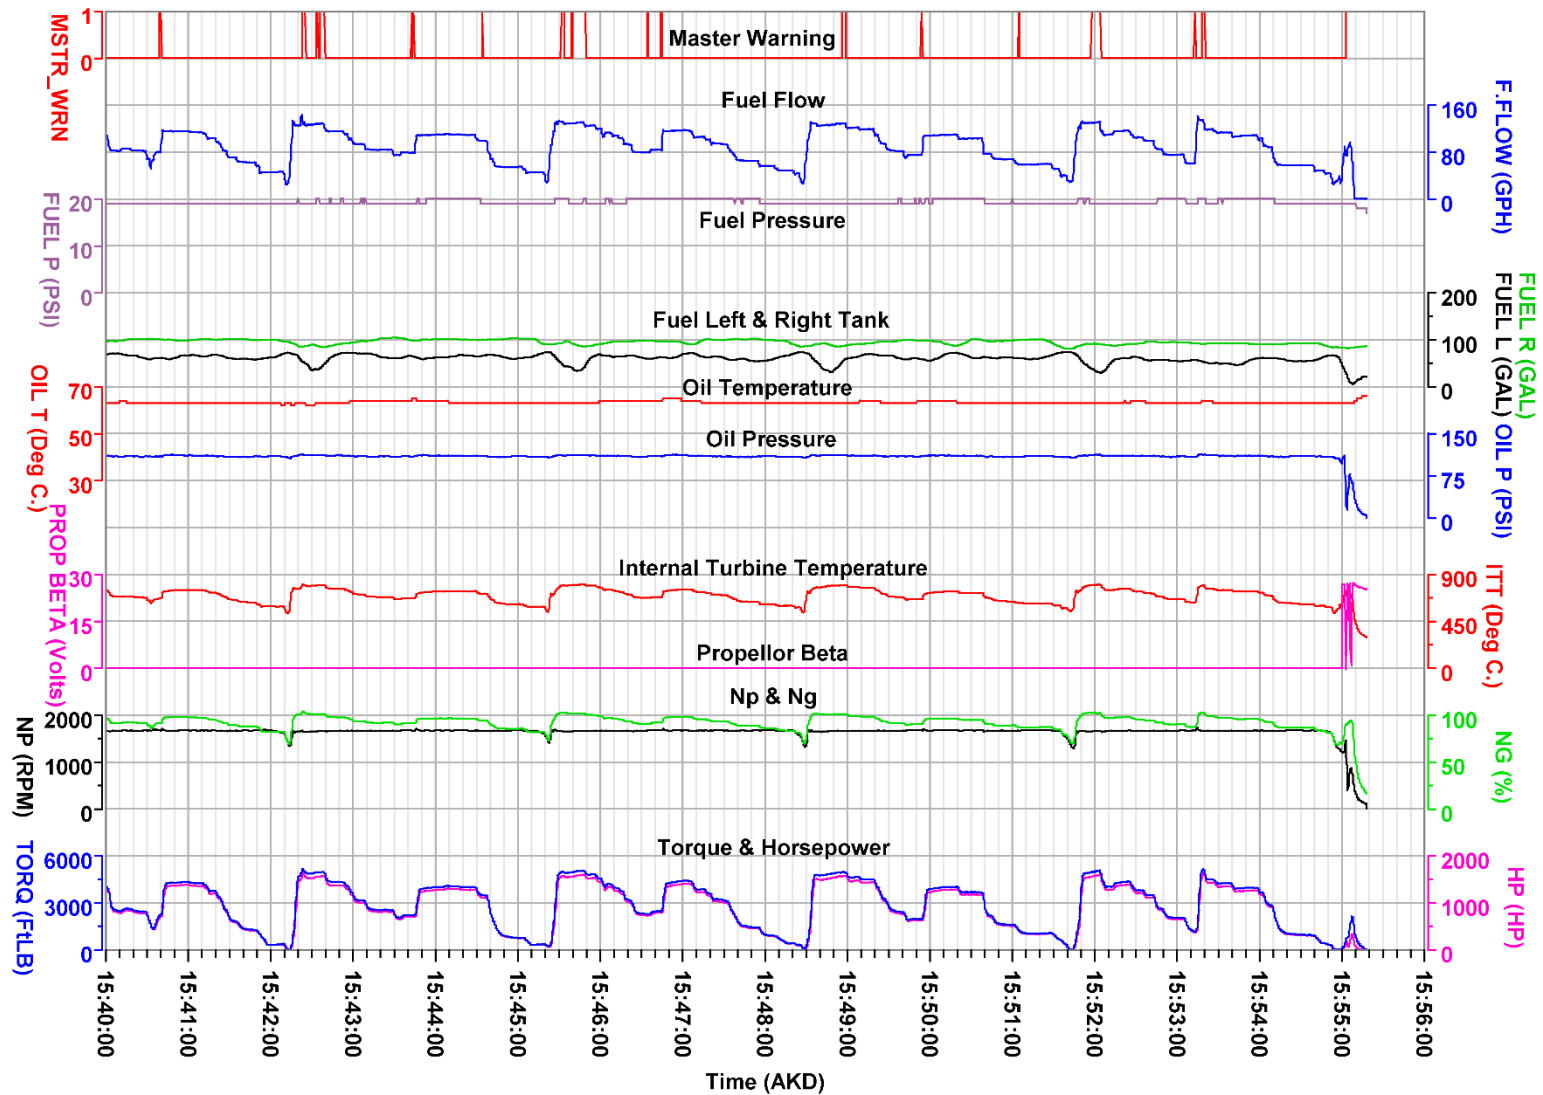
Figure 3 is a plot of the last 15 minutes of the accident flight. The plotted time interval is between 15:40 AKD and 15:56 AKD.

Figure 3. A plot of the last 15 minutes of the accident flight. The plotted time interval is between 15:40 AKD and 15:56 AKD.

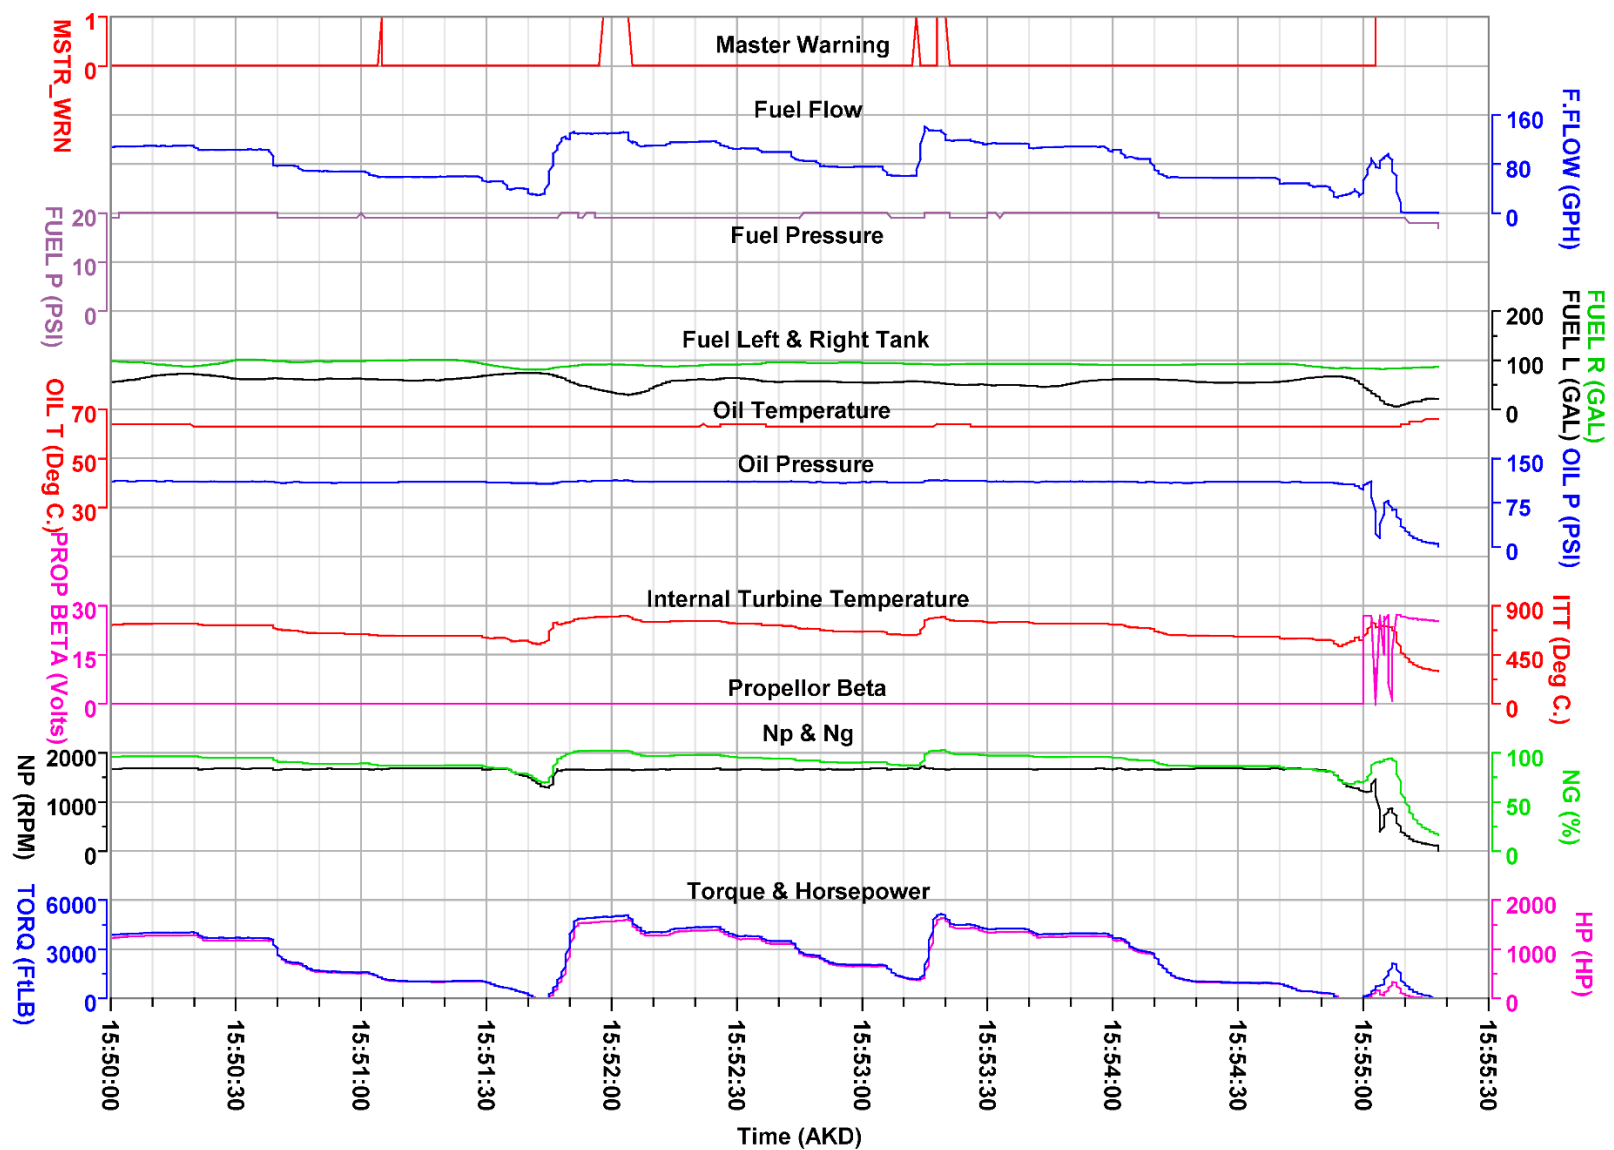
Figure 4 is a plot of the last 5 minutes of the accident flight. The plotted time interval is between 15:50:00 AKD and 15:55:30 AKD.

Figure 4. A plot of the last 5 minutes of the accident flight. The plotted time interval is between 15:50:00 AKD and 15:55:30 AKD.
