# National Transportation Safety Board

ANC22FA047

## COMPUTED TOMOGRAPHY

Location: Clear, Alaska  
Date: June 26, 2022  
Time: 1938 Alaska daylight time  
0338 coordinated universal time (UTC) June 27, 2024  
Helicopter: Bell UH-1B, N9970F

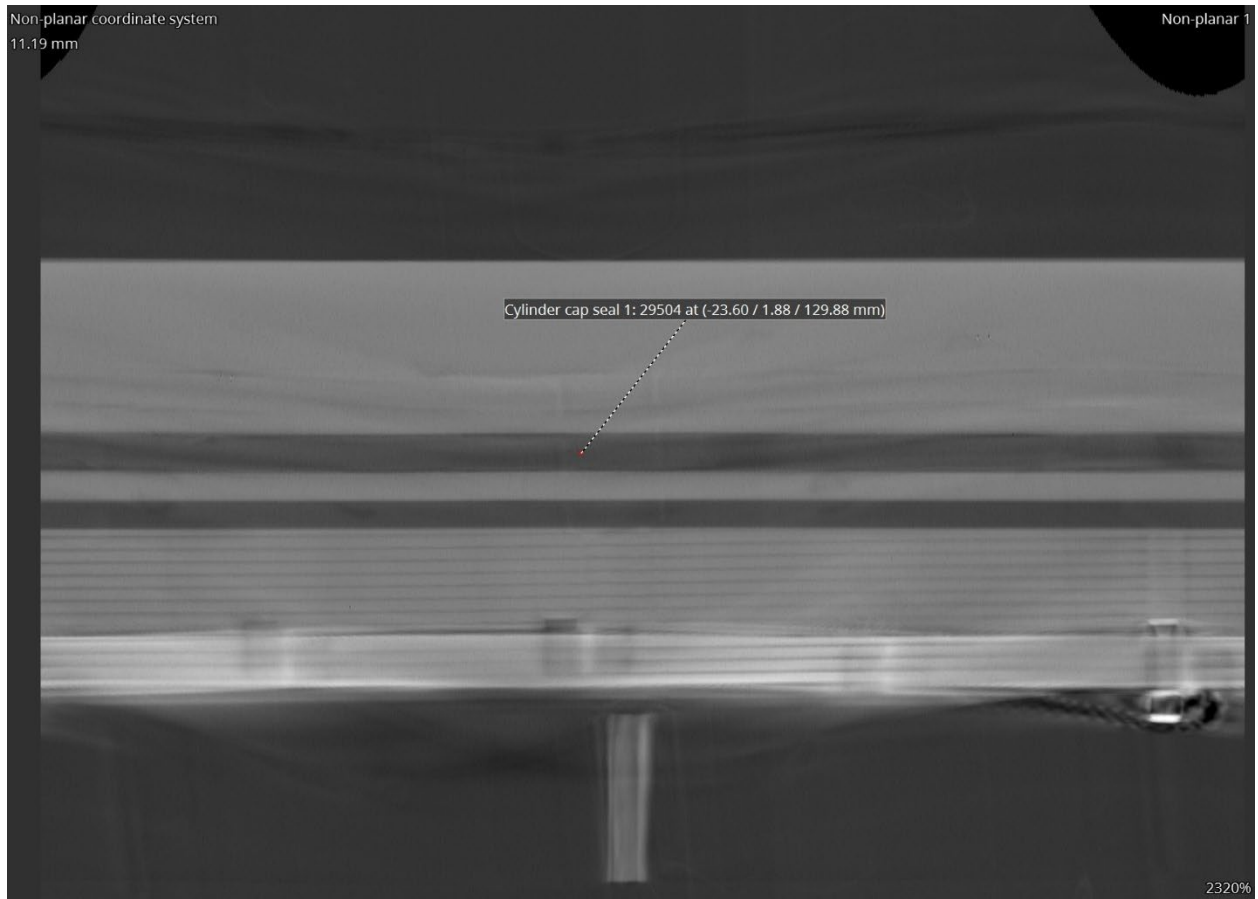
**Figure 48.** Collective actuator - cylinder assembly - cylinder cap seal 1 unrolled. (225 kV)

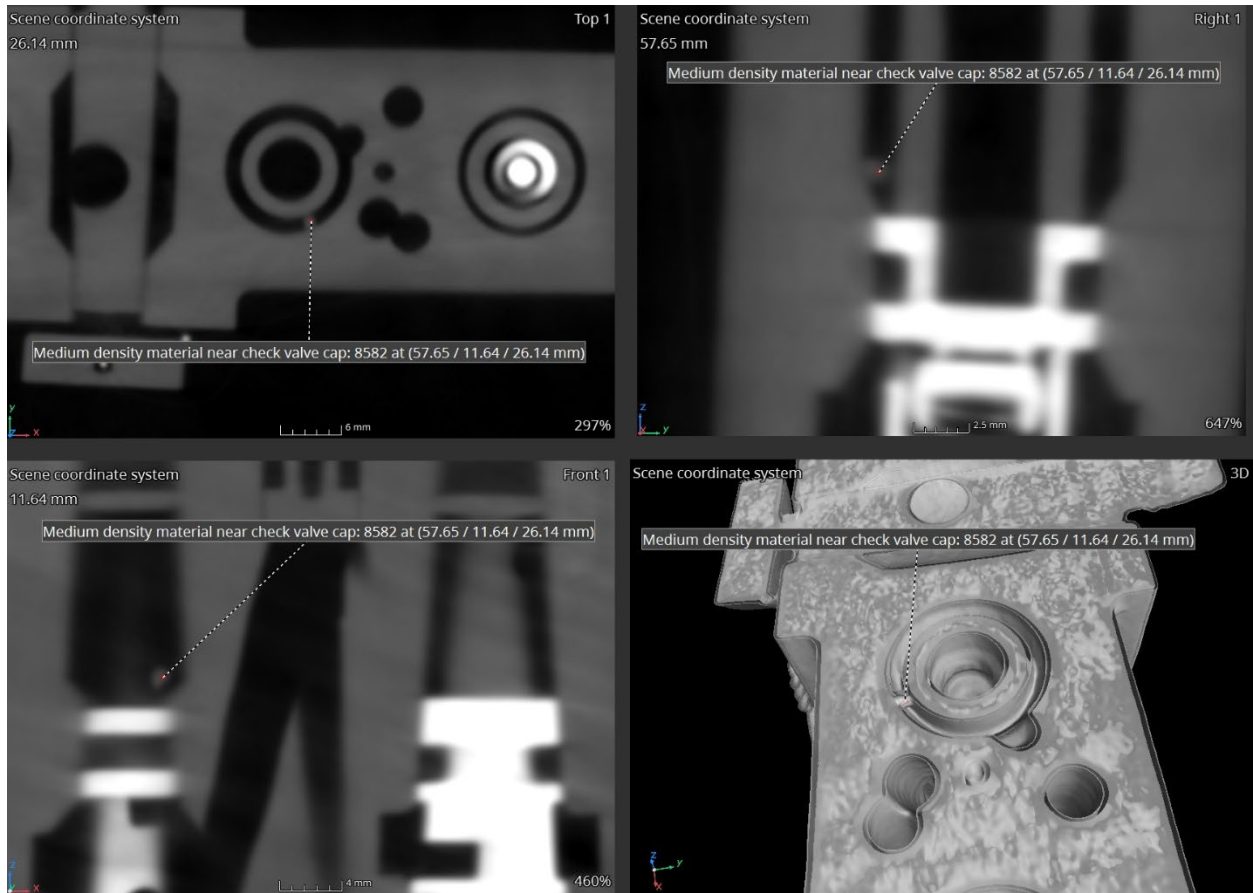
1. The irreversible valve housing was deformed with cracks visible or indications of cracks. (Figures 127, 128, 149, and 151)
2. The pressure and return fittings were crushed and deformed. (Figures 129 and 130)
3. There were indications of low and/or medium density particles and/or material near the sequence valve, near the check valve cap, near the plug between the thermal relief valve and differential pressure relief valve, in the cylinder pressure port, and in the accumulator inlet port. (Figures 133, 134, 138, 144, 146, 155, and 156)

**Figure 138.** Left lateral actuator - irreversible valve - check valve B - medium density material. (450 kV)

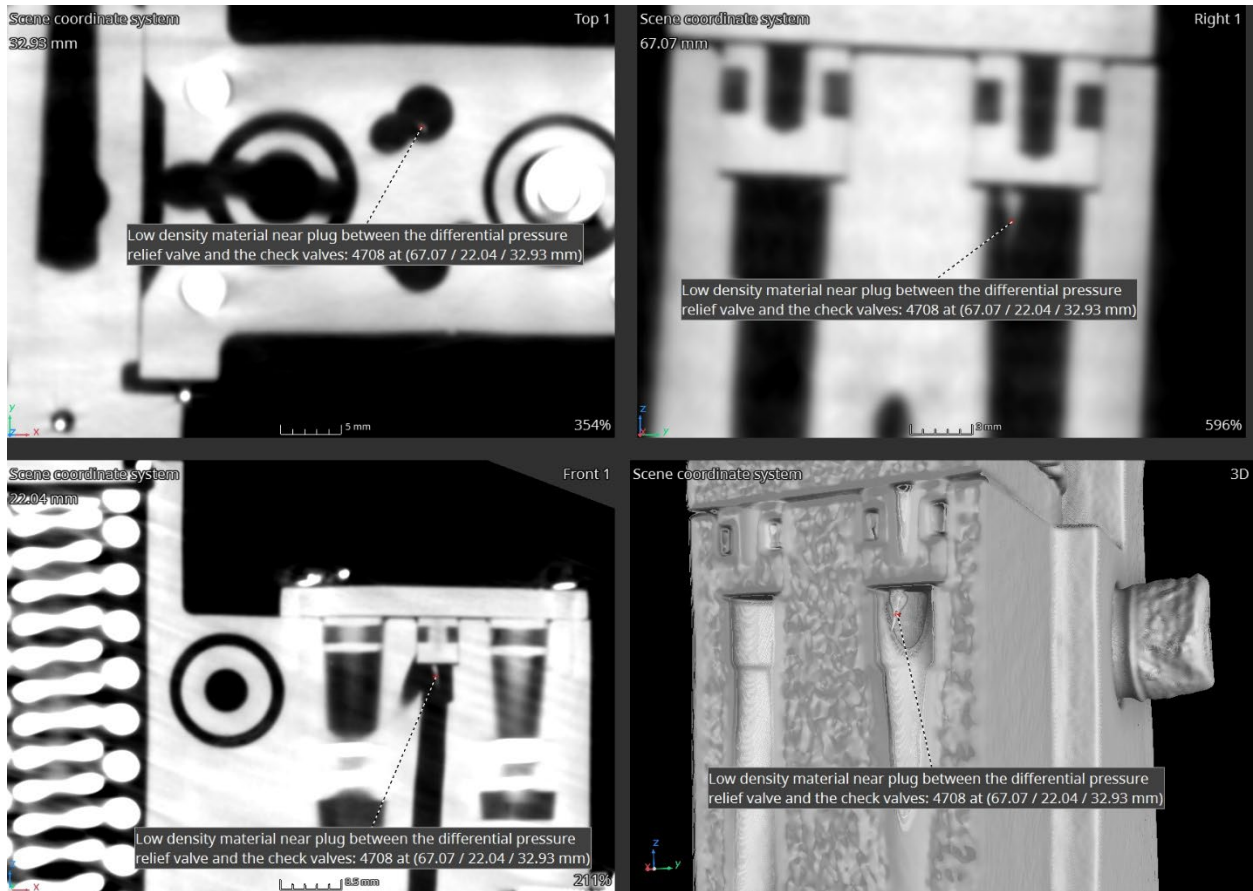
**Figure 144.** Left lateral actuator - irreversible valve - low density material near plug between the differential pressure relief valve and the check valves. (450 kV)

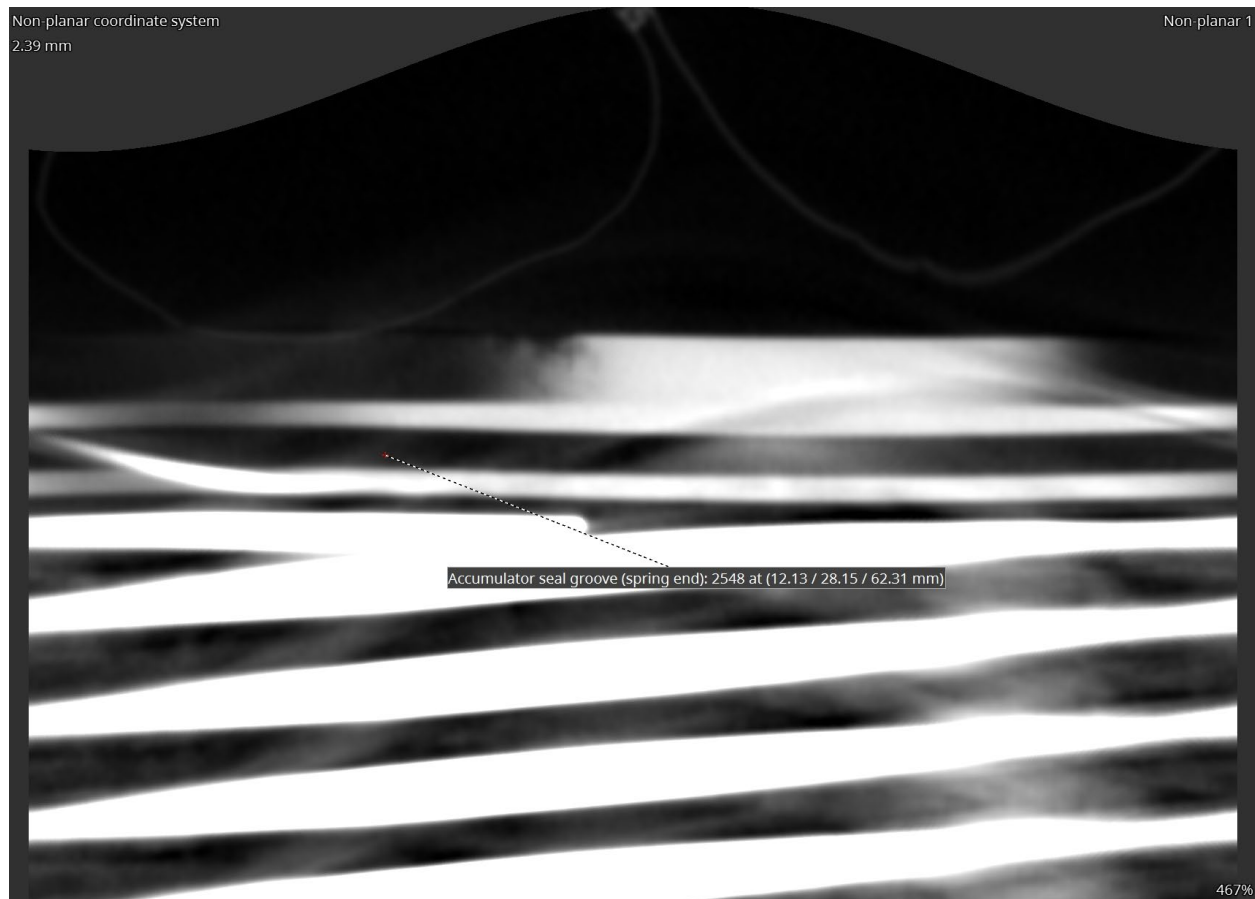
**Figure 154.** Left lateral actuator - irreversible valve - accumulator seal groove unrolled at spring end.  
(450 kV)
