**Date: June 27, 2022**  
**Person Contacted: Doug Buzga**  
**Location: Telephone**  
**NTSB Accident Number: ANC22FA047**

On June 26, 2022, about 1938 Alaska daylight time, a Bell UH1B helicopter, N9970F was destroyed when it was involved in an accident near Anderson, Alaska. The pilot and sole occupant was fatally injured. The helicopter was operated by Northern Pioneer Helicopters LLC as a Title 14 *Code of Federal Regulations* Part 133 flight.

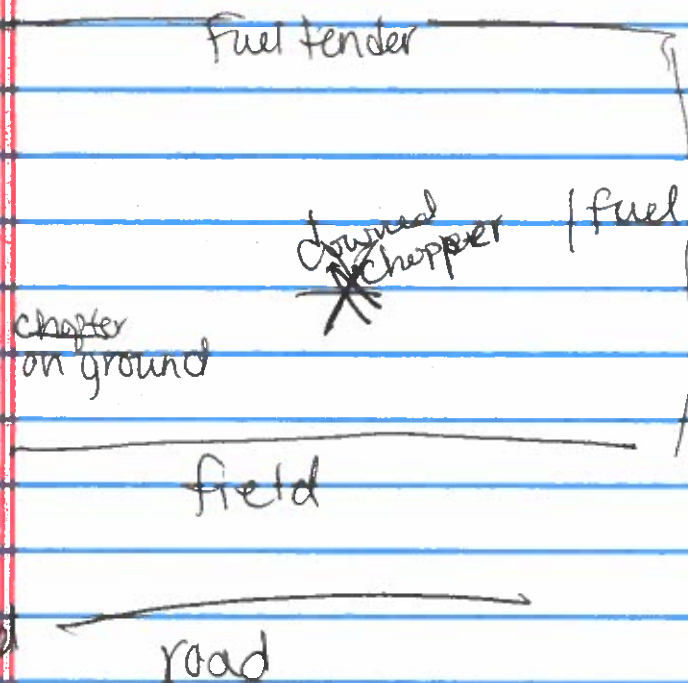
At approx 1930 helo was lifting off he was about 6 stories up when an explosion occurred in the tail rotor. <sup>second explosion near belly</sup> The chopper lost control and dove nose-first into the tarmac and burst into flames. Several smaller explosions occurred after crash spreading debris. Reported immediately to 911 + IC stayed on phone to report

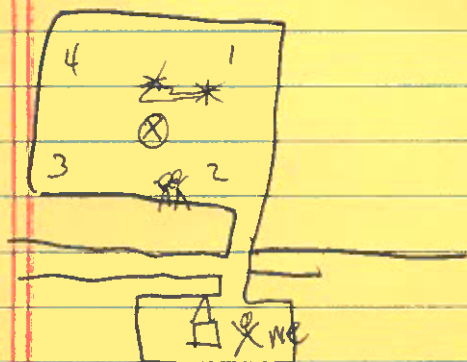
8:10pm Was just walking off the pad and sat down for a few minutes at the cabin talking to lady (cant remember name). I heard the Heli lift off while my back was to the pad. Maybe 45 sec to a  $1\frac{1}{2}$  minute later I heard a pop or 2 in succession and turned in time to see the belly of **70F** extra light. The heli was approx. 150 ft in the air falling rapidly. I cant recall if the explosion was in the air or on the ground. I called all ~~the~~ pretty immediately.

The 2 HECMS on the deck dove behind some
