## **Wreckage Examination Summary**

NTSB ACCIDENT NUMBER: ANC22LA035

AIRCRAFT REGISTRATION/AIRCRAFT TYPE: N703TH, de Havilland DHC-3

ACCIDENT LOCATION: Yakutat, AK

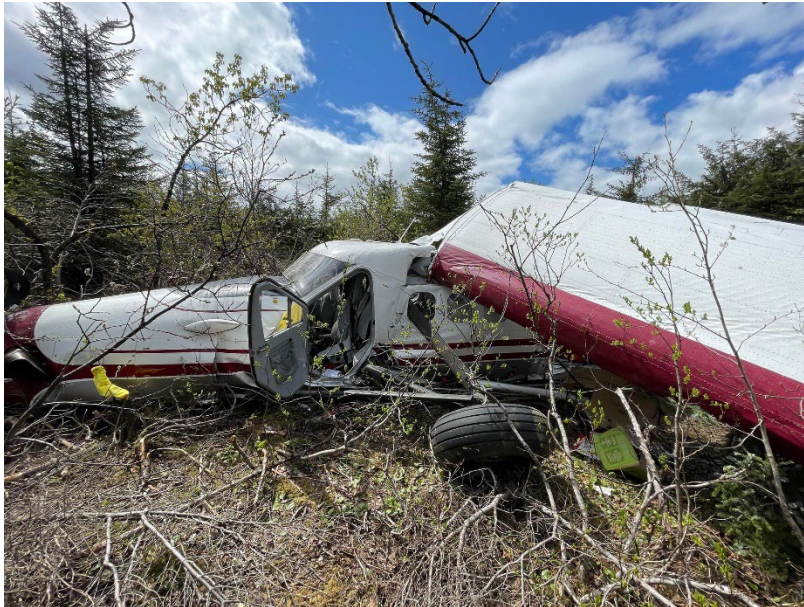
- Cockpit exhibited extensive impact damage to the lower cockpit structure.
- Both main landing gear penetrated the fuselage near the sloping bulkhead. The left main landing gear separated from its attach points. The right main landing gear was partially separated.
- The cockpit floor was buckled.
- Windshields partially separated from windshield frames.
- Both cockpit door frames were broken, and the doors remained attached to the cockpit structure.
