# National Transportation Safety Board

ANC23FA001

## **WRECKAGE EXAMINATION SUMMARY**

Location: Fairbanks Alaska  
Date: October 5, 2022  
Time: 1758 AKDT  
October 6, 2022, 0158 Z  
Airplane: Cessna 185F, N217C

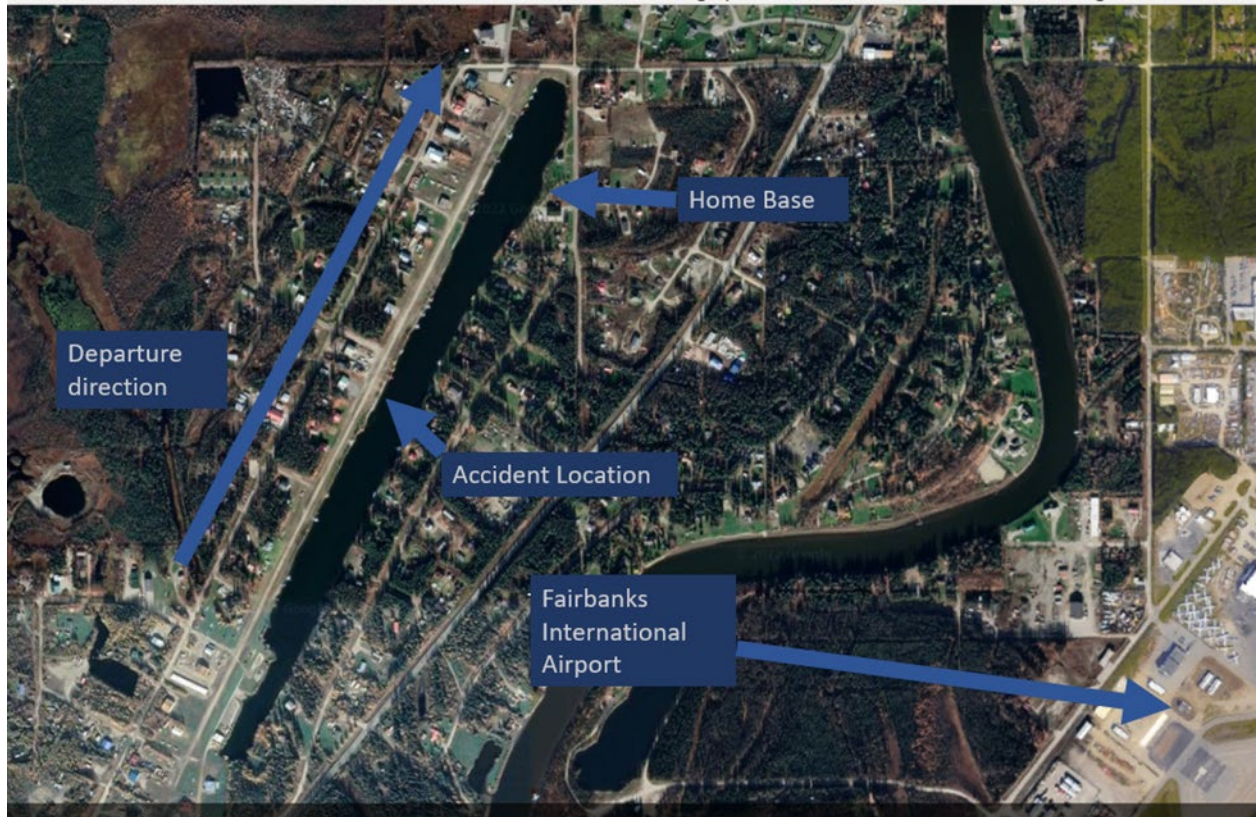
**Figure 1 Accident location.**

The airplane had attempted to depart to the north from Chena Marina. The pilot aborted the takeoff and was taxiing back to attempt another takeoff. Witnesses described the airplane in a lower than normal nose down position, and floats nearly submerged. One witness said the pilot reduced power, the airplane pitched down and began to nose over. The pilot attempted to add power to recover but was unsuccessful and the airplane nosed over in the water and began to sink in a nose down position. Video surveillance confirmed witness statement. Airplane was pulled to shore in attempt to rescue the pilot.
