# National Transportation Safety Board

ANC23FA003

## **AUTOMATIC DEPENDENT SURVEILLANCE- BROADCAST (ADS-B) AND VIDEO STUDY**

Aircraft Performance Study

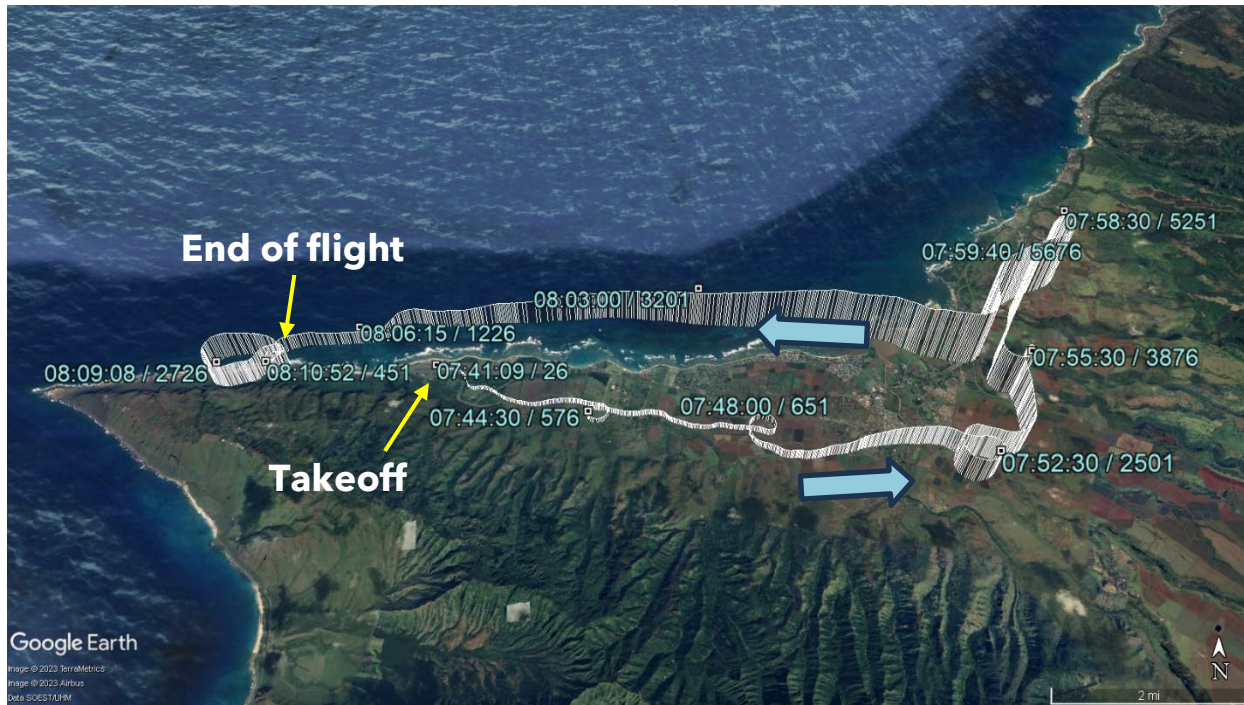
The aircraft took off to the east just after 07:41 from Dillingham Field in Mokuleia, Hawaii. The aircraft climbed initially to an altitude between 550 and 650 ft msl, completing a right then a left 360° turn. During the turns the aircraft's speed increased from 40 kts to 60 kts. After the second turn the aircraft steadily climbed and completed two more 360° right turns and then turned onto a more northerly heading. After 07:58:30 the aircraft completed a right 270° turn and began to fly westward. The aircraft reached a maximum altitude of 5,670 ft and began to descend after 07:59:40. As the aircraft continued its westerly path the airspeed was between 60 and 70 kts. The aircraft descended to 1,200 ft until it began a second climb just after 08:06.

**Figure 3.** Flight path with selected times and altitudes annotated.

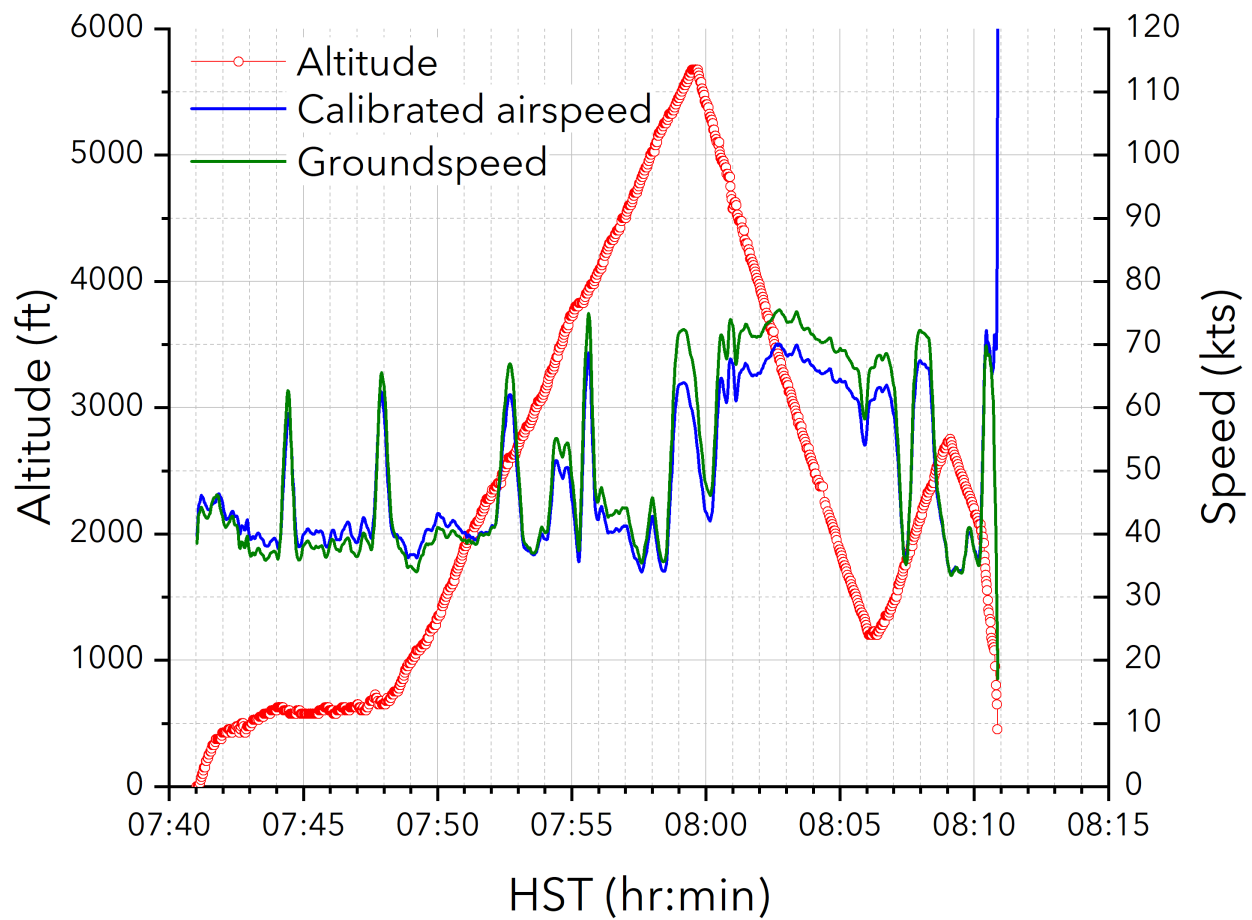
**Figure 4.** ADS-B recorded altitude and calculated ground and calibrated airspeed.
