# National Transportation Safety Board

ANC23FA008

Group Chair's Factual Report

Location: Kaupo, HI  
Date: December 15, 2022  
Time: 2114 Hawaii standard time (HST)  
0714 coordinated universal time (UTC), December 16, 2022  
Airplane: Raytheon Aircraft Company C90A King Air, N13GZ

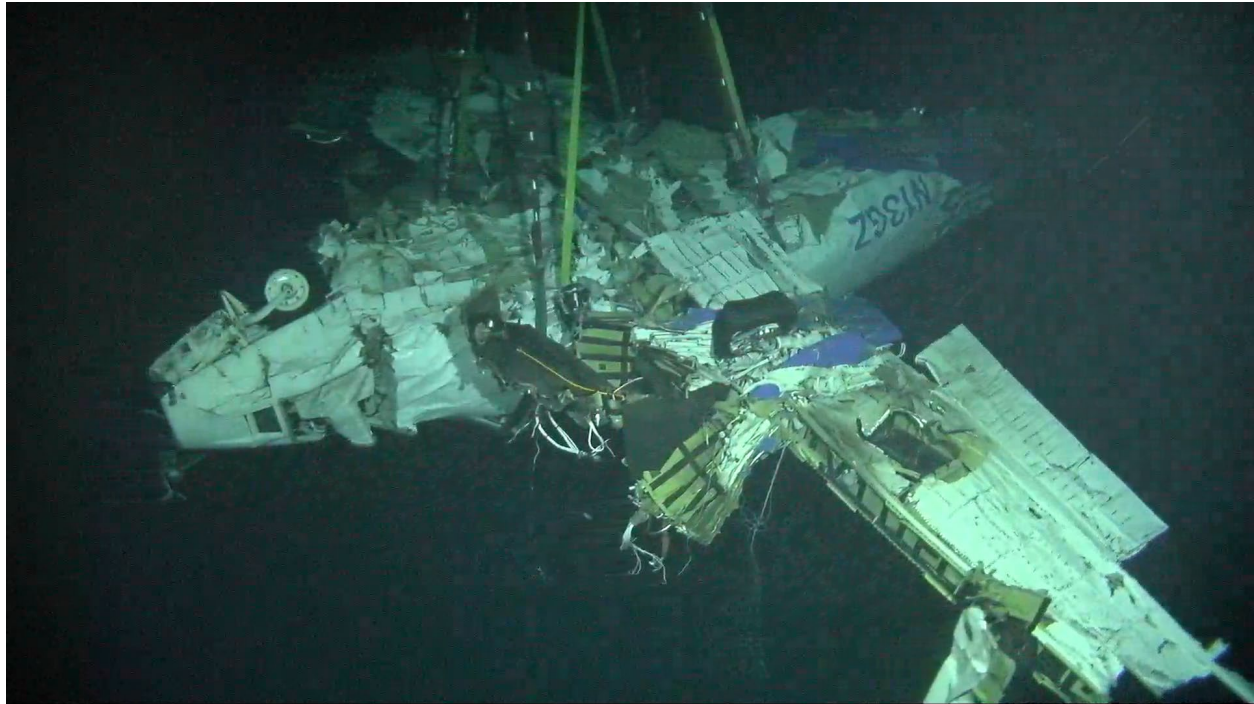
The team decided to attempt the recovery of the complete fuselage and deployed a subsea basket with lifting straps and tools inside. The ROV rigged the wreckage using four wide webbed straps, one around each wing, one forward, and one aft on the main fuselage (Figure 9). The four-point lift maintained stability of the airplane and reduced the chance of the fuselage moving during the operation. Once

connected to the crane, the ROV monitored the lift from the seafloor to the surface. The main wreckage was lifted from a depth of about 1960 m at an ascent rate of 8 m/min on January 10. The crane operated in Active Heave Compensation mode ensuring the best possible stability and the *M/V Island Pride* was allowed to drift with the current to minimize the side loading. The lift was halted at 200 m depth and previously attached taglines were released by the ROV. The ship's Fast Rescue Craft (FRC) was deployed to stand by in case any debris or human remains escaped the fuselage as the water was draining in the final stage of the lift operation.

**Figure 9.** Airplane recovery lift strap orientation (OI photo)

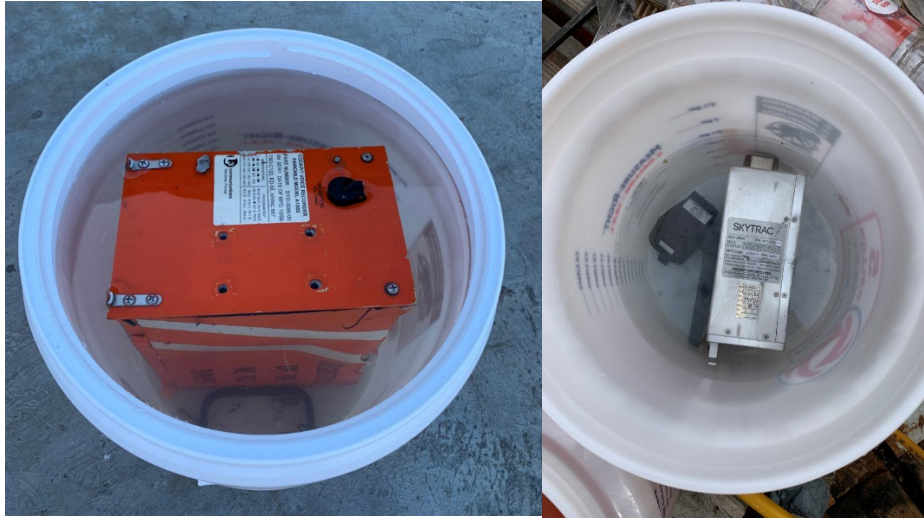
NTSB investigators were able to access the flight recorders once the wreckage was secured onboard the *M/V Island Pride*. The Fairchild A100S CVR was located in the aft fuselage and remained installed in the rack, which was partially separated from the fuselage. The CVR had some deformation to the case. The Appareo Vision 1000 unit remained attached to the cockpit ceiling but was damaged. The SkyTrac ISAT-200A was recovered from the avionics bay in the nose and the Stratus S2 was found loose in the cockpit. The CVR, Appareo unit, Stratus, and SkyTrac units were placed in two 5-gallon containers and submerged in distilled water for shipment to the NTSB lab in Washington, DC (Figure 14).

**Figure 14.** Recovered flight recorders as packaged (NTSB photo)
