# National Transportation Safety Board

ANC23FA008

## **ONBOARD IMAGE RECORDER (APPAREO)**

Location: Kaupo, Hawaii  
Date: December 15, 2022  
Time: 2114 Hawaii-Aleutian Standard Time (HST)  
0714 Coordinated Universal Time (UTC)  
Airplane: Raytheon Aircraft Company C90A, Guardian Flight, N13GZ

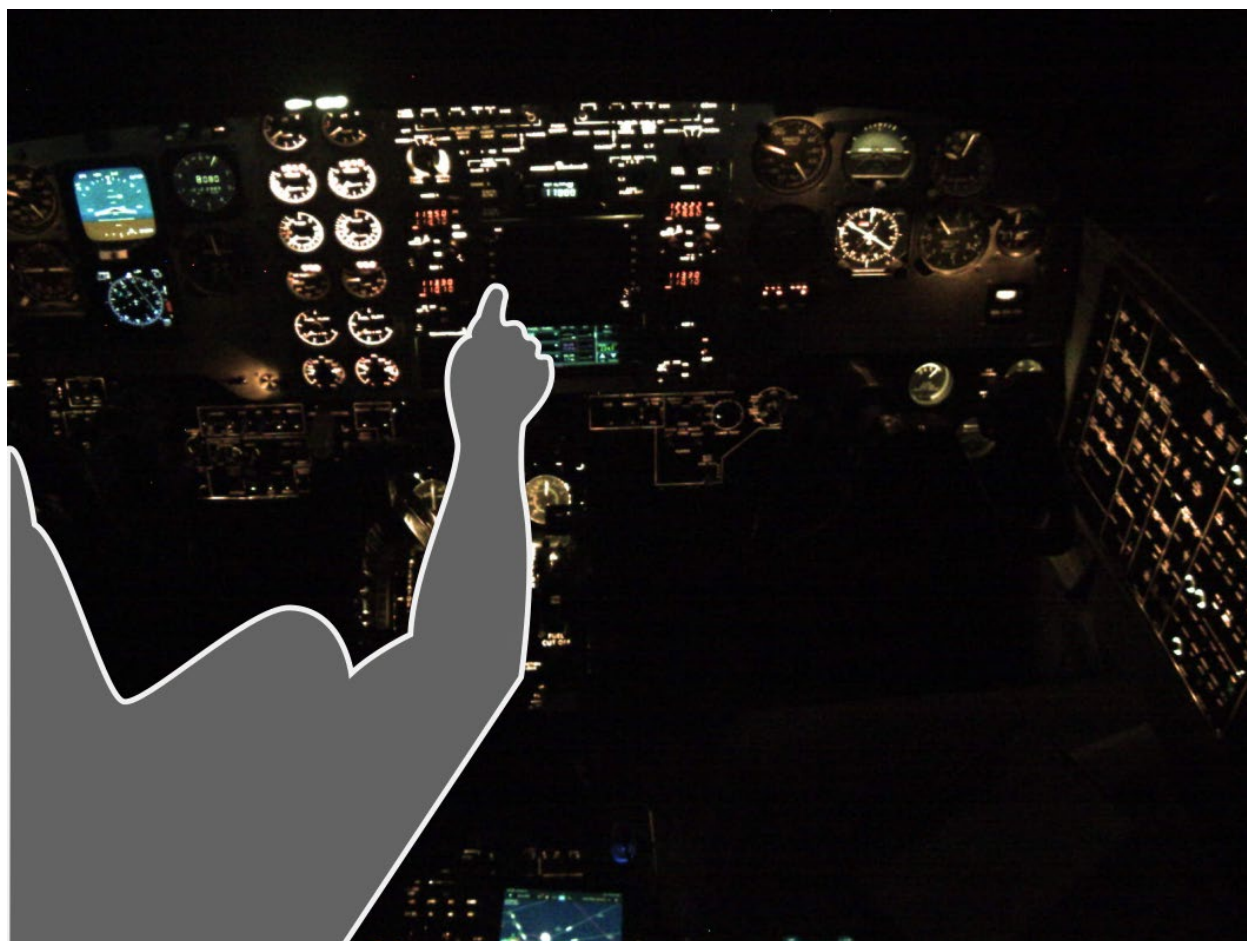
The accident recording was made at a resolution of 1600x1200 pixels at a rate of 4 frames per second (fps). Two associated audio tracks were also recorded; one from the camera's internal microphone, and another that was sounds similar to narrow bandwidth brownian noise, equivalent to a microphone input without a microphone attached subject to automatic gain control. The camera was mounted to the frame of the aircraft and was oriented to show a forward-facing field of view that included a view of the instrument panel and rudder pedals. The field of view of the accident recording is shown in figure 4. The pilot has been redacted in all figures.

**Figure 4.** Image showing typical camera field of view.

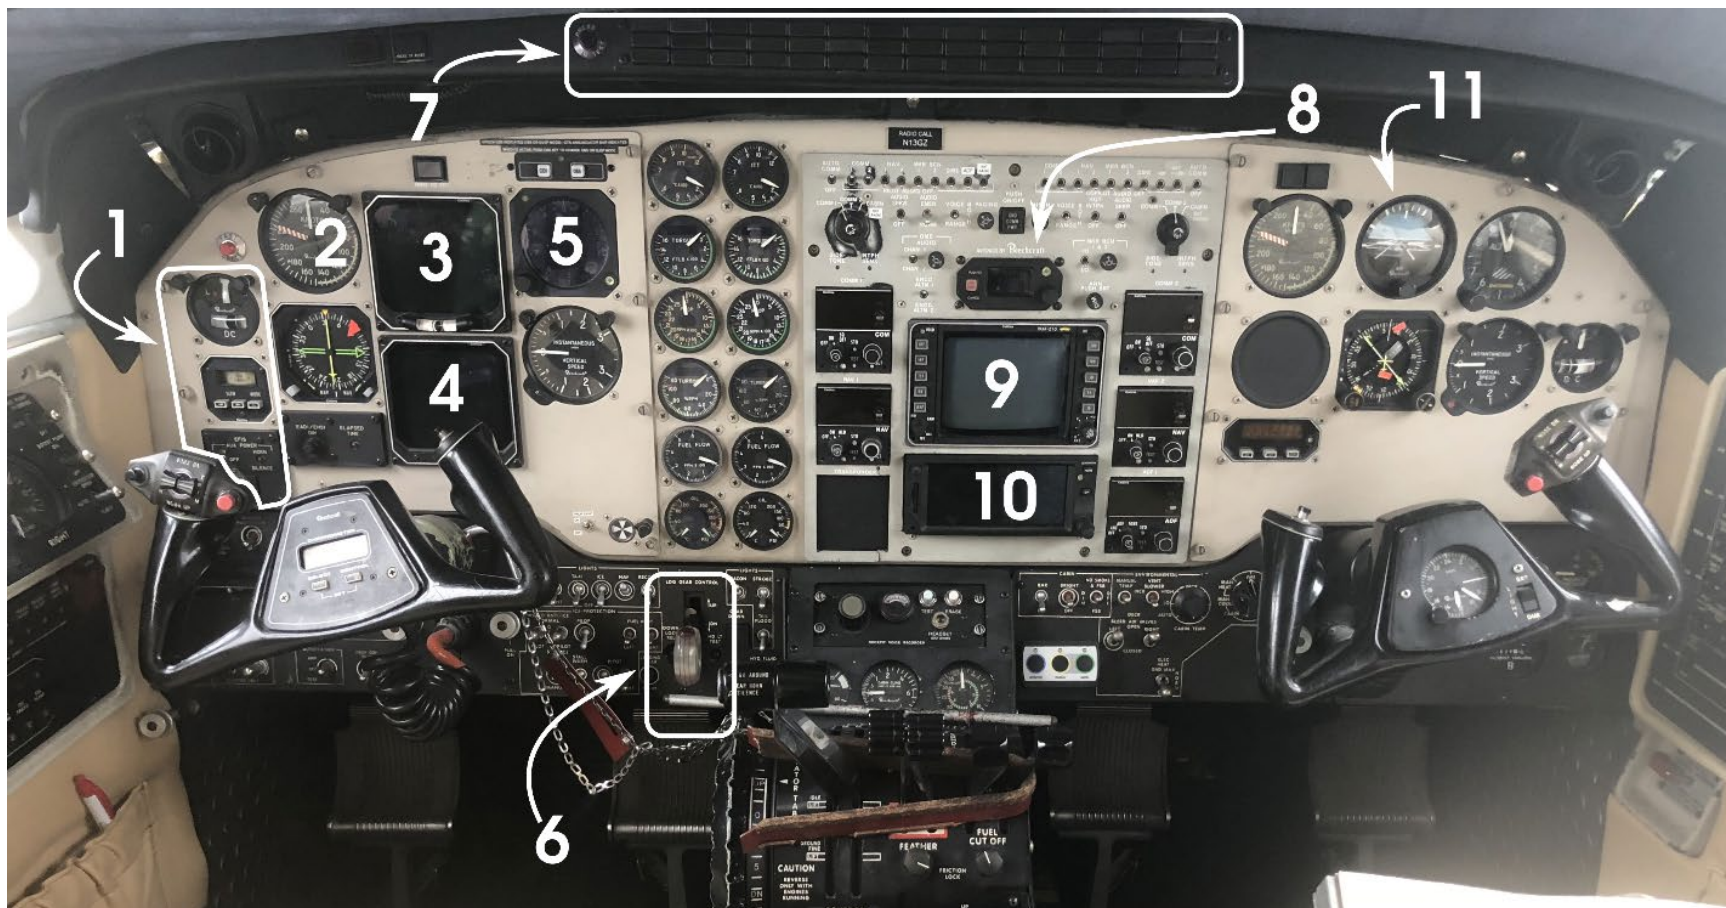
Figure 6 is a photograph of the instrument panel of N13GZ taken at some point before the accident. Significant instruments called out in the summary are numerated with explanatory text.

**Figure 6.** High resolution daytime photo of the cockpit panel in N13GZ

| 21:01:11 | The Collins MFD CRT flashed very brightly for one frame of video, and then returned to darkness. (figure 6) |

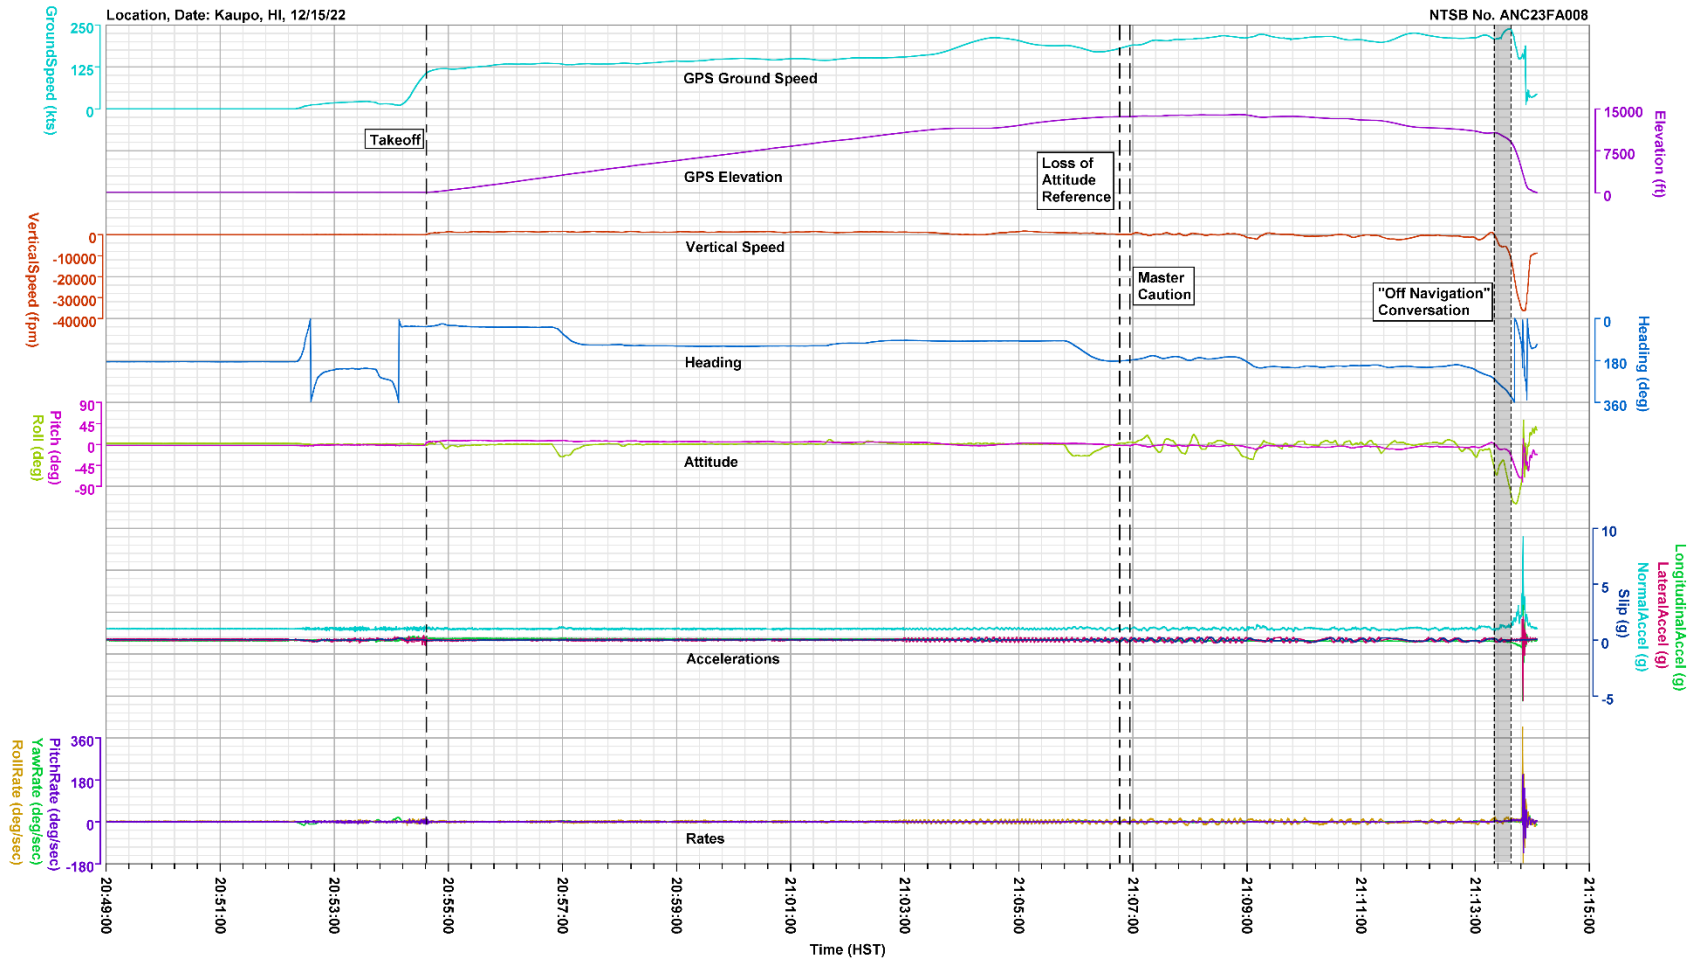
Figure 9 is a chart of the entire flight as recorded by the data recorder portion of the Vision 1000 dataset.

| 21:06:58 | <p>The sound of the autopilot disconnect alert tone was audible, and the autopilot disconnect indicator (AP DIS) light illuminated on the annunciator panel.</p> <p>The EFIS no longer displayed attitude information, but was in a powered state, and was still showing some symbology. The AP DIS (autopilot disconnect) light flashed approximately 8 times and went solid after the pilot reset the master caution. Then the AP DIS extinguished. Red warnings on the EFIS flashed several times, and then remained lit.</p> <p>The pilot's EFIS did not show an artificial horizon for the remainder of the accident recording. The EFIS symbology before and after the illumination of the AP DIS annunciator is shown in figure 8. The pilot has been redacted.</p> <p>This event is also depicted as a vertical line on figures 9, 10 and 13.</p> |
| 21:07:01 | <p>The A/P FAIL (autopilot fail) annunciator illuminated, followed by the master caution illuminating a quarter second later.</p> <p>This event is also depicted as a vertical line on figures 9 and 10.</p> |

| 21:13:21 – 21:13:40 | <p>[The time interval associated with this conversation is shown on figures 9, 10, and 11 as a grey bar, on the Google Earth plot in figure 14 as a white line, and in this table with a grey background.]</p> <p>The aircraft's current altitude was at 10,180ft and the rate of descent had increased. The roll increased to 65 degrees angle of bank to the right.</p> <p>ATC asked the pilot to verify that he was direct TAMMI. The pilot responded "<b>uh ...one three golf zulu is uhhh off navigation... here... we're gonna give it a try (give it a try)</b>". While the pilot was responding to ATC, the vertical speed indicator pegged at -3,500fpm.</p> <p>ATC read back the suggested course and altitude.</p> |

**Figure 9.** Flight Overview Plot for the time range between 2040 and 2115 HST. The grey bar denotes the time span of the 'off navigation' conversation on page 26 of the transcript and also depicted on figures 10, 11 and 14.

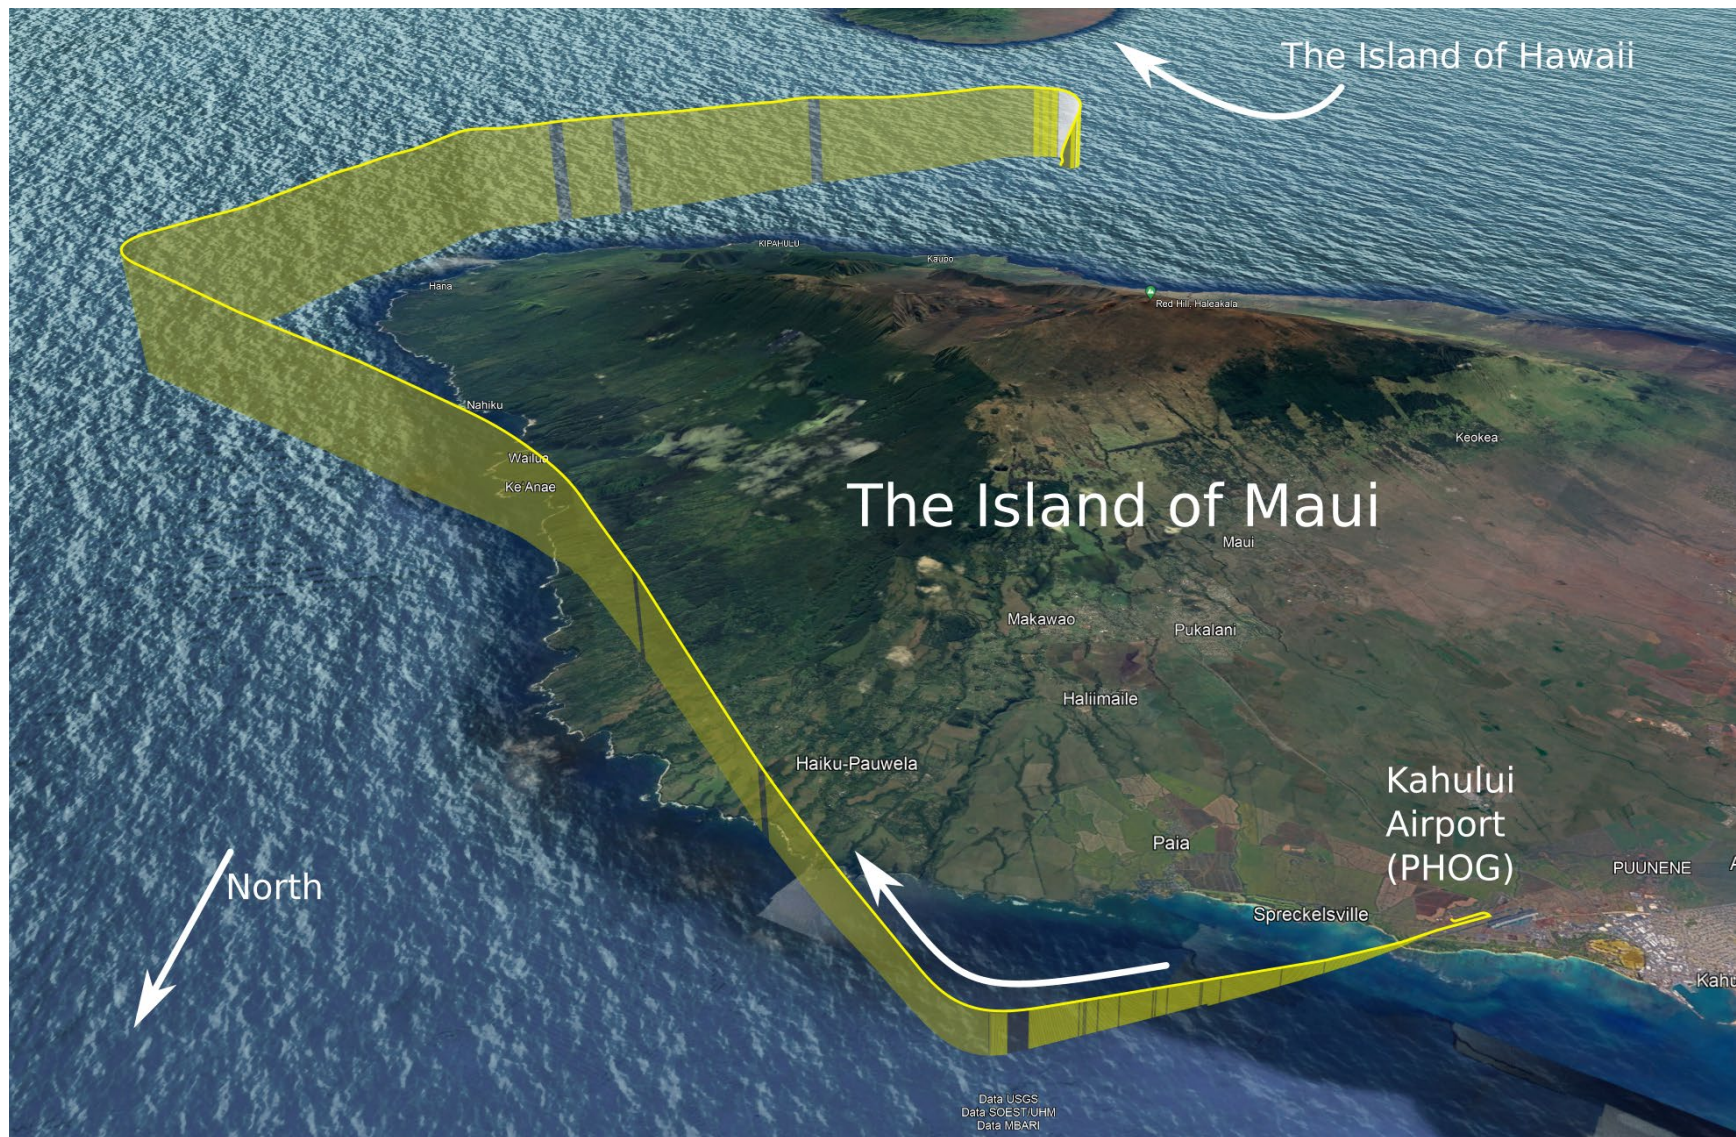
Figure 12 is a Google Earth map overlay of the entire flight. The weather and lighting conditions in Google Earth are not necessarily the weather and lighting conditions present at the time of the accident.

**Figure 12.** Overview Map of entire flight.

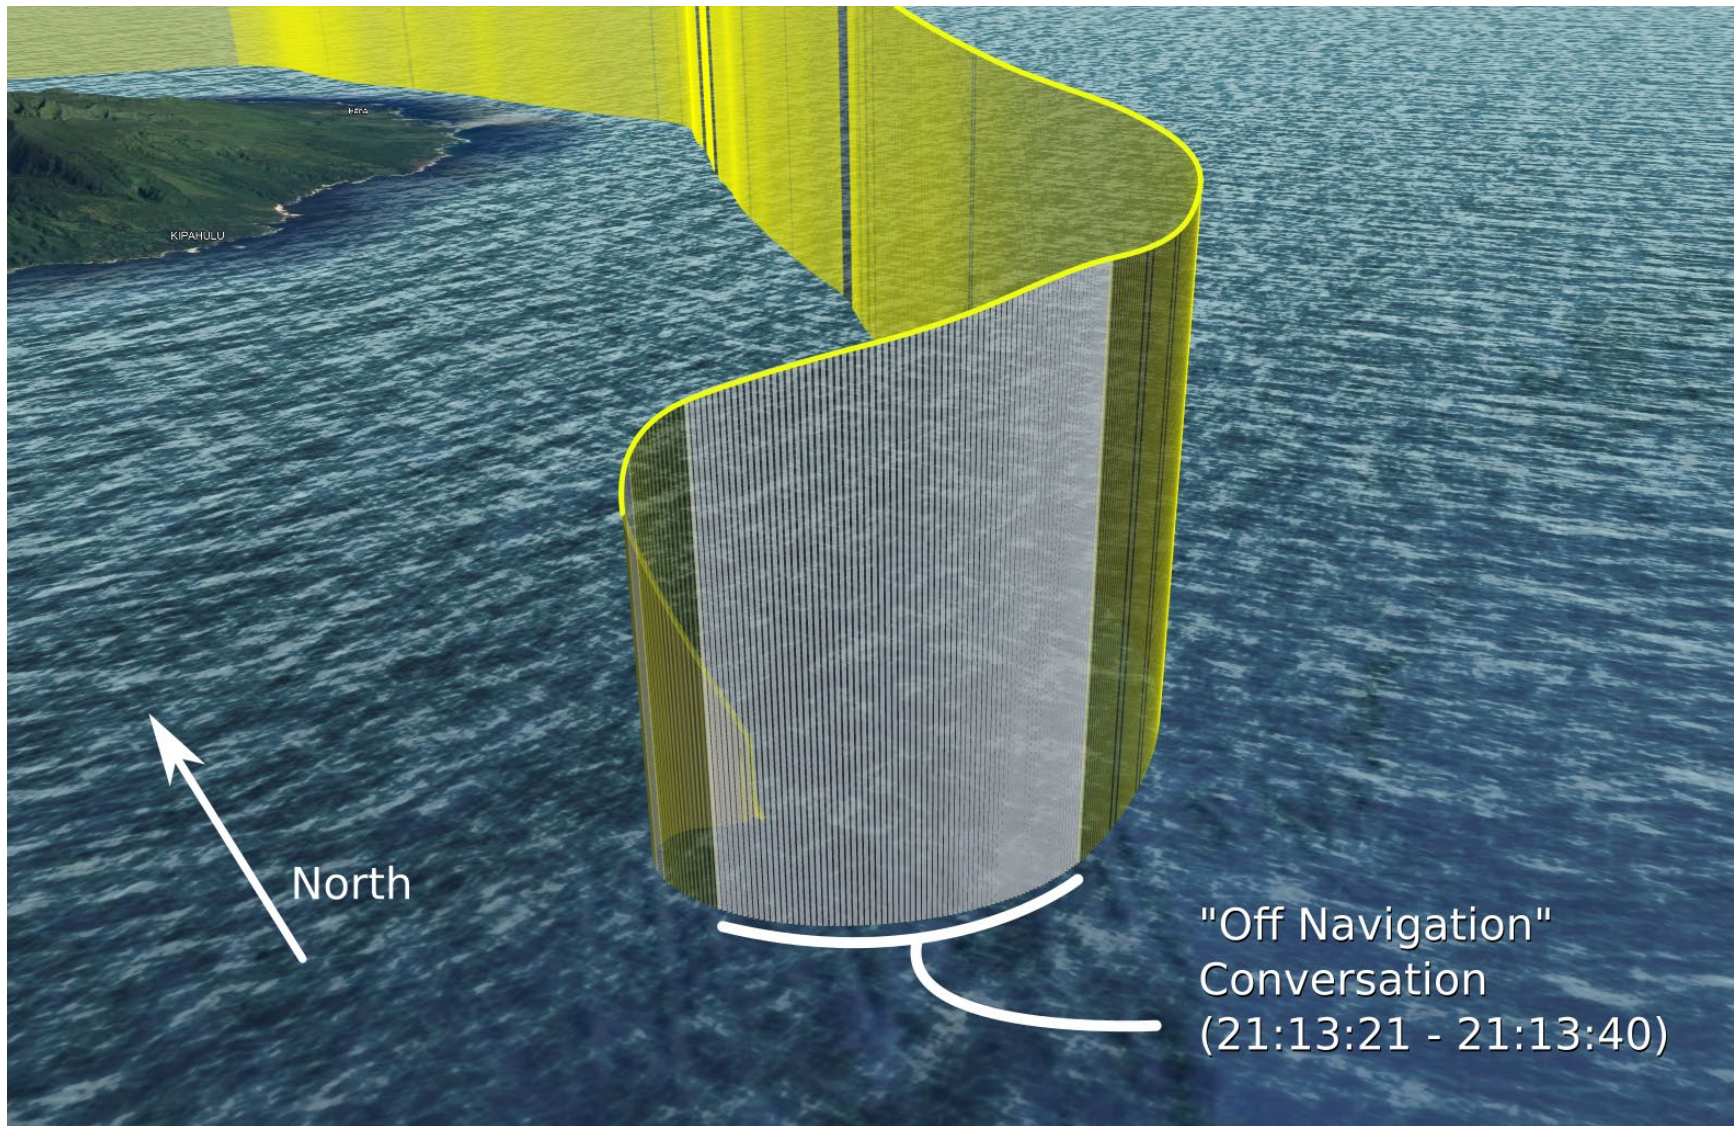
Figure 14 is a Google Earth map overlay of the "Off Navigation" radio conversation portion of the flight.

**Figure 14.** Aircraft track during the "Off Navigation" conversation, between 21:13:21 and 21:13:40 HST.
