# National Transportation Safety Board

ANC23LA002

## **WRECKAGE EXAMINATION**

Location: Cordova , AK  
Date: October 16, 2022  
Time: 1427 Local  
2227 Zulu  
Airplane: Piper PA-32-300 N3423W

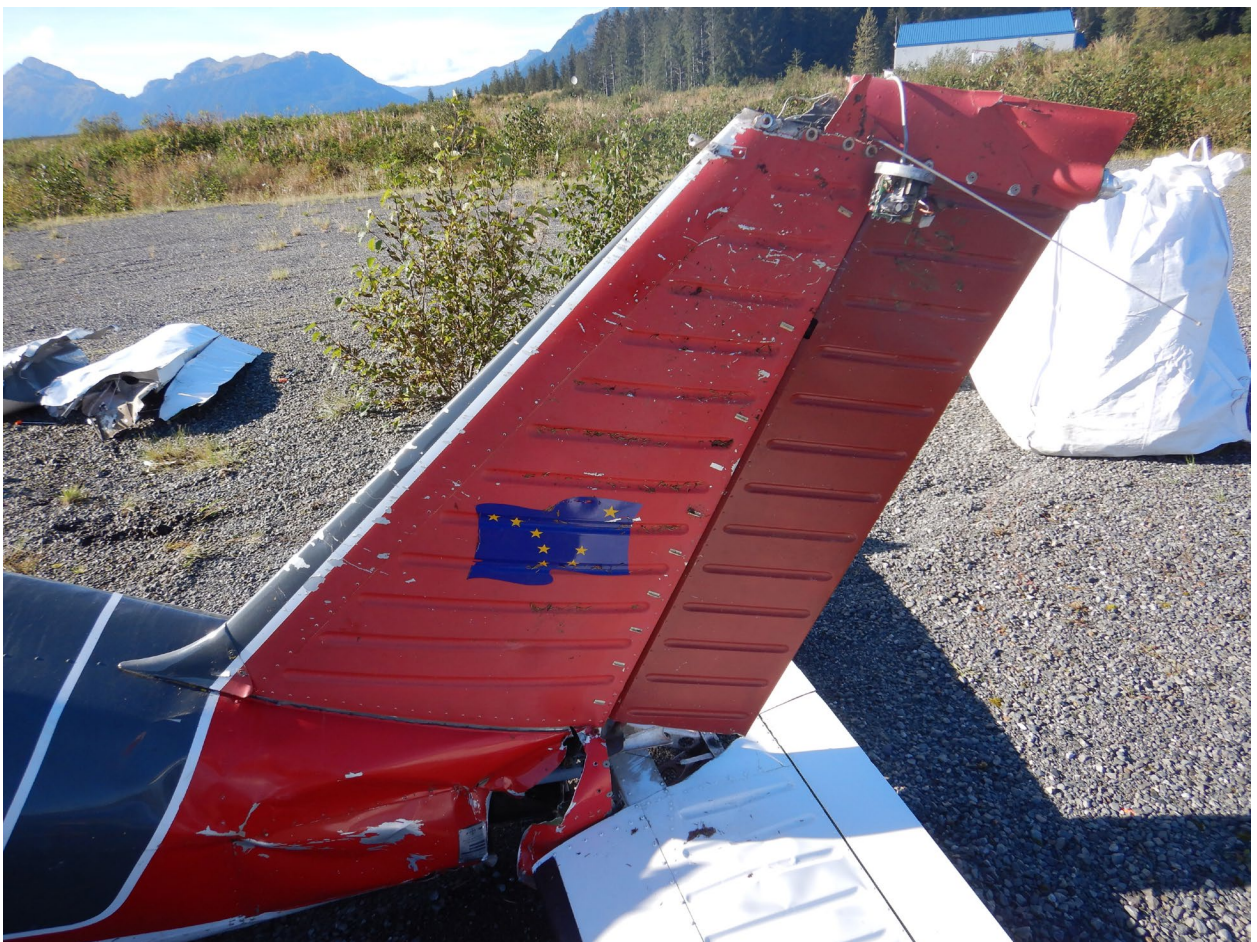
**Figure 9. View of the left vertical stabilizer and rudder.**

Vertical stabilizer had minor impact points along the leading edge with horizontal scratches along the sides starting at the leading edge (*figure 6,7*). The tip cap of the vertical stabilizer was impact separated (*figure 8*).

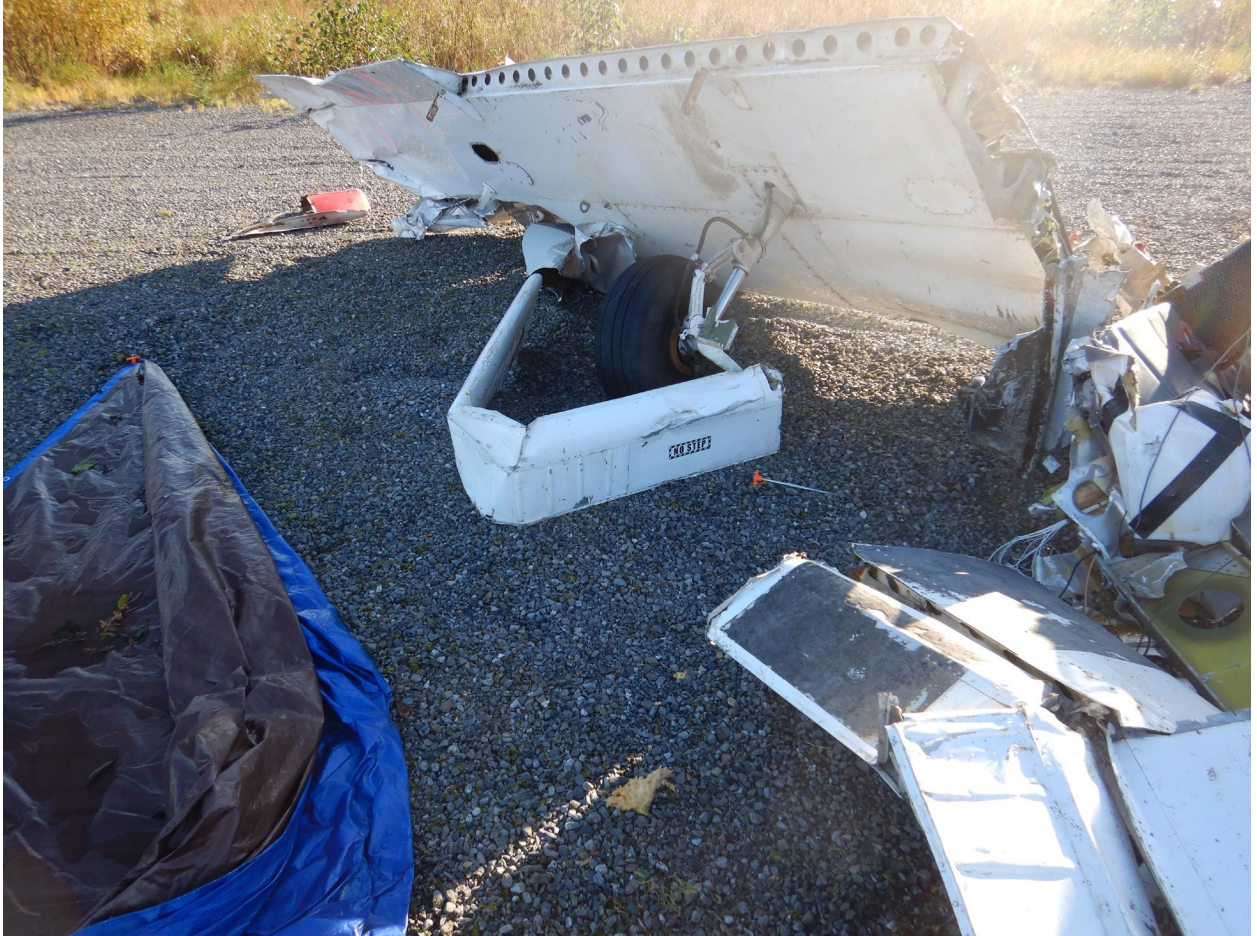
**Figure 22. View of left wing looking at the underneath side of the wing.**

Left wing leading edge was impact damaged from the root to at about one foot outboard and significant impact damage about 67" outboard to the wing tip (*figure 21*). Fiberglass wing tip was impact separated. The left wing fuel cap was missing. Left aileron had a slight upward bend centered about mid span and was still attached to all attachment points. Left aileron control tube was still connected to the aileron and control cables. The cables pulled out into the upper wing surface near the wing root with broom strawing at the break in the cable from overload forces (*figure 24*). The left flap was impact separated from the left wing with the flap attachment portion still attached to the wing.

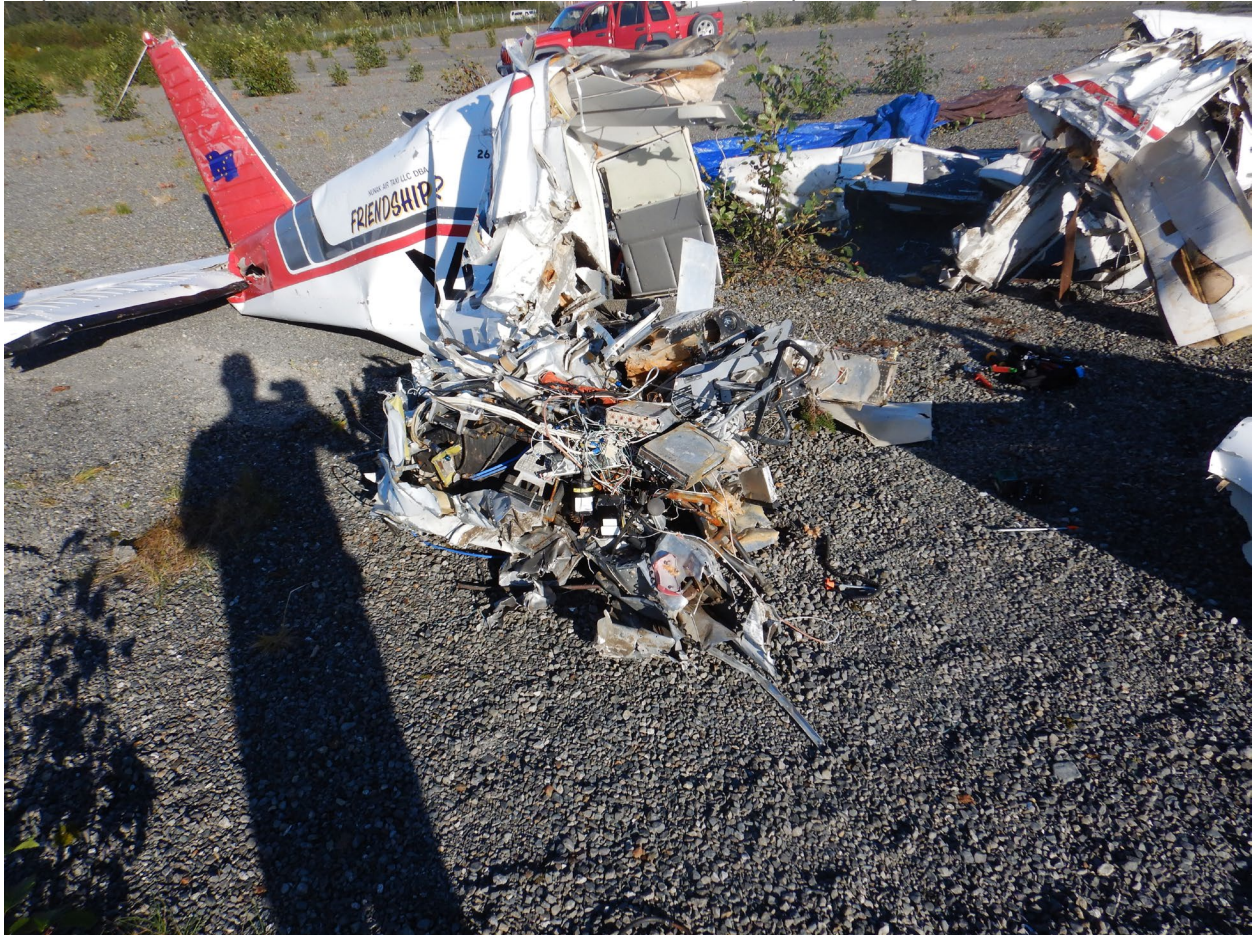
**Figure 30. View of cockpit area.**

Cockpit had significant impact damage. The flight controls/cables were all impacted separated at the floor below the instrument panel (*figure 32*).

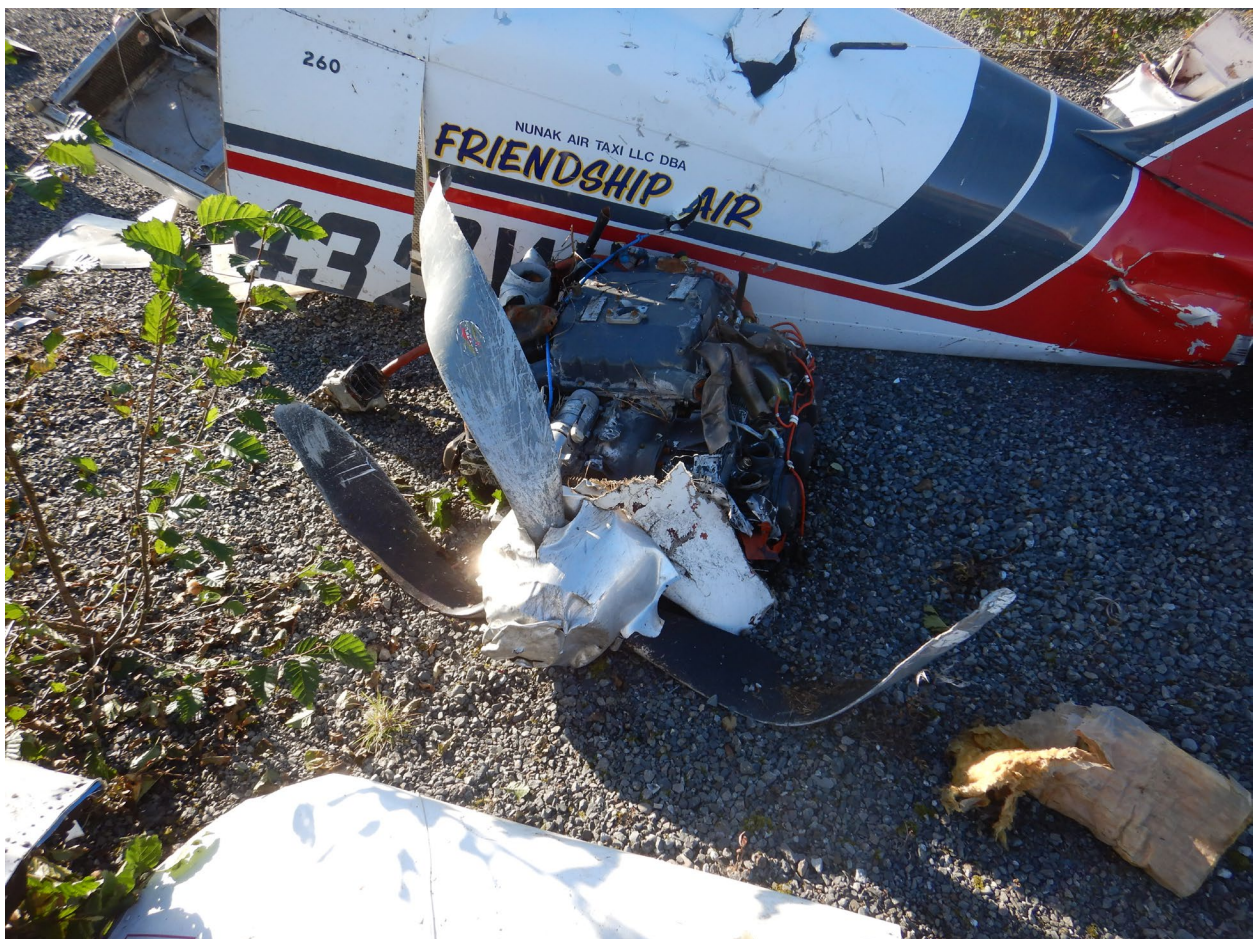
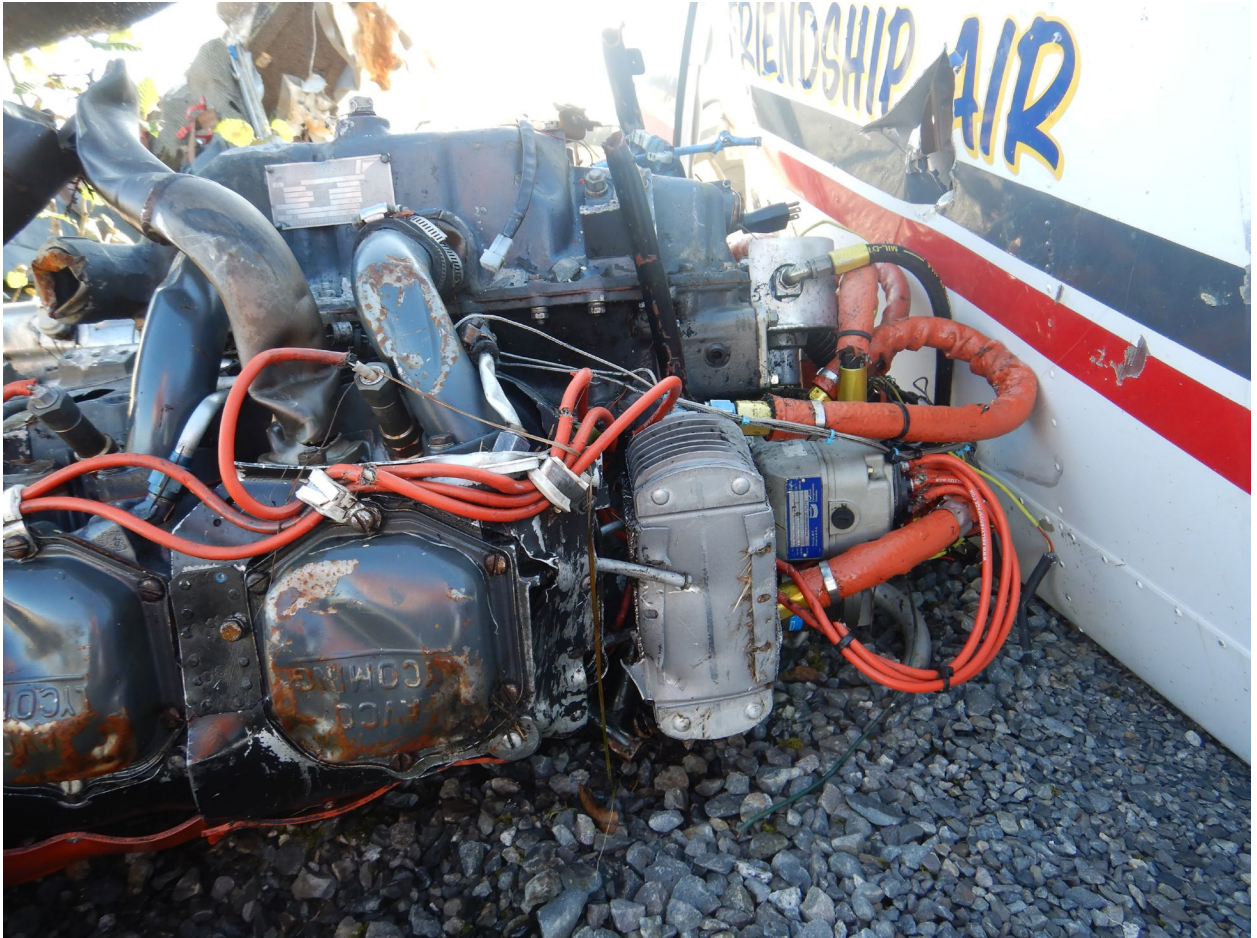
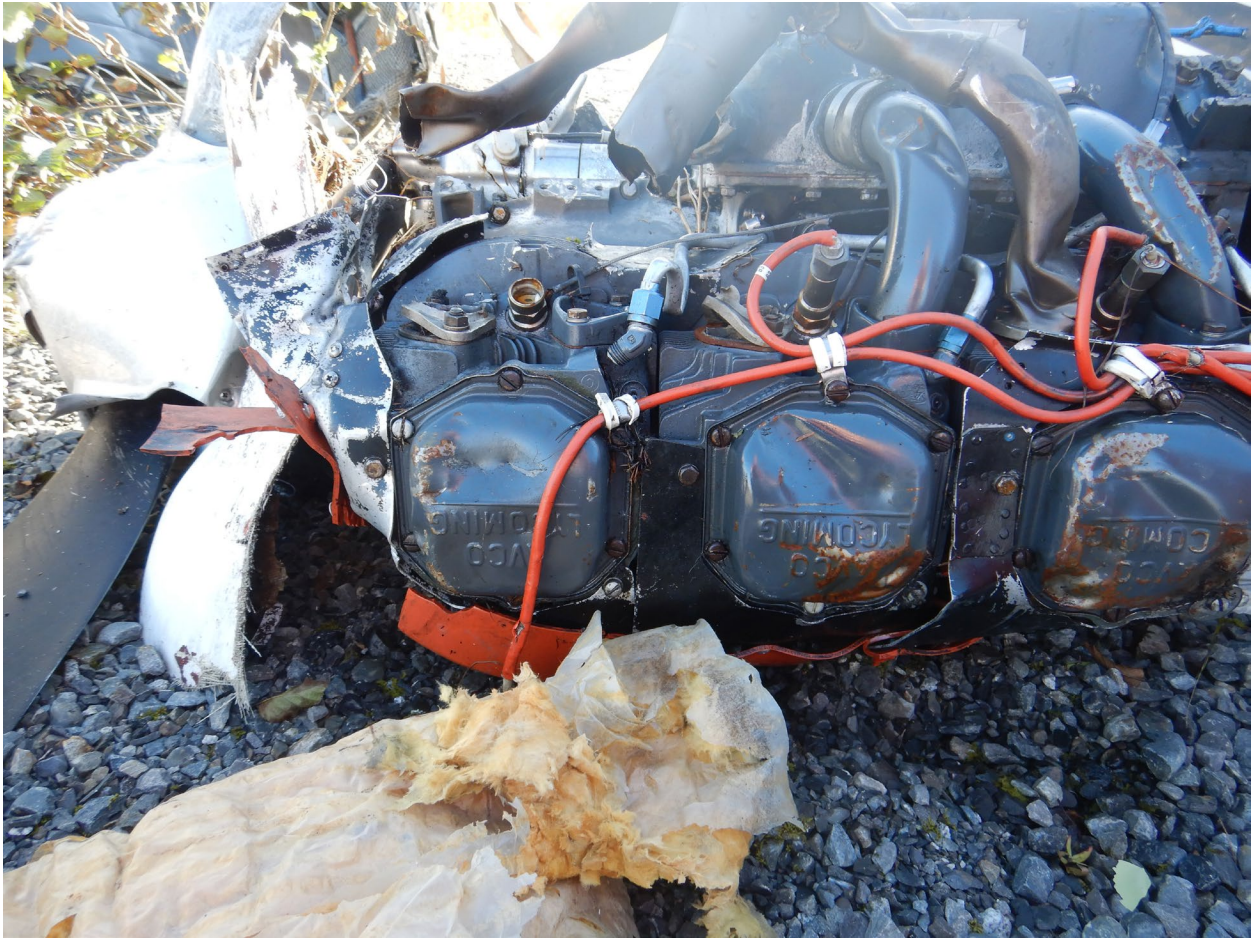
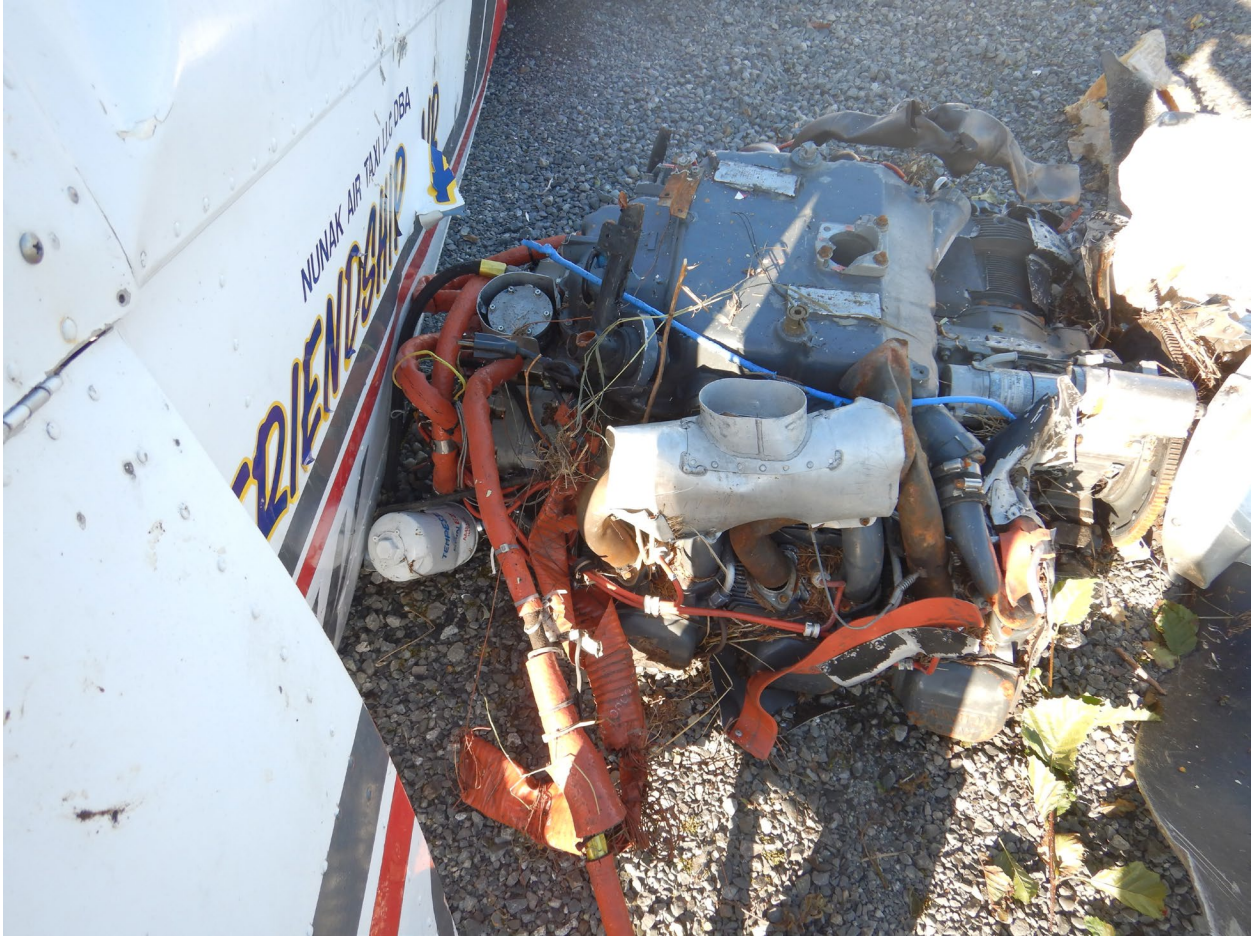
Engine could be rotated by hand. Limited by the ability of one person to lift and turn the engine with the propellers attached. Magnetos were securely attached to the engine (*figure 42, 43*). Removed the sparkplugs to inspect inside of the cylinders but due to broken intake and exhaust connections, water had entered into the cylinders. The engine internals were exposed to the elements for almost a year. The spark plugs and inside of the cylinders were rusted.
