# National Transportation Safety Board

ANC23LA078

## ENGINE EXAMINATION

Location: Nenana, AK  
Date: September 16, 2023  
Time: 1600 Local  
Airplane: N907W Murphy Moose SR3500

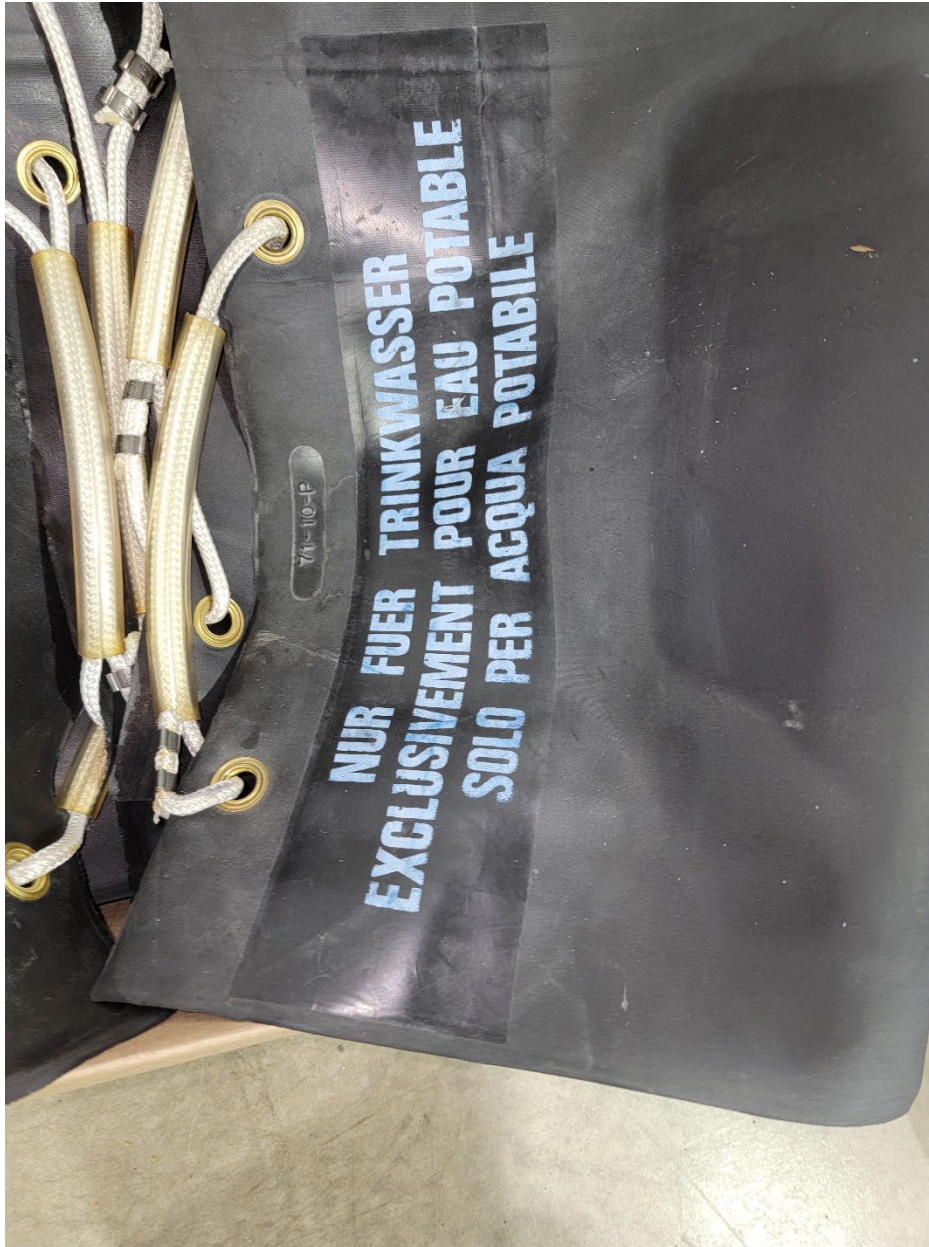
Fuel was added to the fuel tanks via liquid containment bags that lays flat when empty. The owner referred to the bags as Swiss fuel bags (*figure 4*). The fuel bags used an attachable hose and filter to transfer fuel into the airplane's fuel tanks (*figure*

**Figure 4. Swiss fuel bags used to transfer fuel into the airplane.**

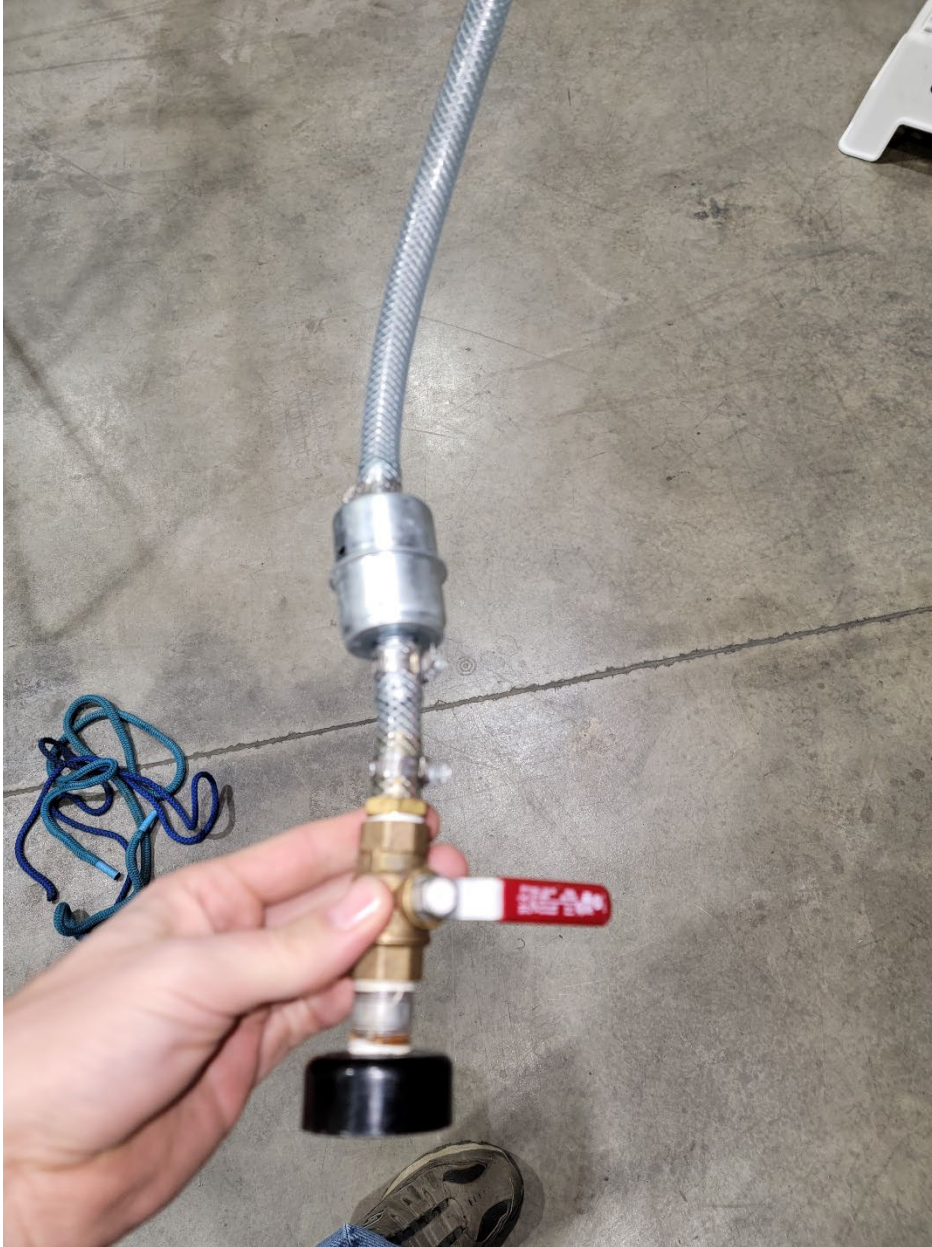
5). The filter 533248/091611K2 contained a metal 149-micron filter. The filter was examined with no observed contaminants (*figure 6*).

**Figure 5. Hose and filter assembly used to transfer fuel from the Swiss fuel bags.**

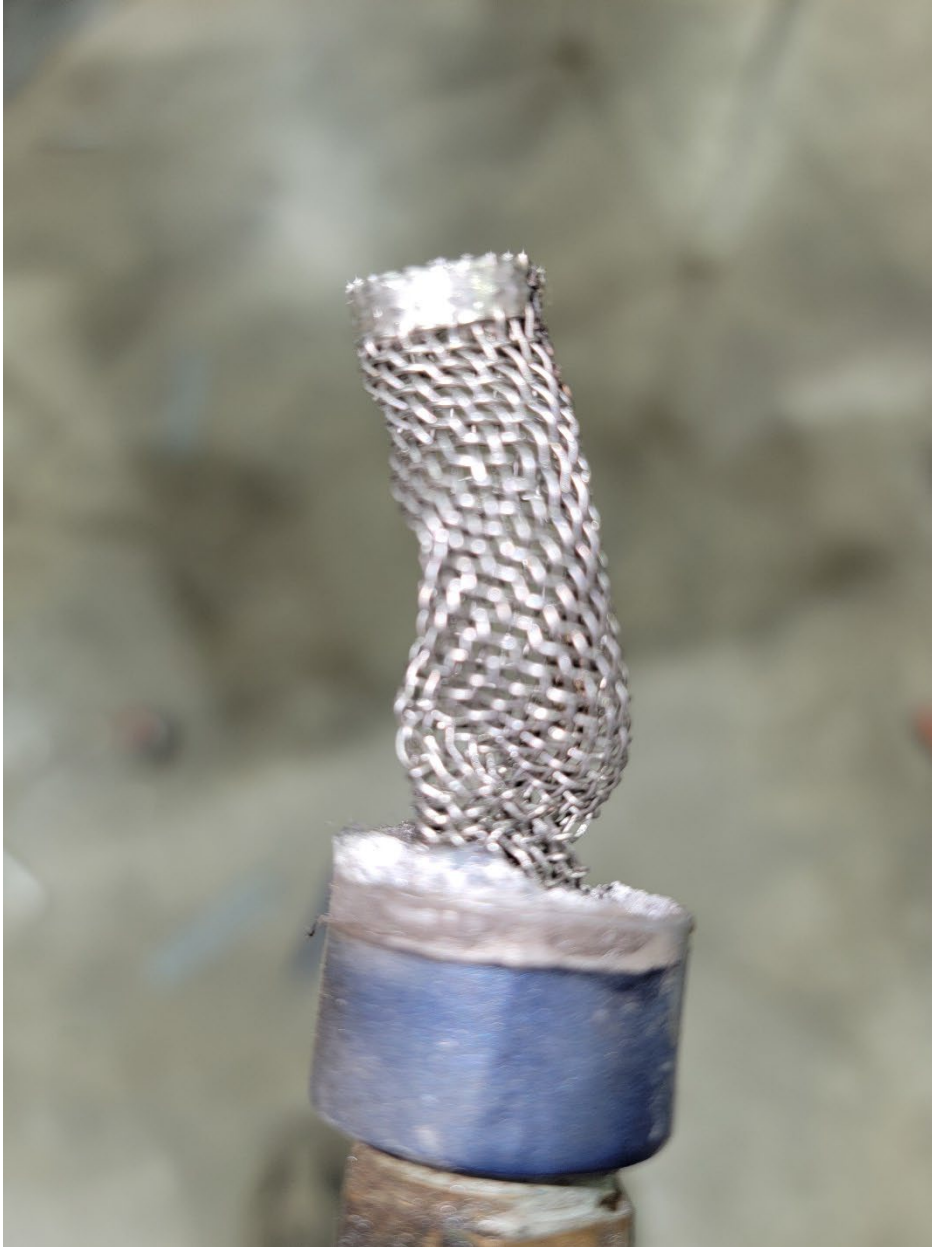
**Figure 7. Airplane wing fuel tank screen.**

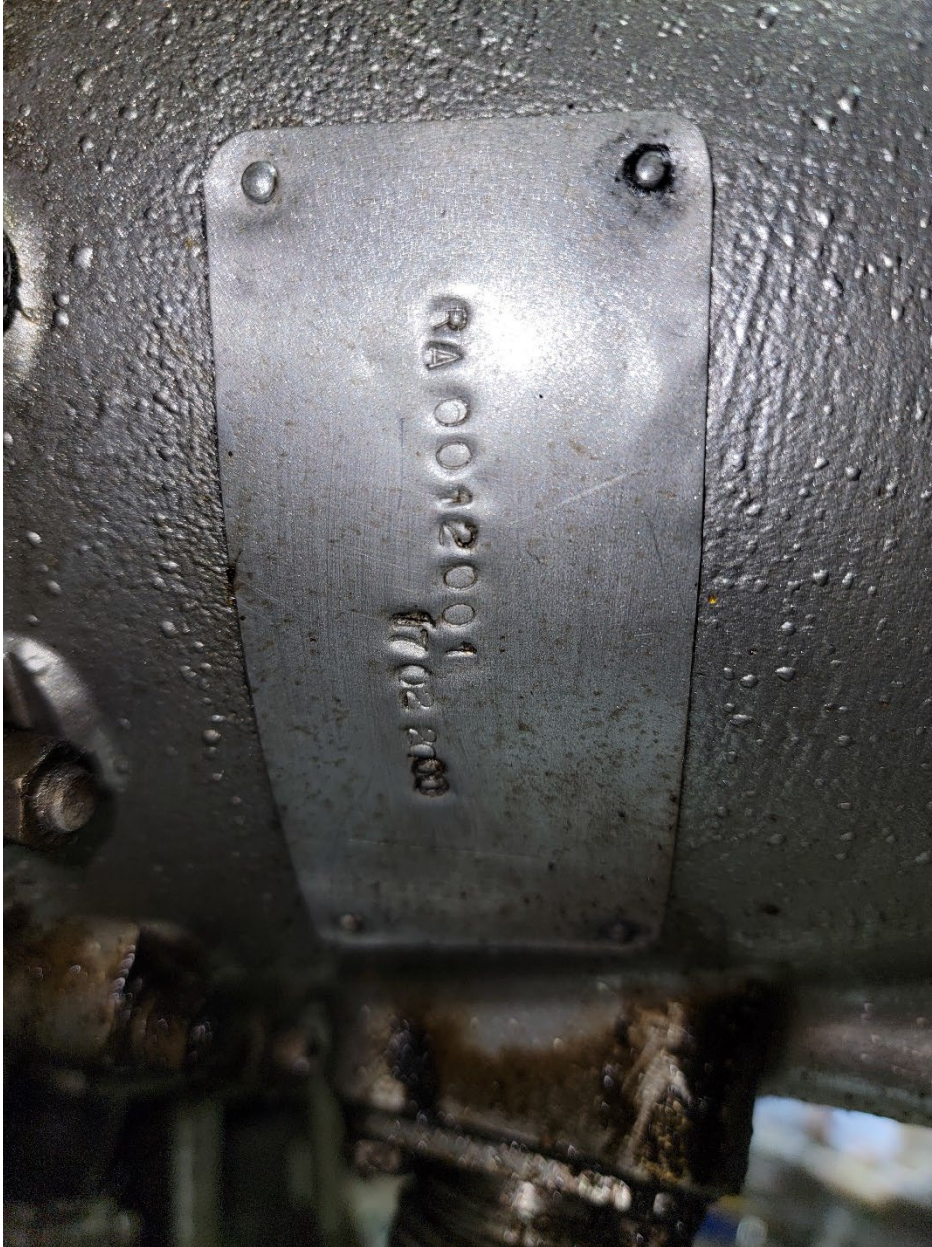
**Figure 10. Engine case number.**
