# National Transportation Safety Board

ANC24FA008

## STRUCTURES

Location: Anchor Point, Alaska  
Date: December 8, 2023  
Time: 1315 Alaska Standard Time (AST)  
2215 Coordinated Universal Time (UTC)  
Airplane: Piper PA-18-150, N1880P

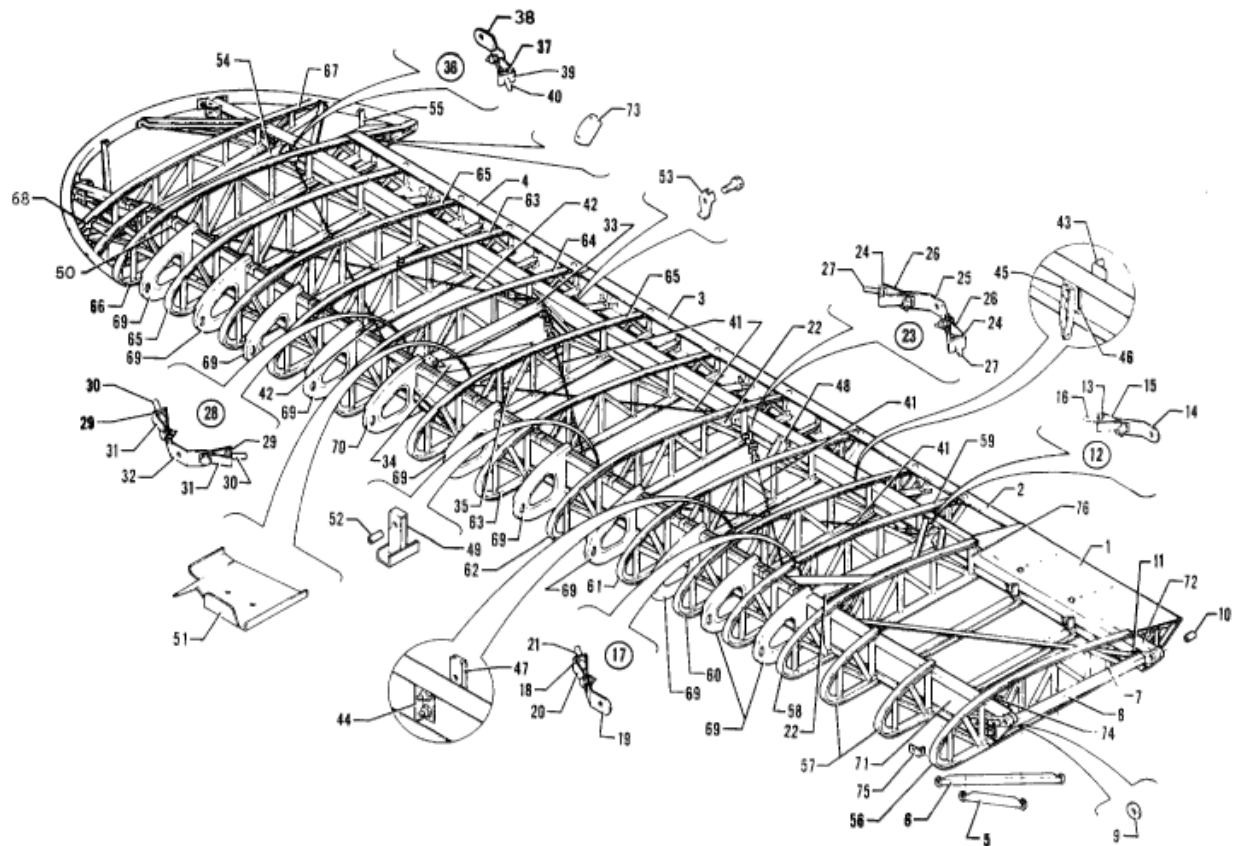
**Figure 2.** Piper PA-18-150 Internal wing structure (Piper diagram)

All wing stations (WS) identified were measured in inches outboard of the wing root. The Piper PA-18-150 fabric covered wing is equipped with aluminum I-beam type forward and aft spars that run the length of each wing (Figure 2). The spars are connected together by 3 single element drag struts at WS 43, WS 83, and WS 178 and 1 three element N-brace drag strut at the wing strut attach point location between WS 116 and WS 123. There is a diagonal brace tube installed between the spars at the inboard end where the fuel tank is installed. Diagonal cross brace wires are installed in an 'X' configuration between the spars between drag strut locations. The wing aerodynamic shape between the spars is defined by lightweight aluminum truss-style ribs at 14 locations along the span. Lightweight truss style or stamped leading edge ribs are installed coincident with the wing ribs with additional leading edge ribs installed between each interspar rib location. The leading edge is covered

with aluminum skins. Additional aluminum upper wing skins about 10 inches wide were installed aft of the forward spar on the accident airplane. A fuel tank is installed between the two inboard wing ribs with the diagonal brace running through the tank.
