# National Transportation Safety Board

ANC24FA085

## **WRECKAGE EXAM**

Location: Remote Location  
Date: August 31, 2024  
Time: 10:00  
18:00  
Airplane: PA-18 150, N7154Z

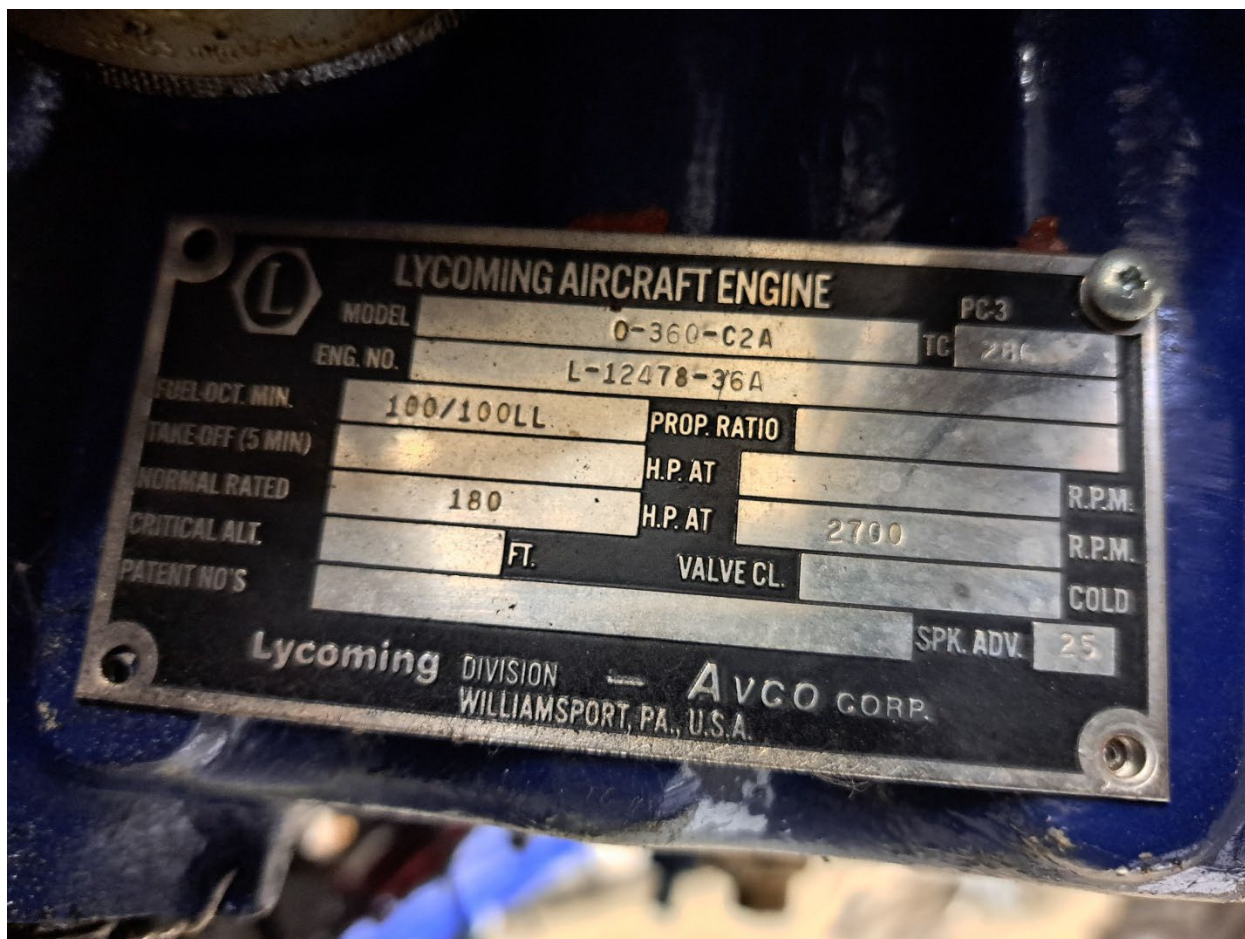
Figure 14 Engine data tag

A Lycoming O-360-C2A engine, serial number L-12478-36A a four-cylinder, air cooled, direct drive, horizontally opposed, normally aspirated (carburetor), internal combustion engine was installed (Figure 13, 14). The engine remained attached to the airframe and was in good condition. The engine had sustained extensive impact damage to the underside and was pressed against the firewall. The engine cowling was cut from the airframe. Thumb compression was confirmed on all 4 cylinders.

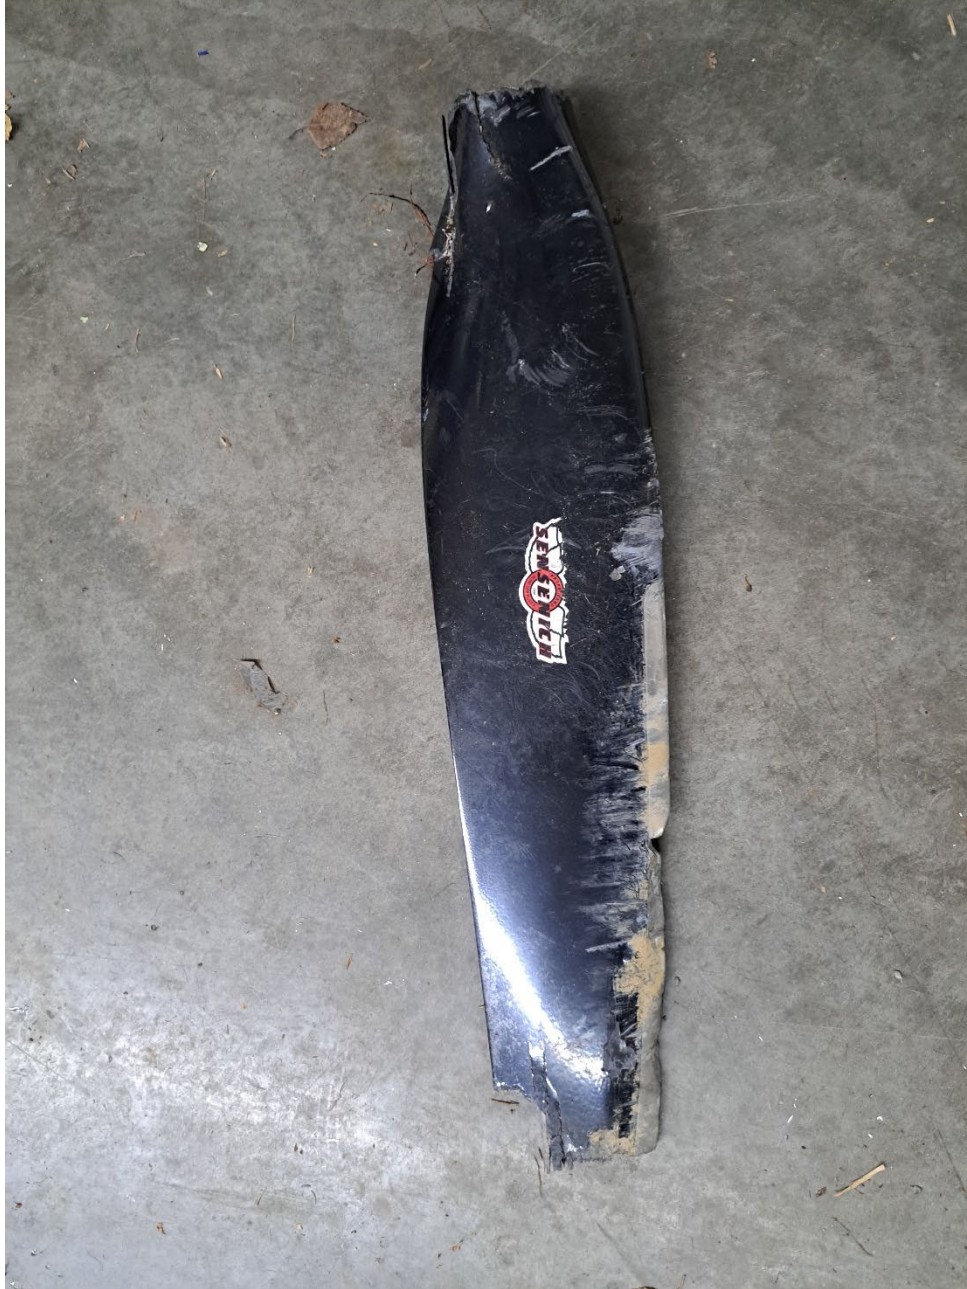
**Figure 18 Propeller blade**

propeller hub remained attached to the crankshaft; however, both propeller blades separated at the hub due to impact (Figure 17). Both blades of the propeller were fractured near the root with a small section of the propeller blades remaining in the hub assembly. One piece of the propeller was found buried at the accident site and was fractured about 30 inches from the root (Figure 18). A small section of a propeller tip section was found, but it could not be determined which propeller blade this piece came from.
