**National Transportation Safety Board**

ANC24LA064

**EXAMINATION SUMMARY**

Location: Petersville, Alaska  
Date: July 12, 2024  
Time: 1700 Alaska daylight time  
Aircraft: DeHavilland DHC-2T, N535KT

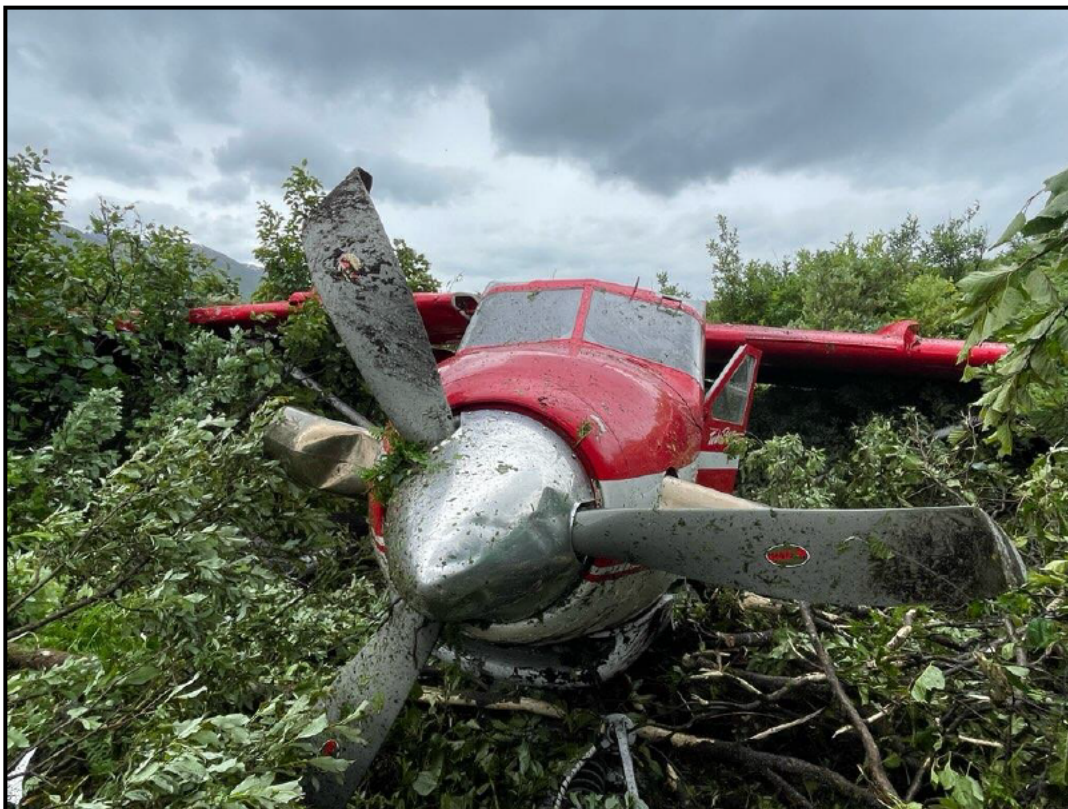
Photograph #1: Operator supplied photo.

Engine: The engine was involved in an incident where the aircraft landed on a hillside in a thick vegetation. See photographs #1 and #2.

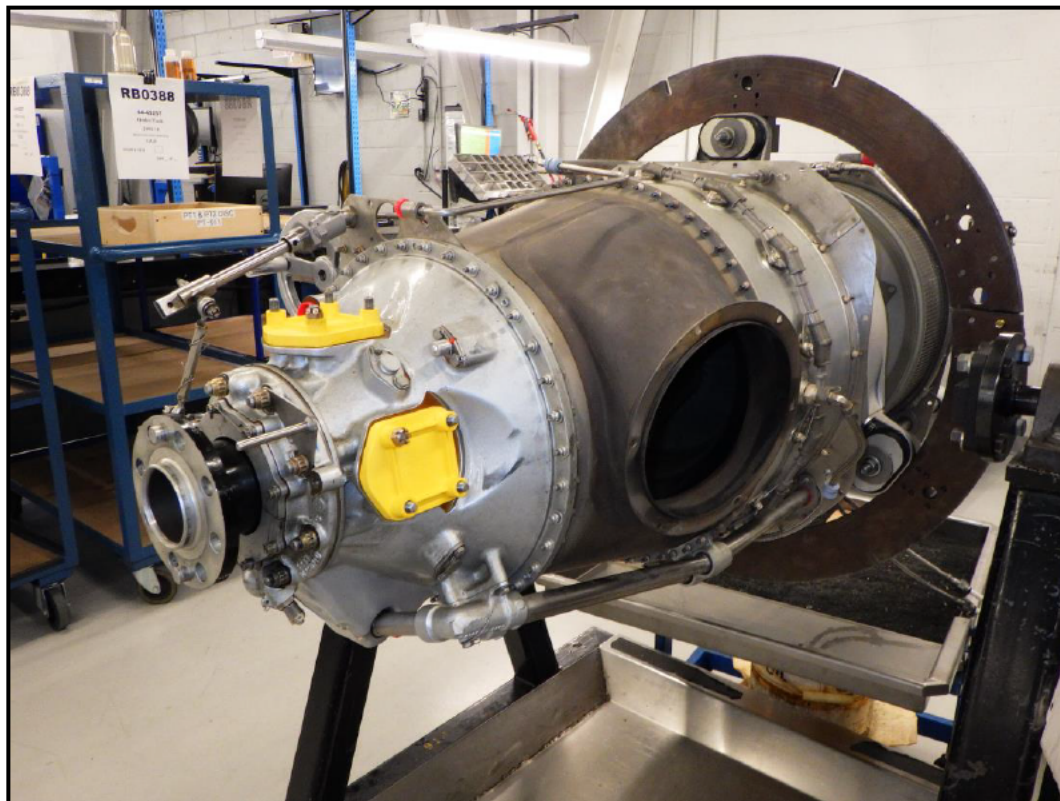
Photograph #3: Engine front left side view (at receiving).

General External Appearance: No buckling damage was found on the GG case and the exhaust duct. The GG case was found with one fractured bolt at one of the engine mounting pads. The exhaust duct was found with a bent exhaust port flange on the right side of the engine. See photographs #3 to #9.
