# National Transportation Safety Board

ANC25MA018

## **POWERPLANT FACTUAL REPORT**

Location: Nome, Alaska  
Date: February 6, 2025  
Time: 15:20 local time  
Airplane: Textron Aviation 208B, Registration Number N321BA

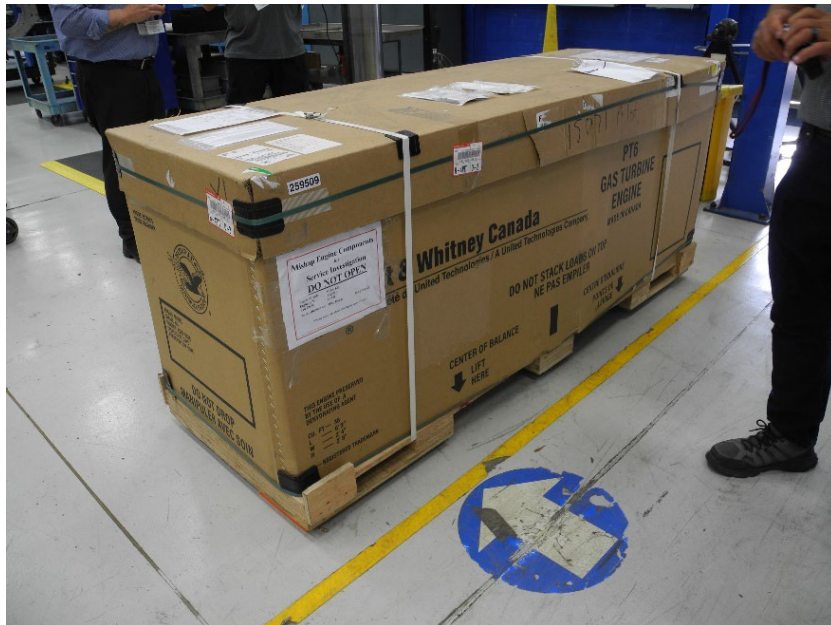
The engine was in a standard cardboard engine container which was opened in the presence of the NTSB (**Photo 1**).

**Photo 1** - Engine in Shipping Container - As Received

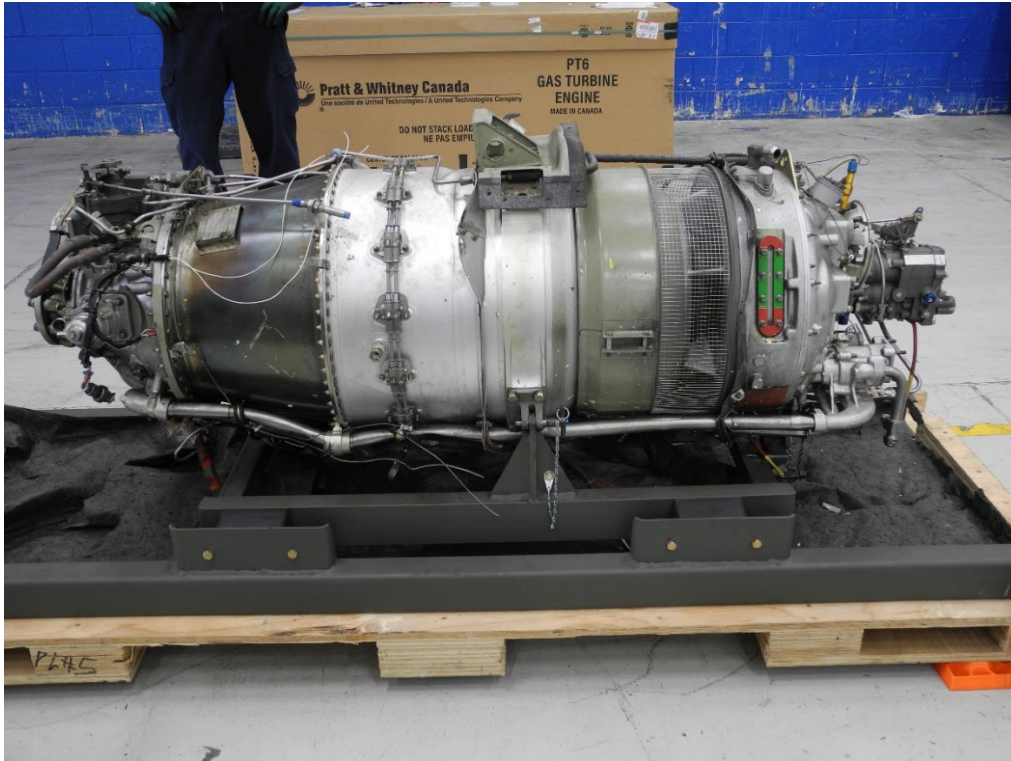
The engine did not display any evidence of fire or un-containment (**Photo 2** & **Photo 3**). The engine was generally clean.

**Photo 2** - PT6A-140 S/N PC-E VA0701 - Left Side View

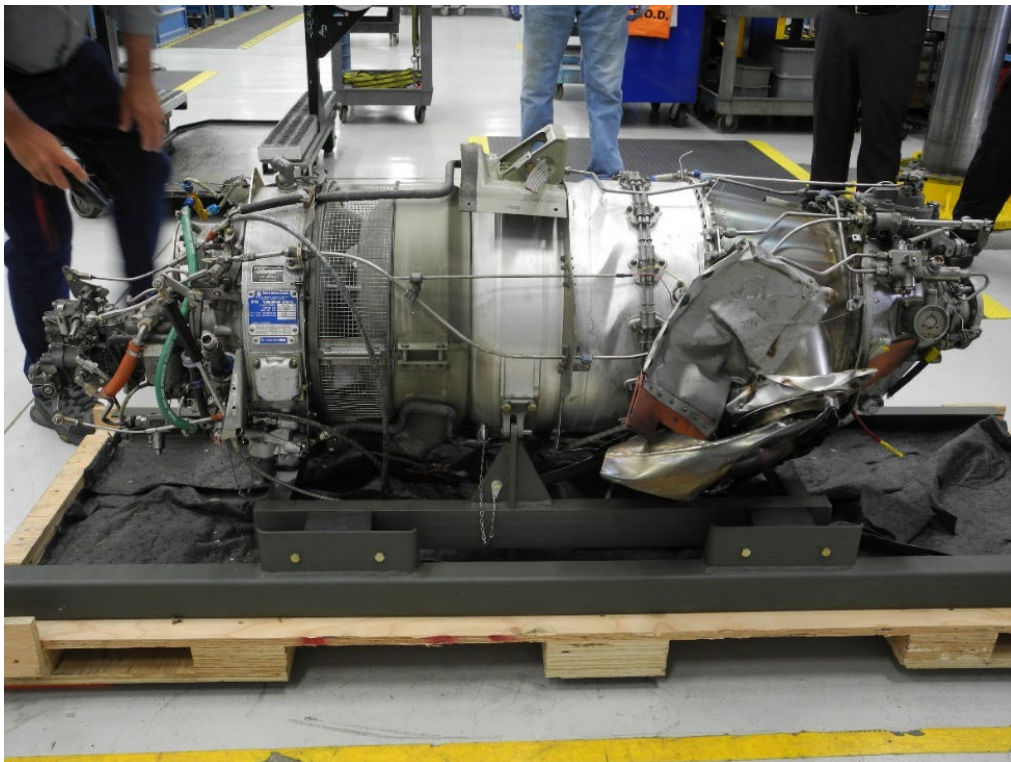
**Photo 3** - PT6A-140 S/N PC-E VA0701 - Right Side View

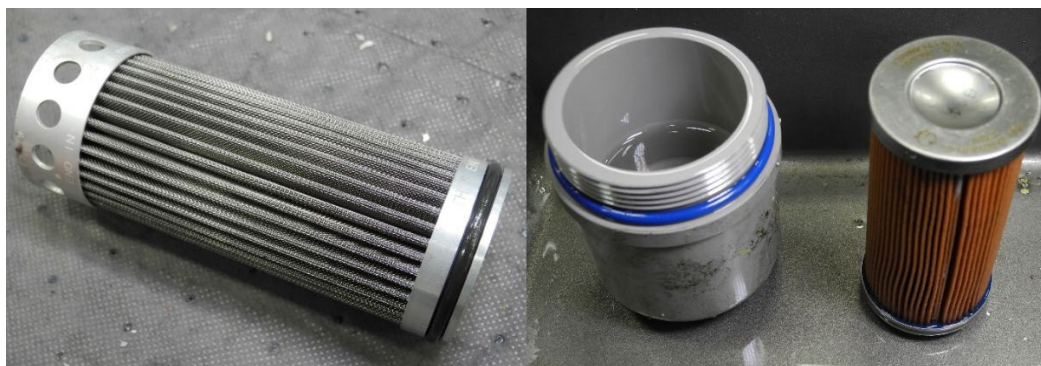
No oil could be seen in the site glass; however, when the oil tank drain plug was removed, approximately one gallon of clean oil was drained. The oil filter (**Photo 5**) was clean and oil wetted. The fuel filter was clean, and the filter bowl contained clean fuel.

**Photo 5** - Oil Filter (at Left) and Fuel Filter and Bowl (at Right)

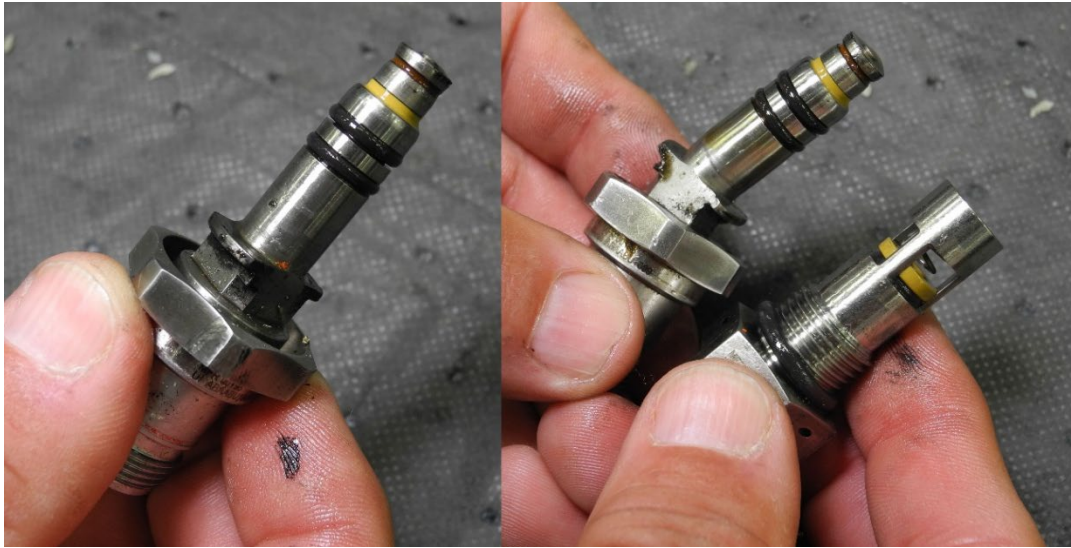
The AGB and RGB chip detectors (**Photo 6**) were clean and oil wetted.

**Photo 6** - Chip Detectors - AGB (Left) and RGB (Right)

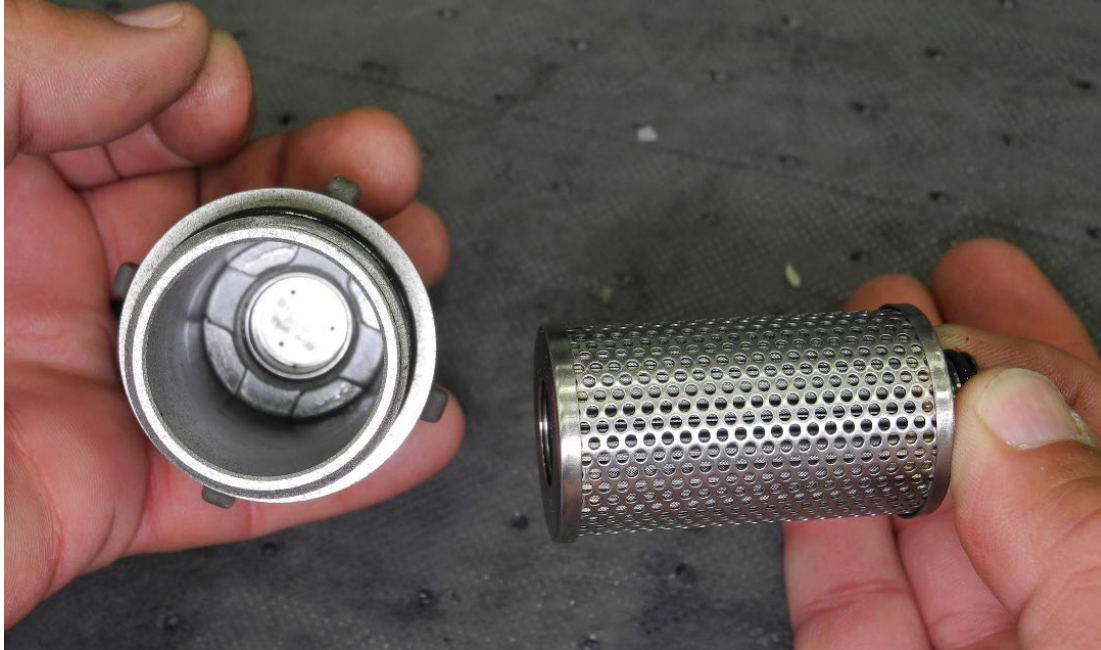
The P3<sup>1</sup> system was present; however, the P3 filter housing was fractured at the fitting (**Photo 7**) so a pressure test could not be performed. The P3 B-nuts on the compressor housing and the FCU were tight. The P3 filter and filter bowl were free of debris (**Photo 8**). The B-nut of the Py fitting was secure and was removed using 50 inch-pounds in-lbs of torque, however, the safety cable of the B-nut was missing one ferrule. The B-nuts on the bulkhead fittings on the firewall and the torque limiter were tight.

**Photo 8** - P3 Filter and Bowl - Clean

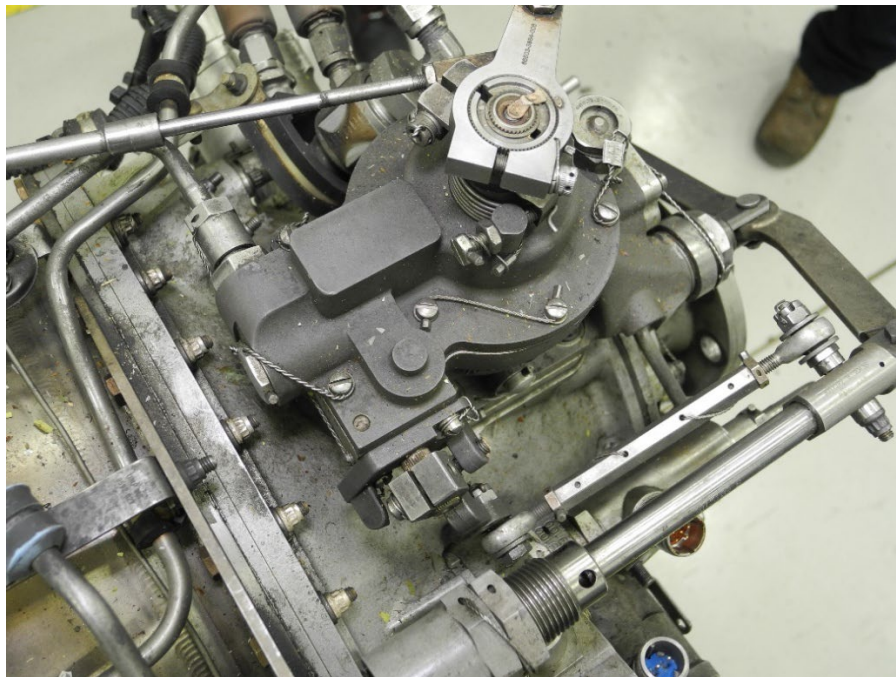
The CSU was intact, undamaged, in the Max RPM position and the push-pull cable was still attached (**Photo 12**). The CSU input lever and underspeed lever shafts rotated freely.

**Photo 12** - CSU - Intact and Undamaged

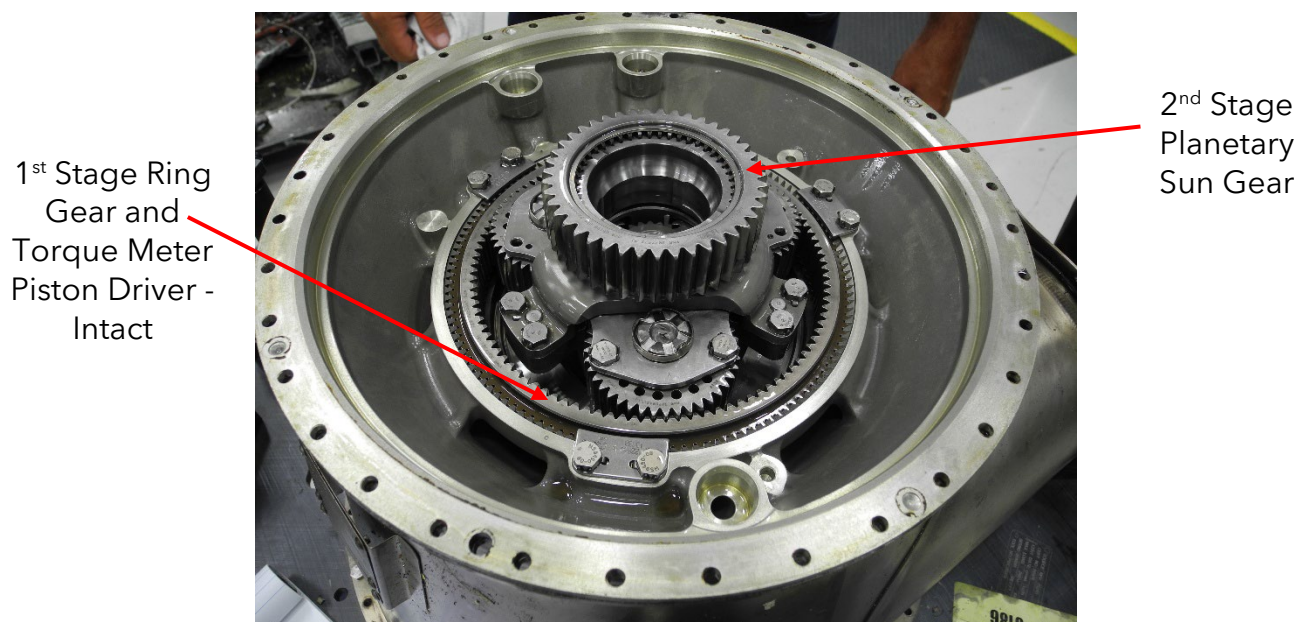
The RGB was disassembled revealing intact, undamaged and oil wetted 1<sup>st</sup> and 2<sup>nd</sup> stage planetary gear assemblies (**Photo 17** & **Photo 18**). All gears meshed smoothly, and all bushings and bearings rotated normally.

**Photo 17** - RGB 1<sup>st</sup> Stage Reduction Gears - Intact and Undamaged

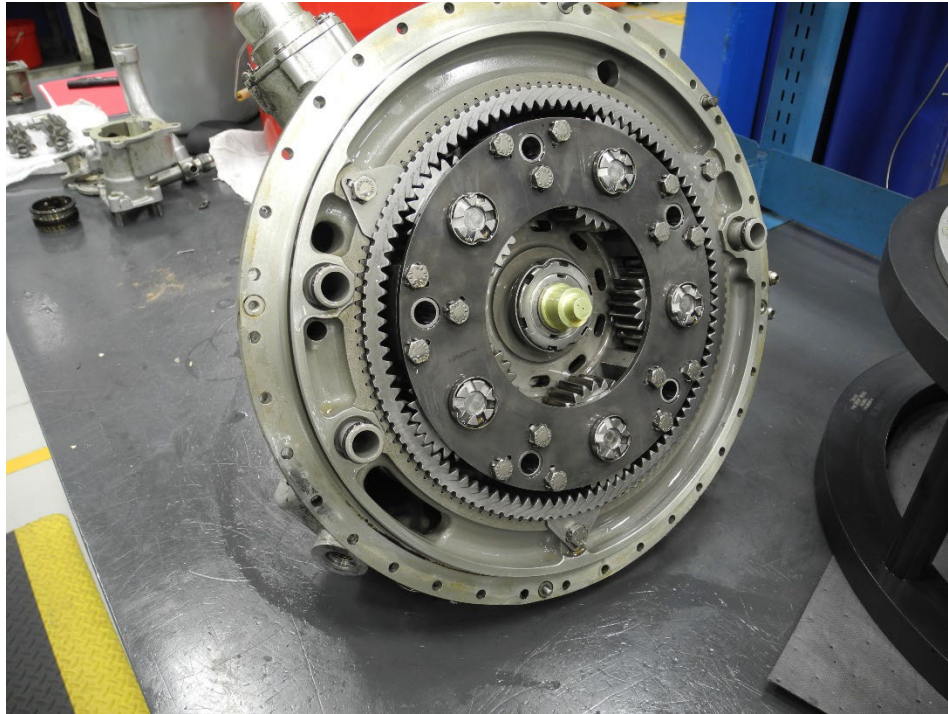
**Photo 18** - 2<sup>nd</sup> Stage RGB Planetary Gear Assembly - Intact and Undamaged

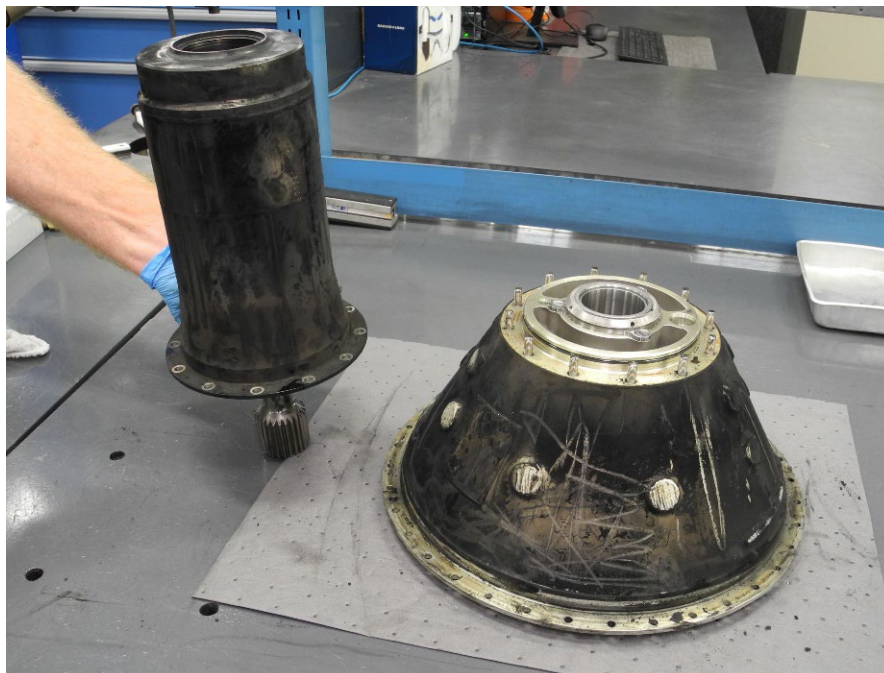
The PT shaft housing was removed from the RGB rear housing (**Photo 19**) revealing an intact 1<sup>st</sup> stage sun gear (**Photo 20**), PT shaft, coupling and Nos. 3 and 4 bearings. The bearings were oil wetted and rotated normally.

**Photo 19** - PT Shaft Housing and RGB Aft Housing

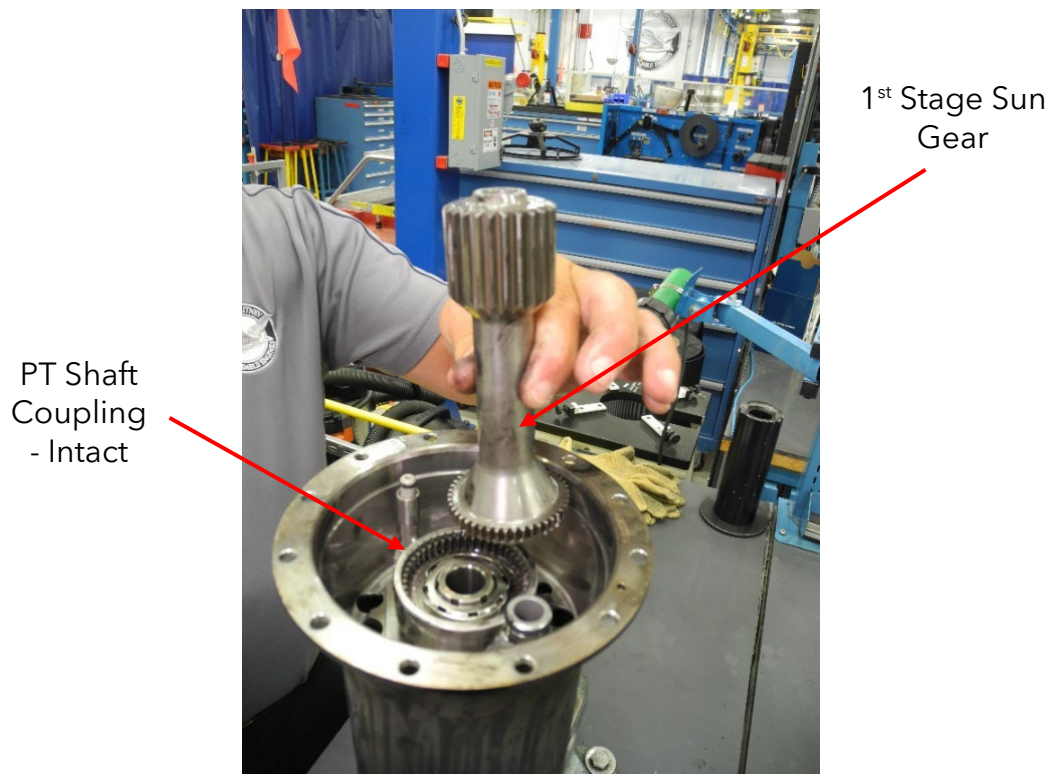
**Photo 20** - PT Shaft Housing and Coupling

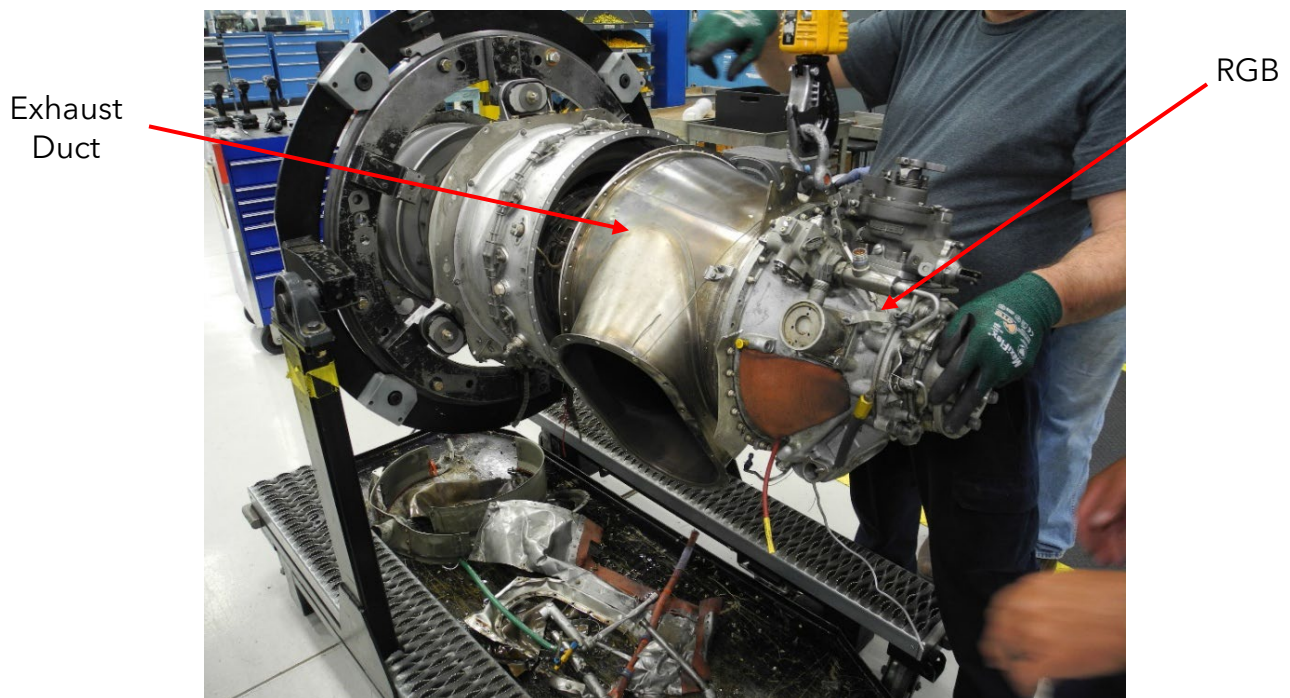
The exhaust duct was intact and undamaged (**Photo 21**).

**Photo 21** - Exhaust Duct and RGB Removal

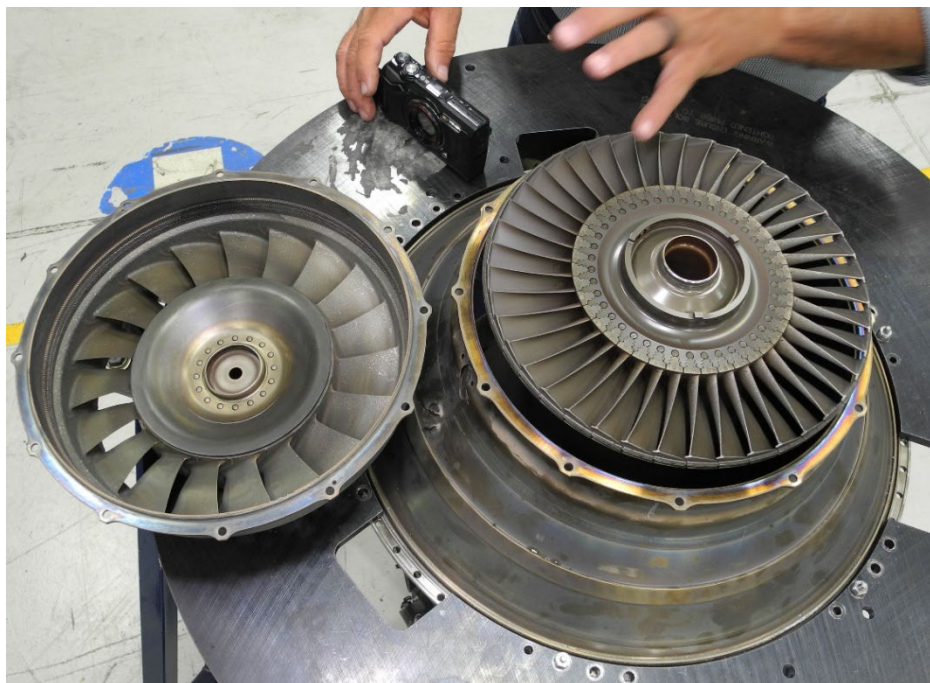
The downstream side of the PT vane ring was intact. There was a circular score on the baffle, consistent with contact against the PT disk. The PT hub and blades were intact (**Photo 24**).

**Photo 24** - PT Vane Ring and PT Wheel - Intact

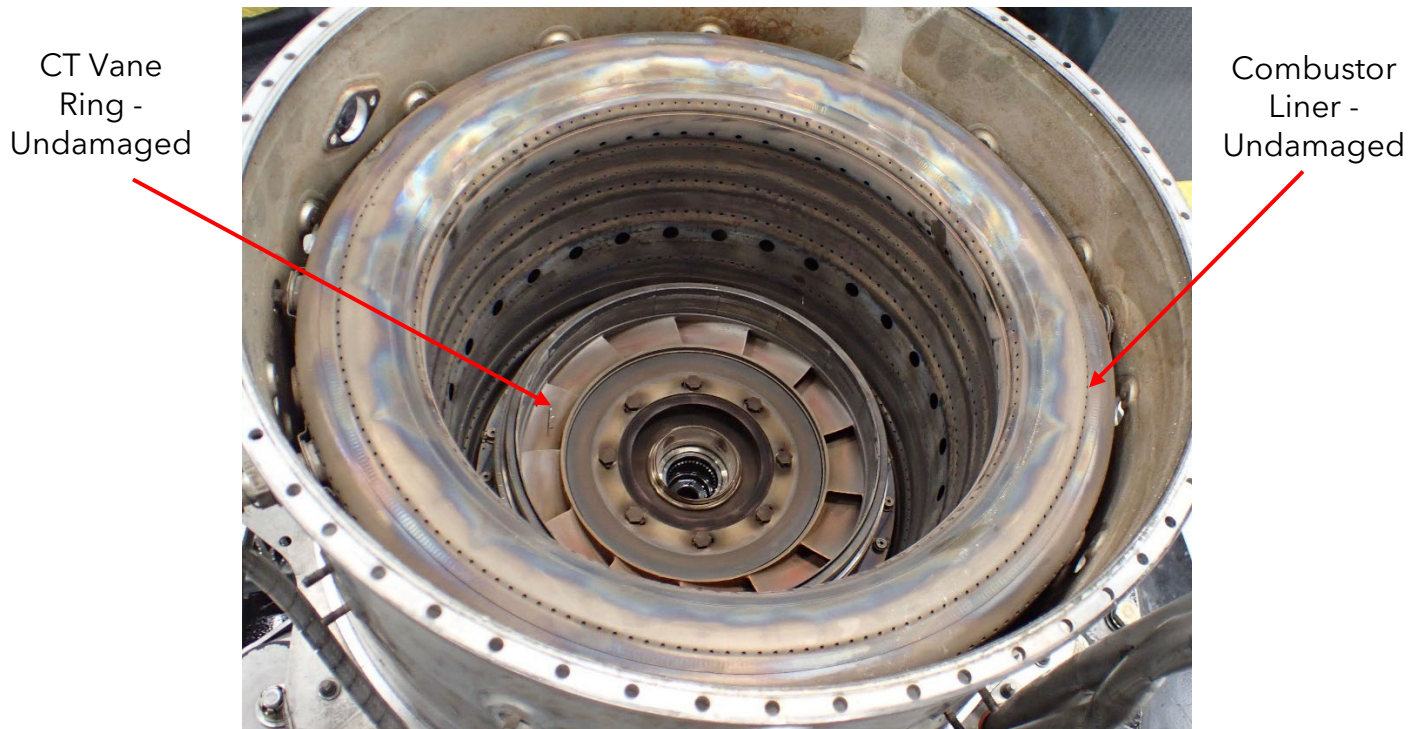
The CT vane ring was intact and undamaged (**Photo 30**). The combustor liner was intact and undamaged.

**Photo 30** - CT Vane Ring and Combustor Liner in GG Case

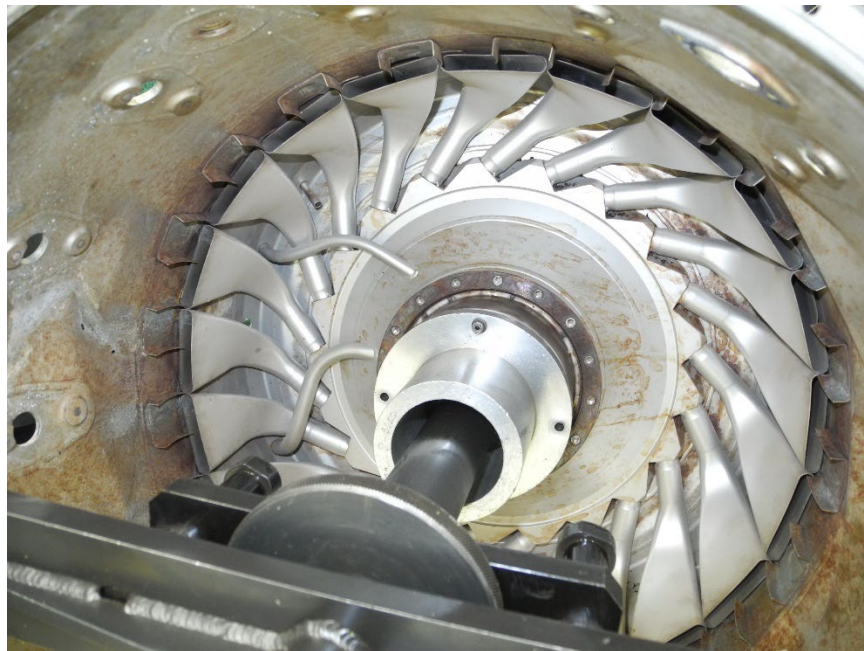
The gas generator (GG) case was intact; however, it was buckled near the 12 o'clock location (**Photo 31**). The fuel nozzle assemblies were all present and intact. Two transfer tubes were impact damaged. A visual examination of the fuel nozzles revealed clean nozzles. The diffusers were intact and undamaged (**Photo 32**).

**Photo 32** - GG Case Diffusers - Intact

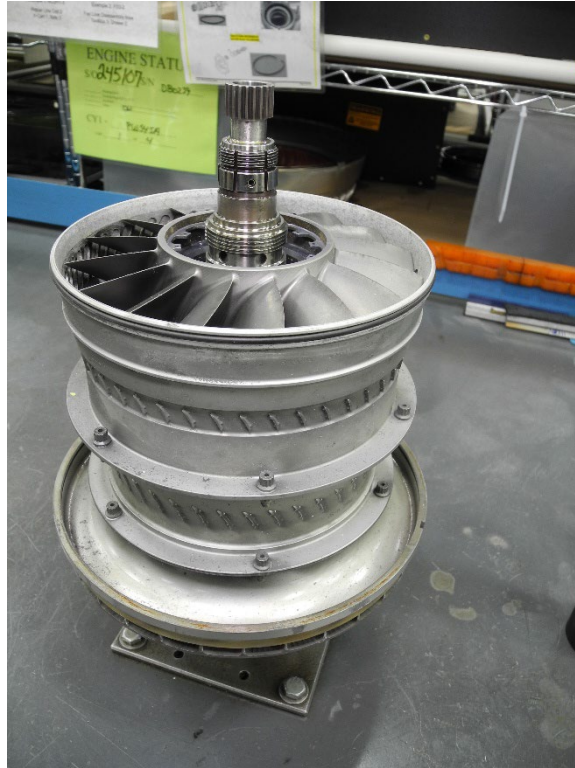
The compressor assembly was intact (**Photo 33**). The No. 1 and No. 2 bearings rotated and were oil wetted.

**Photo 33** - Compressor Assembly - Intact

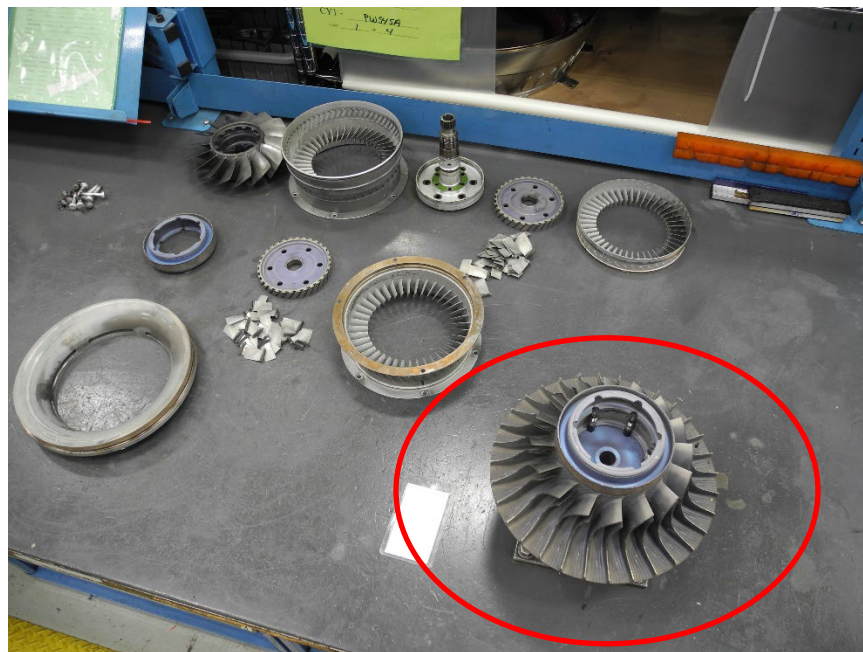
The centrifugal compressor impeller (**Photo 38**) was intact; however, the vane shroud lines were rotationally scored associated with deformed and rolled material (**Photo 39**), consistent with contact against the impeller shroud (**Photo 40**). The impeller shroud was rotationally scored, predominantly near the inducer (**Photo 41**).

**Photo 38** - Impeller - Intact

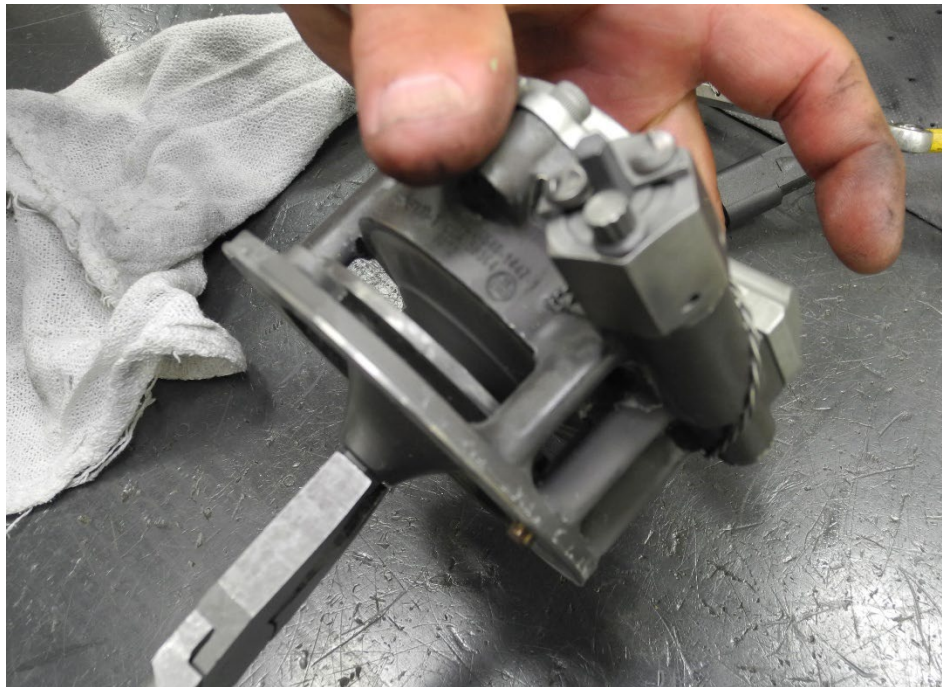
The bleed valve was removed and manually cycled and was found to operate smoothly (**Photo 42**).

**Photo 42** - Bleed Valve - Operational Confirmation

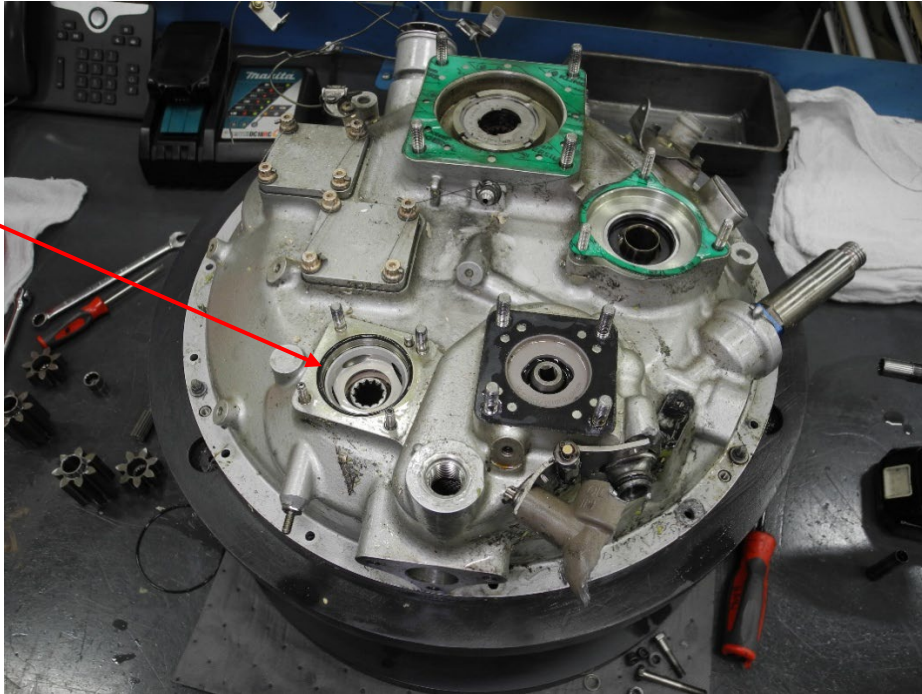
The AGB (**Photo 42**) was intact and undamaged.

**Photo 43** - AGB - Intact

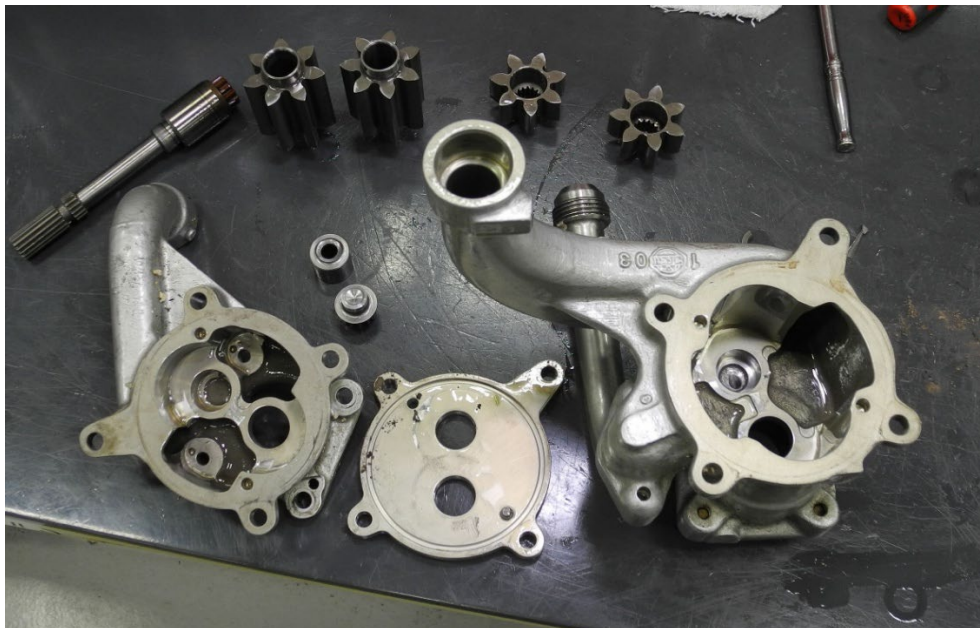
The external oil scavenge pumps were removed and examined, revealing intact housings and pump elements (**Photo 44**).

**Photo 44** - External Oil Scavenge Pumps

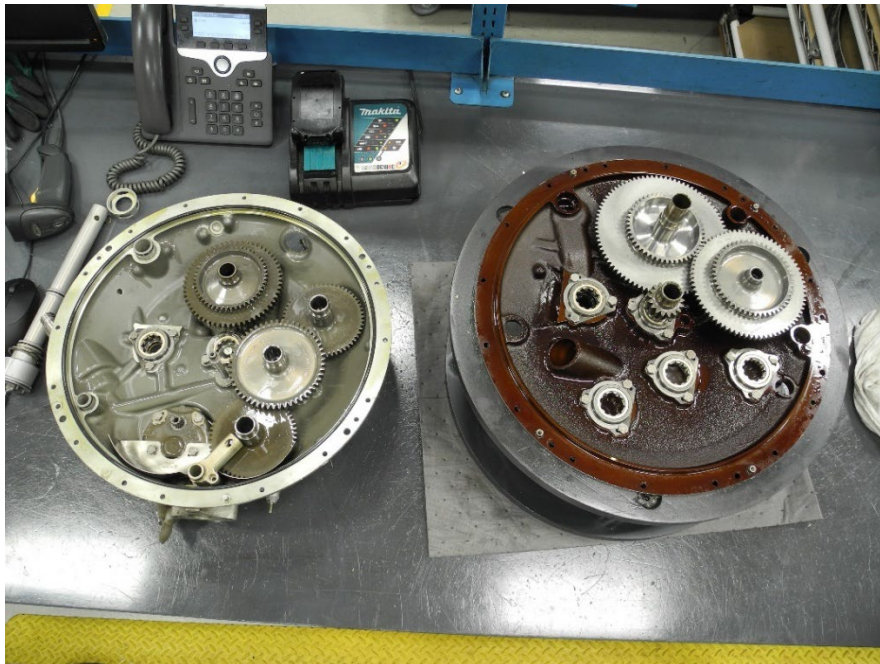
All the accessory drive splines rotated smoothly in unison with the rotation of the AGB coupling shaft except for the oil scavenge spline. The AGB was disassembled (**Photo 46**), revealing intact, undamaged and oil wetted gears and bearings.

**Photo 46** - AGB - Disassembled

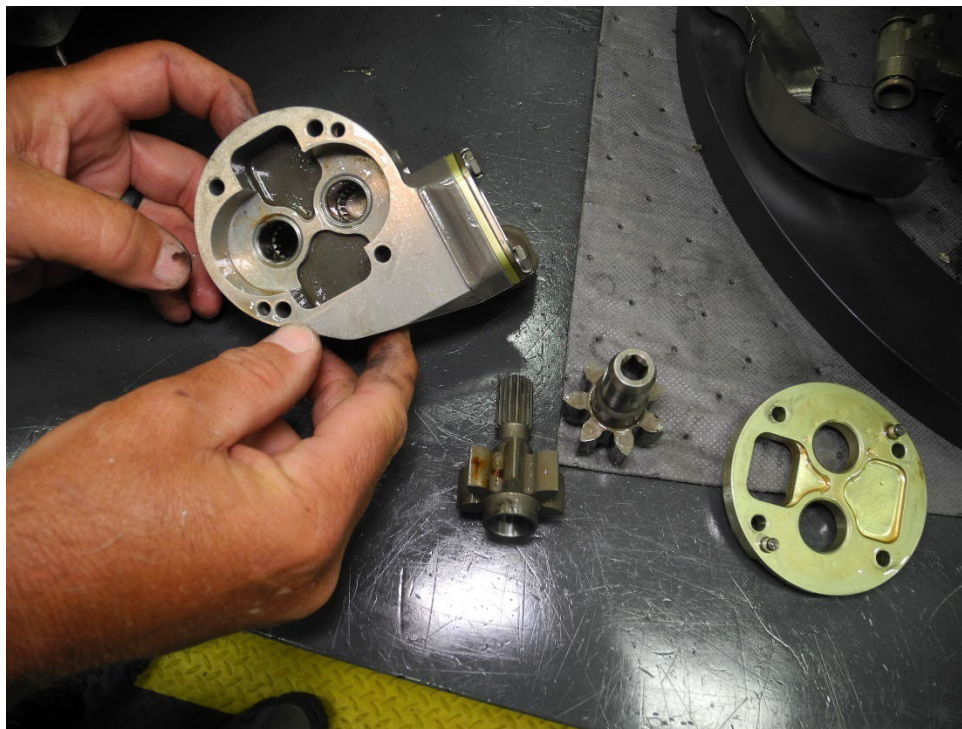
The internal oil scavenge pumps (**Photo 48**) were examined, revealing intact, undamaged and oil wetted housings, gears and journal bearings.

**Photo 48** - Internal Oil Scavenge Pump

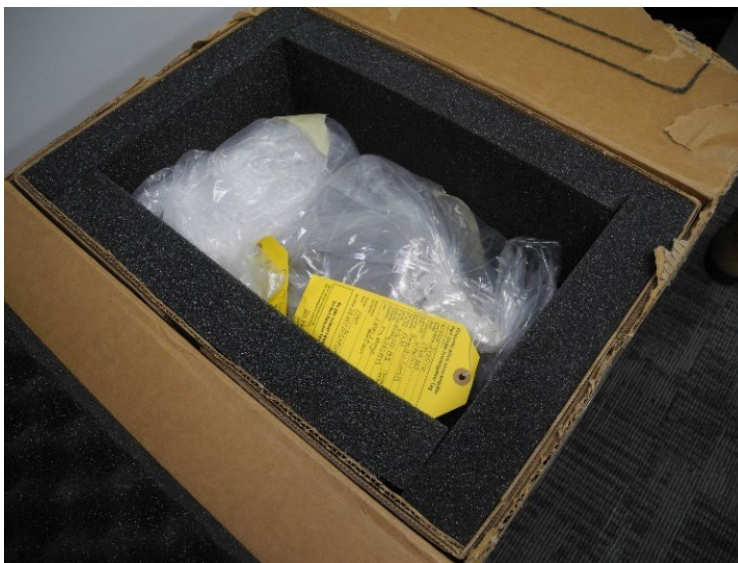
The FCU and the CSU were received at the Woodward facilities in Loves Park, Illinois on June 10 – 11, 2025 in one cardboard box. They were protected, separately wrapped, and undamaged by shipping (**Photo 49**).

**Photo 49** – FCU and CSU in Shipping Container

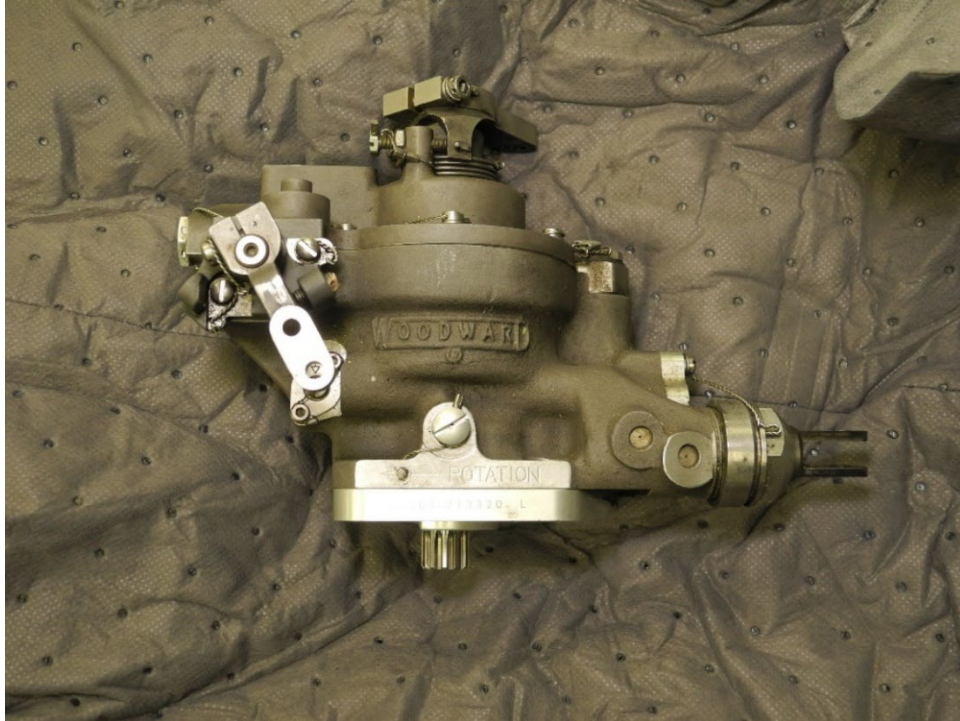
The CSU was inducted by the Woodward receiving department. It was intact and undamaged (**Photo 50** and **Photo 51**). The lock wire on the beta valve and on the air bleed link lever was the original installed by Woodward (**Photo 52** and **Photo 53**).

**Photo 50** - Woodward CSU P/N 8210-002-01, S/N 22275591 - Side View

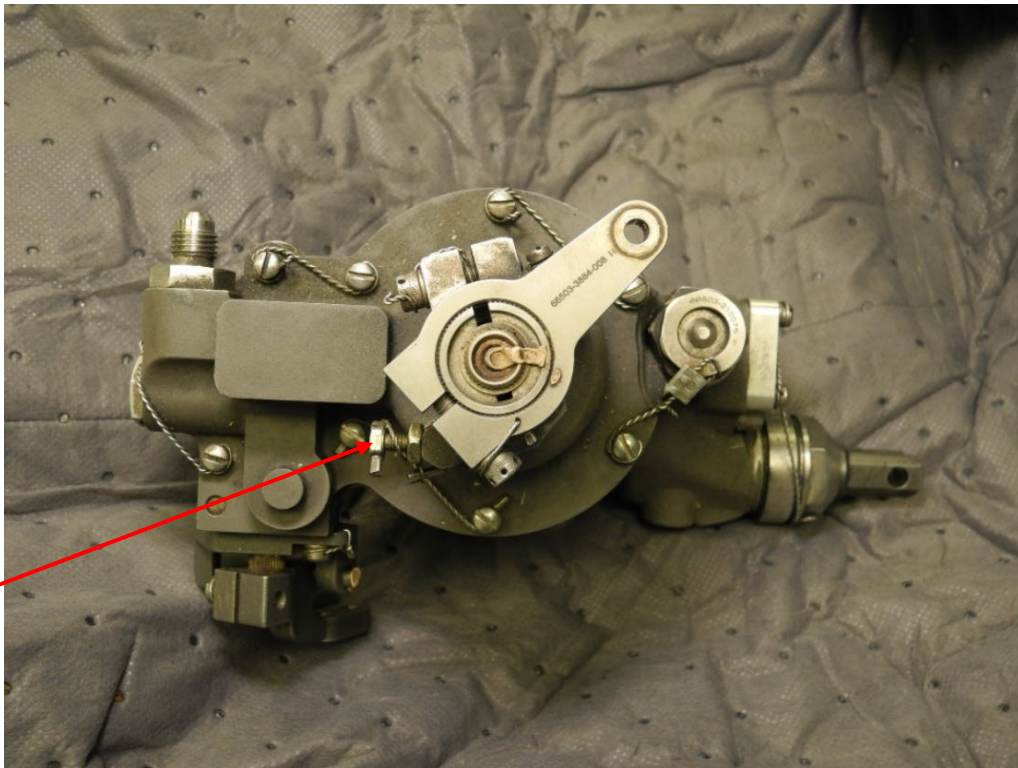
The speed setting lever, the maximum speed setting stop screw, and the eccentric screw had non-Woodward lockwire. The torque stripe was missing on the eccentric screw.

**Photo 51** - Woodward CSU P/N 8210-002-01, S/N 22275591 - Top View

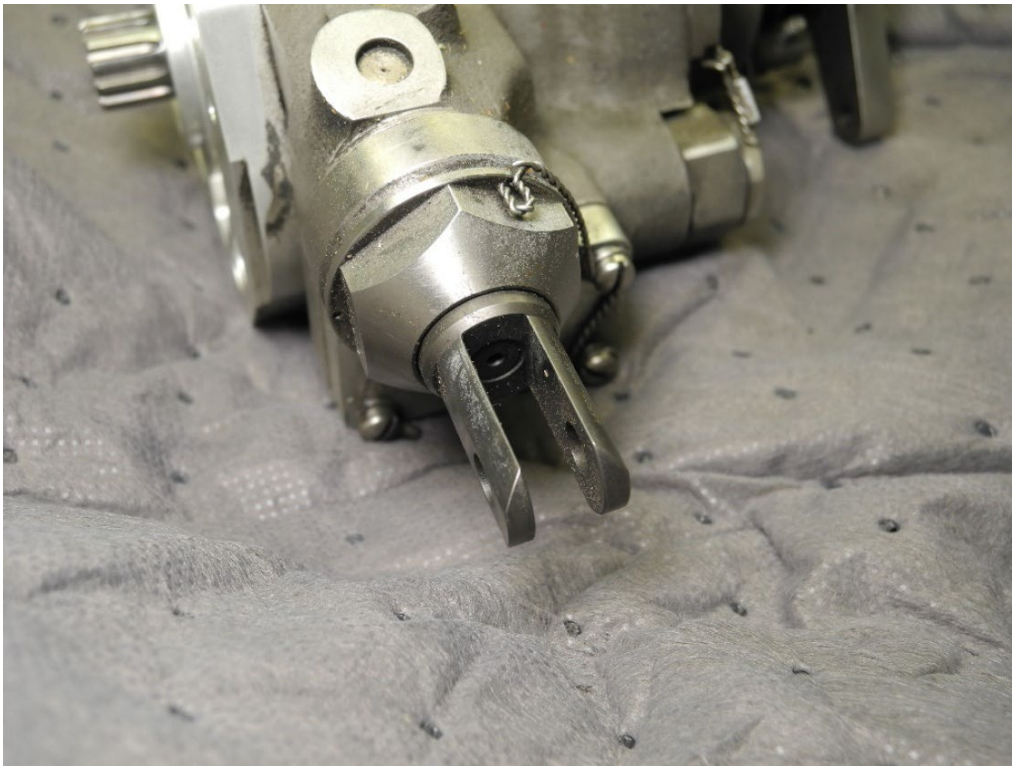
**Photo 52** - Woodward CSU - Detail of Beta Valve - Undamaged

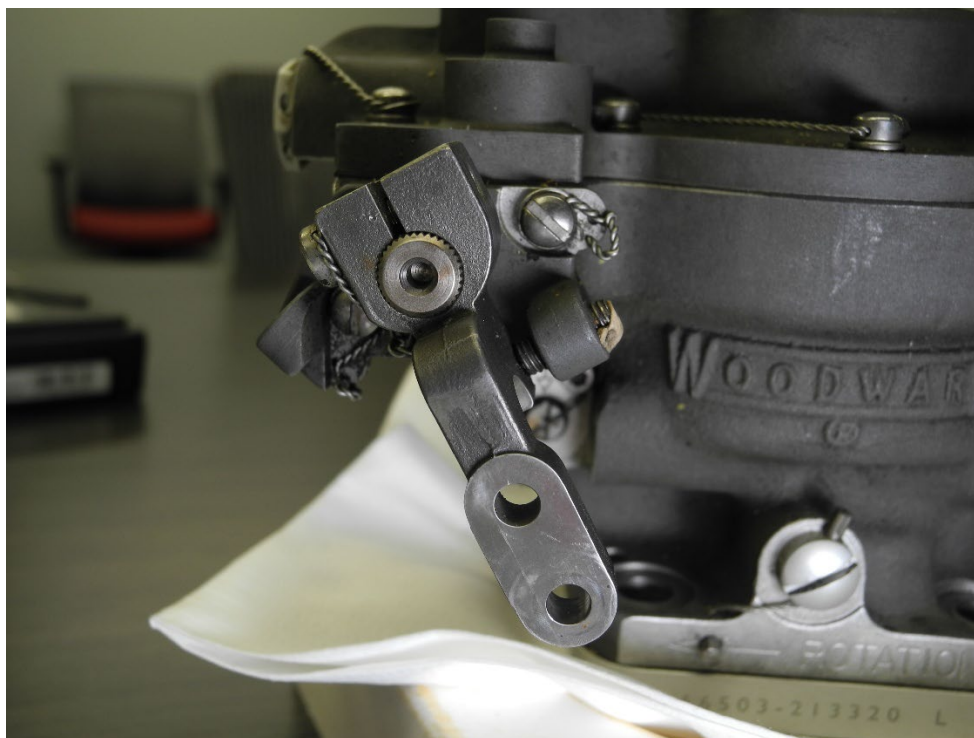
**Photo 53** - Air Bleed Link Lever

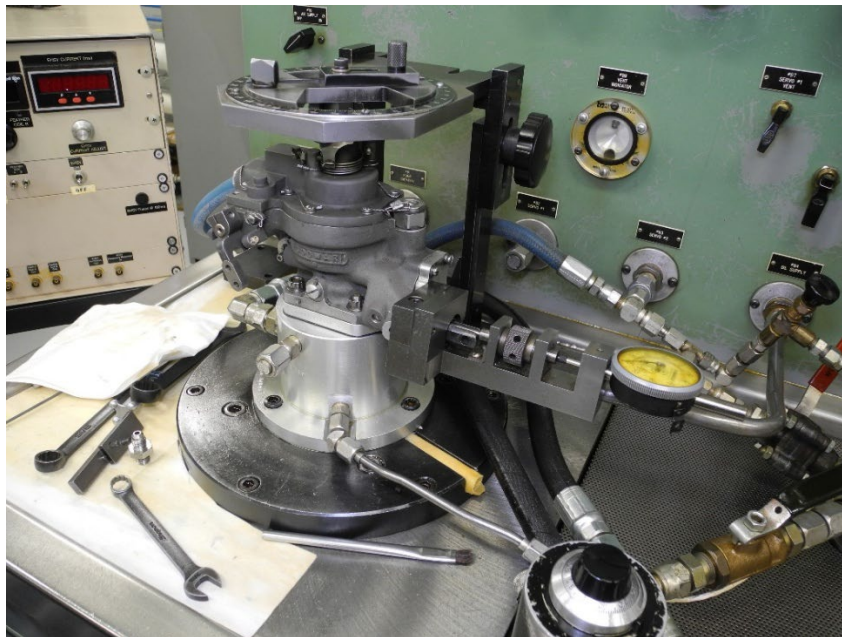
The CSU was installed in the Woodward production test stand (**Photo 55**) and tested to the Woodward factory acceptance test procedure (ATP).

**Photo 55** - CSU in Woodward Test Stand

- The maximum speed RPM was 4210 RPM slightly below the factory specifications.
- The overspeed setting of the pneumatic control valve was higher than factory specifications.
- The underspeed setting was higher than factory specifications

None of the discrepancies would have precluded normal governor operation. The CSU was not disassembled.

The maximum speed stop screw and the eccentric screw were re-adjusted. The CSU tested again and found it to be within specifications, except for a minor pressure variation of the pneumatic control valve at the overspeed setting at 4590 RPM.

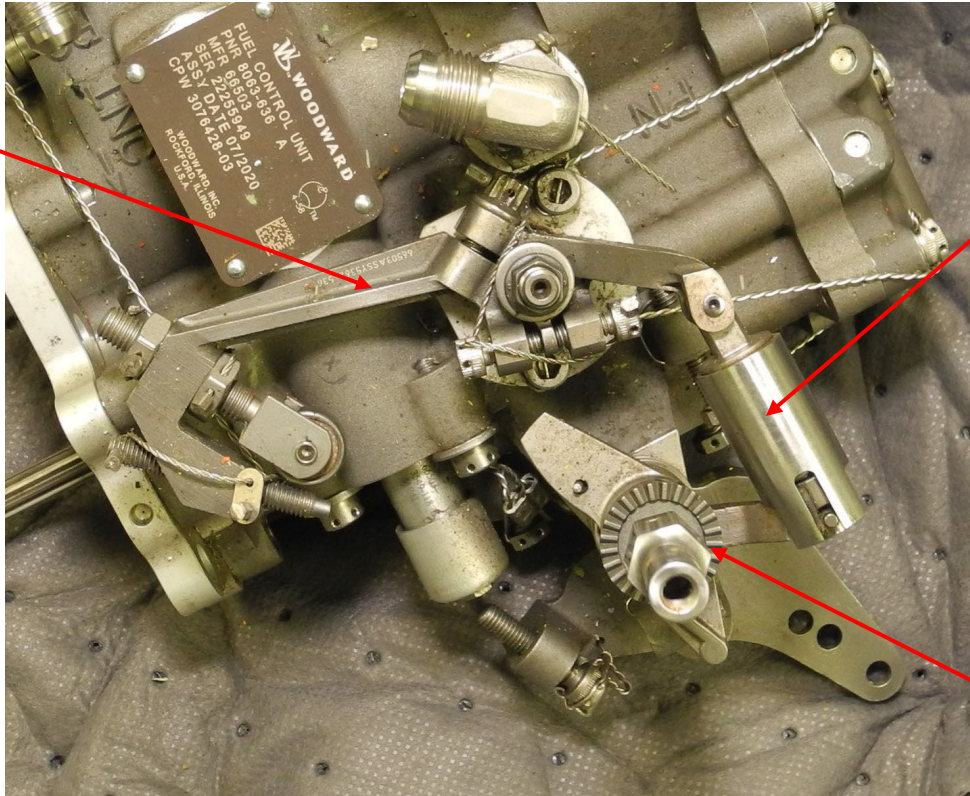
The FCU (**Photo 56** and **Photo 57**) was intact; however, there were various dents and scratches on the housing, consistent with impact damage. Most of the lockwire was not the Woodward original. The lock wire and safety cables in various locations were broken, consistent with impact damage.

The power lever (PL) shaft was bent (**Photo 58**). The PL maximum forward stop screw was bent and the PL was over-travelled (**Photo 59**) beyond the max stop screw. The PL could not be rotated; however, once the yield mechanism linkage was removed, the throttle lever could be rotated normally.

**Photo 57** - Detail of Power Levers Arrangement

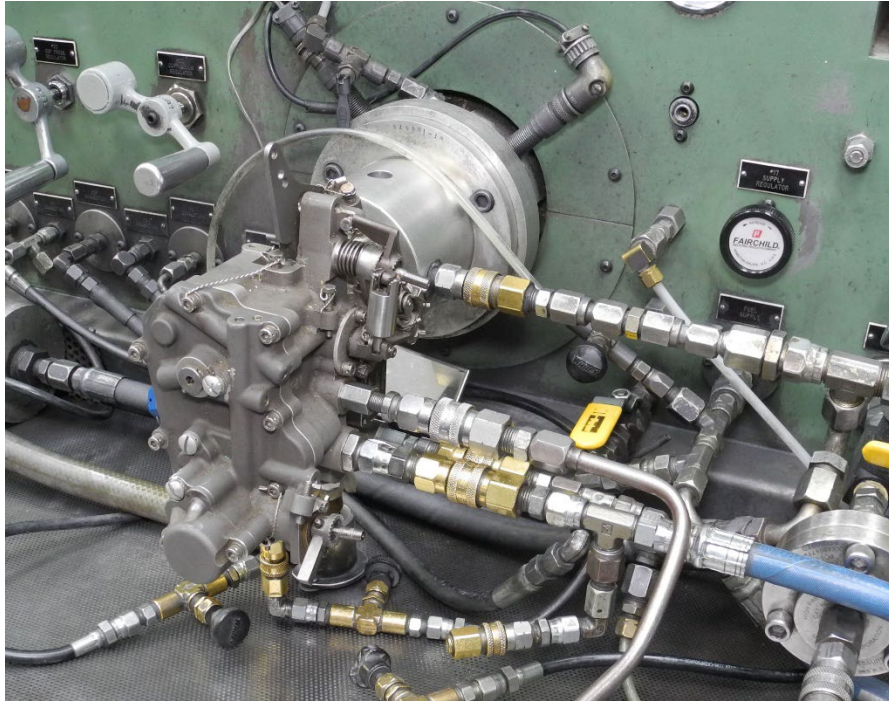
The FCU was installed in the Woodward production test stand (**Photo 61**) and tested to the Woodward factory ATP.

**Photo 61** - FCU in Woodward Test Stand

The speed setting schedule high and low idle points were below the test specification limits up to 4%. The high and low idle points are field adjustable, and it was noted that the lock wire on the adjusting screws was not original.

None of the minor discrepancies would have precluded normal FCU operation.
