# National Transportation Safety Board

ANC25MA018

## **POWERPLANT FACTUAL REPORT**

Location: Nome, Alaska  
Date: February 6, 2025  
Time: 15:20 local time  
Airplane: Textron Aviation 208B, Registration Number N321BA

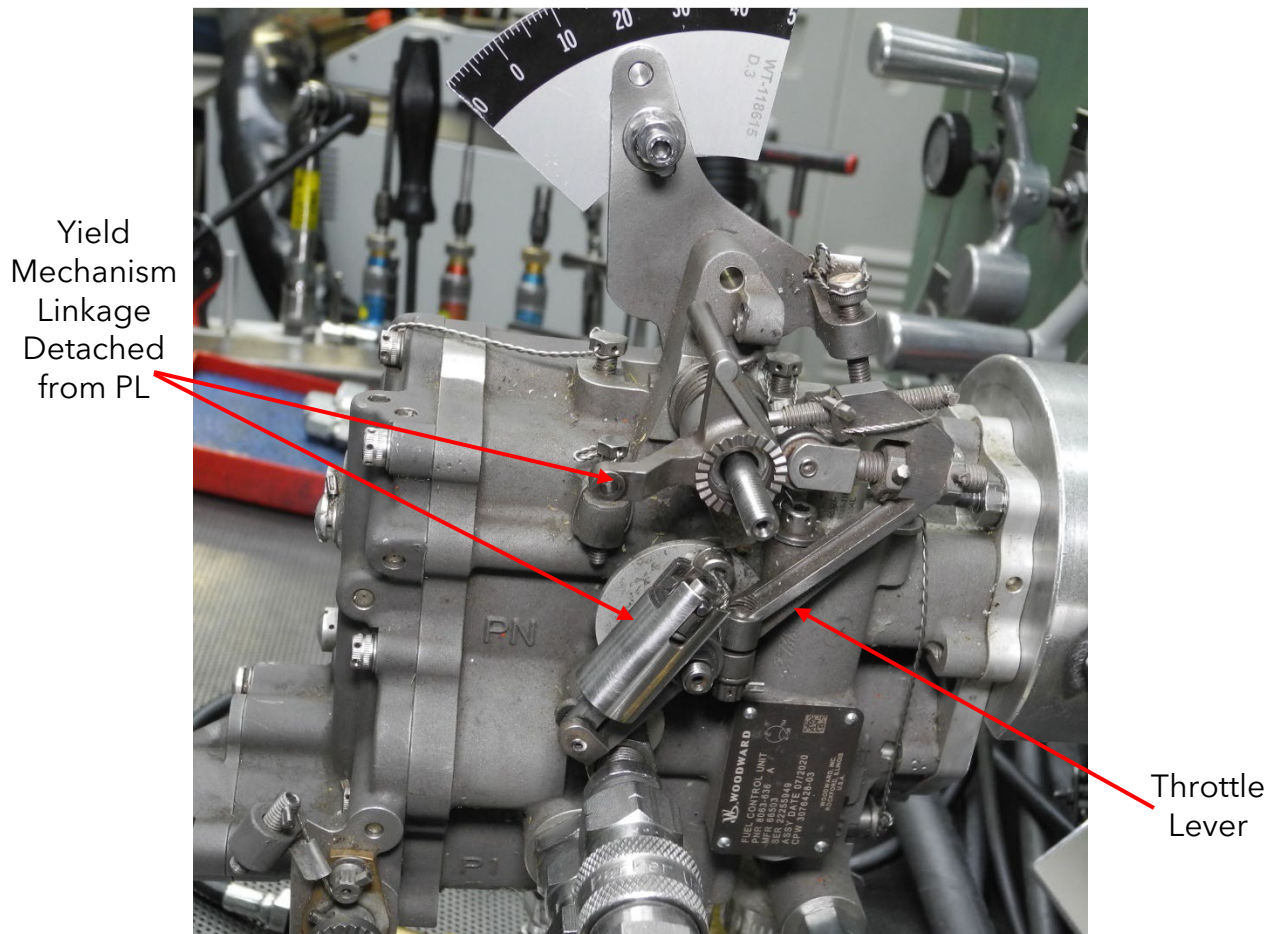
The FCU could not be fully tested without being able to rotate the PL. Because the PL could not be turned, the yield mechanism linkage was removed so that the throttle lever could be rotated (**Photo 62**). It is to be noted that the PL is only an external motion transfer mechanism and does not connect to any internal FCU components. Only the throttle shaft connects to the FCU internal mechanisms.

**Photo 62** - PL and Throttle Lever Disconnected via Yield Mechanism Linkage

Because of the impact damage to the PL and the manual O/R lever, the full test procedure could not be performed.

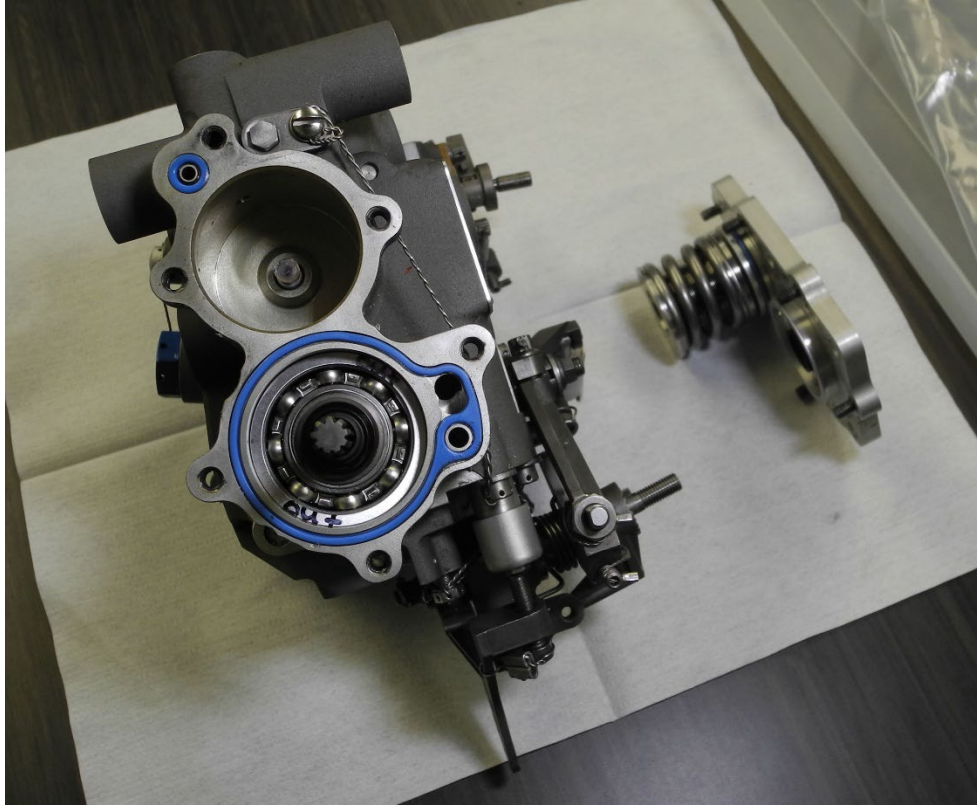
The start and acceleration schedule was high by up to 3%. The CDP schedule had one low-flow test point out of limit high. Because of the high start and acceleration schedule the base plate was removed to inspect the CDP bellows and rod guide (**Photo 63**). A small wear mark was found on the carbide pad of the bellows and the rod guide. A measurement of the deformation revealed a wear depth of 0.0003 to 0.0005 inches, which is consistent with normal wear at the operational time of the FCU.

**Photo 63** – FCU Base Plate – Removed for Inspection.
