# National Transportation Safety Board

ANC25MA018

## **POWERPLANTS - PROPELLER**

Group Chair's Factual Report

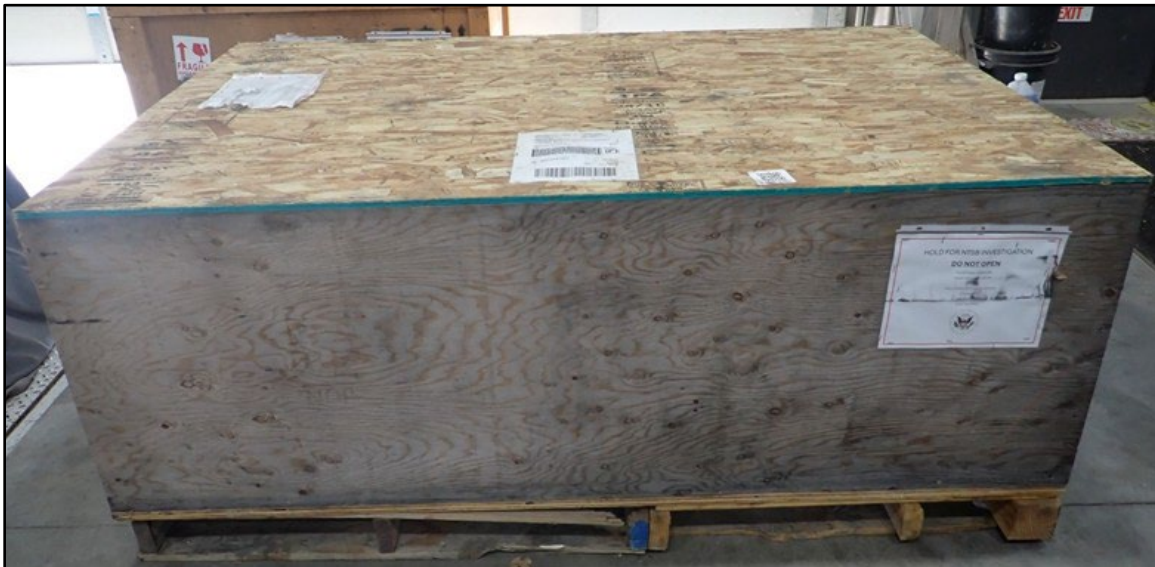
**Figure 2.** Photo of the Shipping Crate - As Received

The shipping crate was stored inside a secure building at McCauley and was opened by the investigation team present for examination of the propeller (Figure 2). The propeller, with three blades attached to the hub and one separated blade, was found secured within the crate (Figure 3).
