Re: CEN14FA300, 1985 Piper Malibu PA-46-310P, S/N 46-8508088, N2428Q (JetPROP conversion SN 002)  
Autopilot equipment examination at Honeywell, 2/11, 2/12 & 3/23/2015 (Olathe, Kansas)  
Flight Computer crystal examination at Honeywell, 4/13/2015 (Phoenix, Arizona)

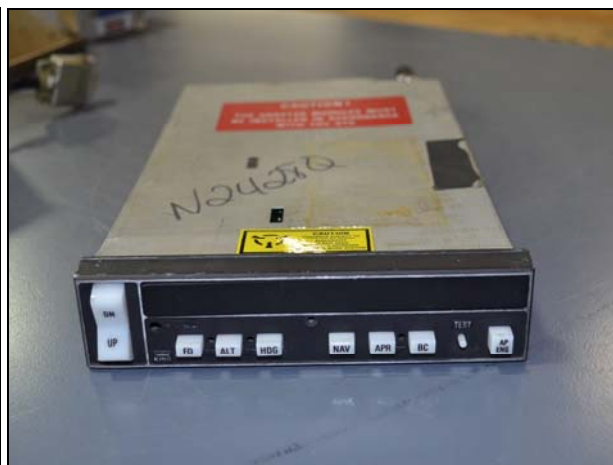
KC 192 front and top views: no damage detected

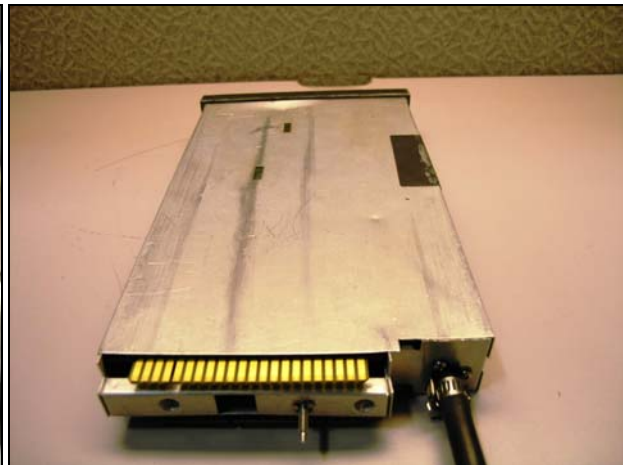
KC 192 rear and bottom views – no damage detected

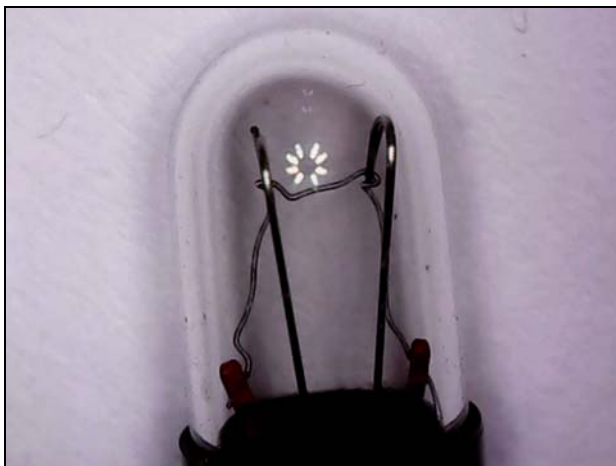
**GS lamp:** filament not broken, no stretching (no spaghetti appearance)

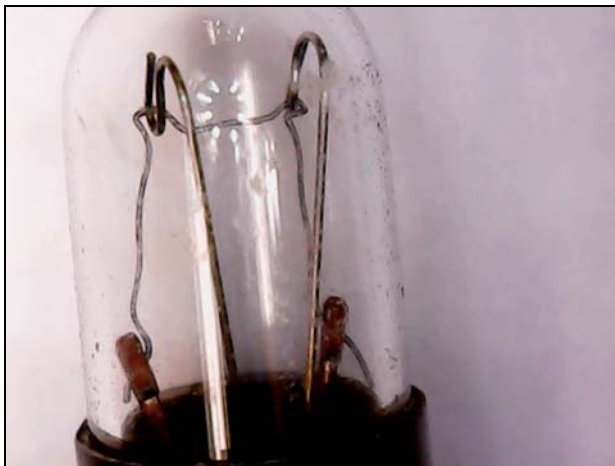
TRIM lamp: filament not broken, no stretching (no spaghetti appearance)

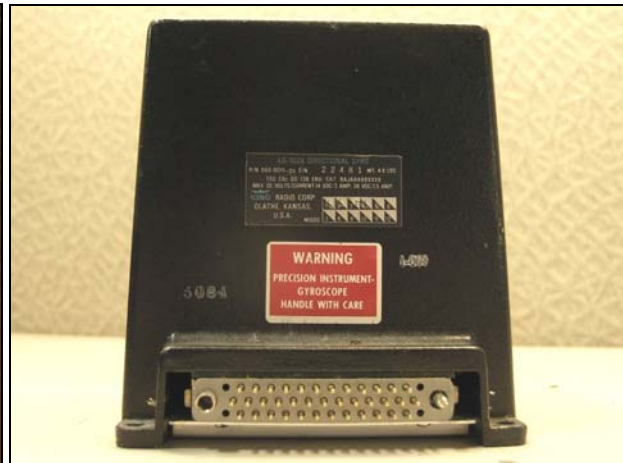
KG 102A rear view – no visible damage detected

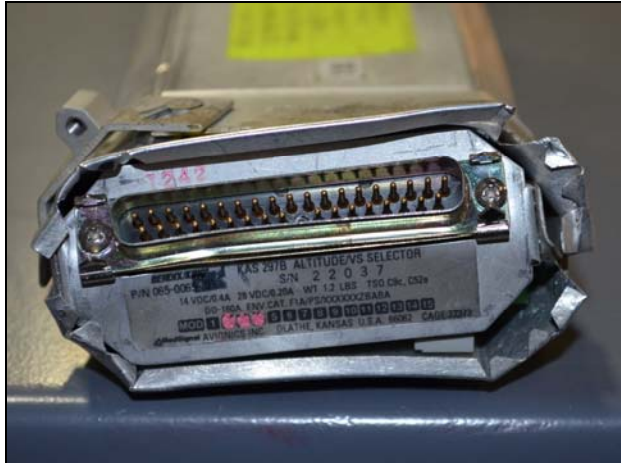
The KAS 297B is impact damaged – bezel and rear connector damaged. The testing was limited to data recovery from the non-volatile memory (NVM). The KAS 297B stores the last altitude and vertical speed selected by the flight crew. The unit covers were removed to allow removal of the NVM device, I316. I316 was installed into an exemplar unit. Upon power-up, the last selected altitude of 27,000 feet with a vertical speed descent of 500 feet/minute was displayed.

KAS 297B rear connector damaged

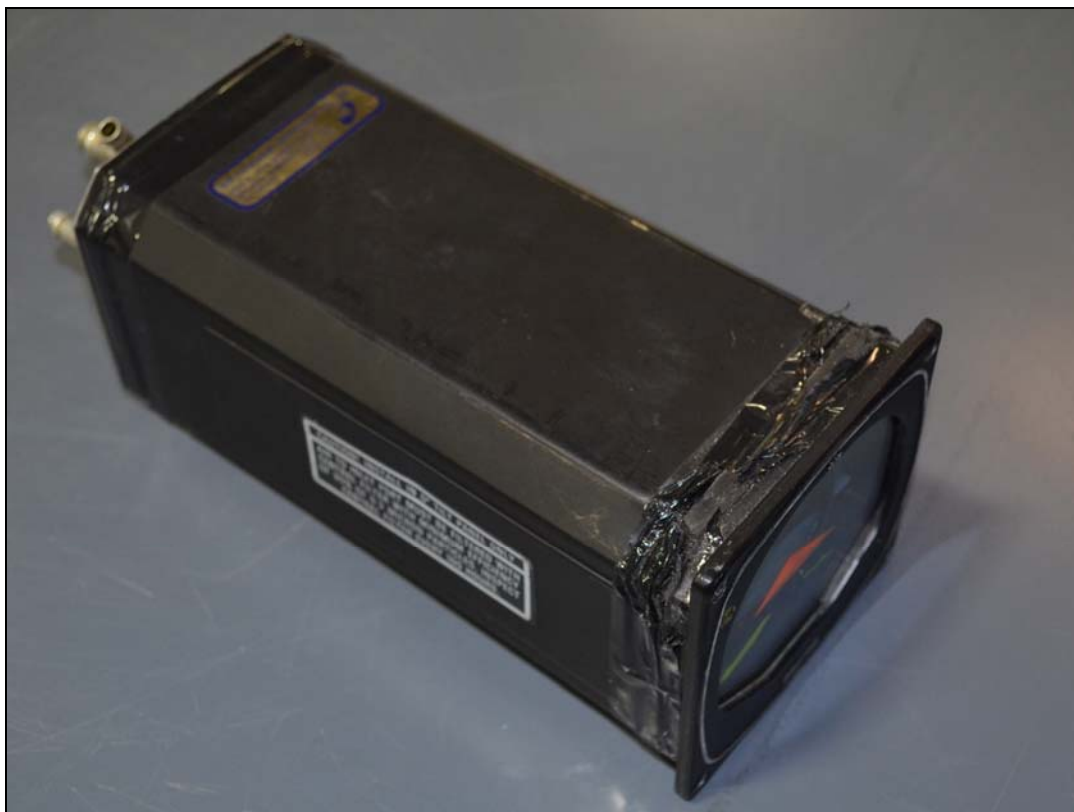
KI 256 – no apparent physical damage observed in this view
