# Continental Motors

## ENGINE EXAMINATION REPORT

| ENGINE MODEL | GTSIO-520-L 4B |
| FILE NUMBER | 14-177 |

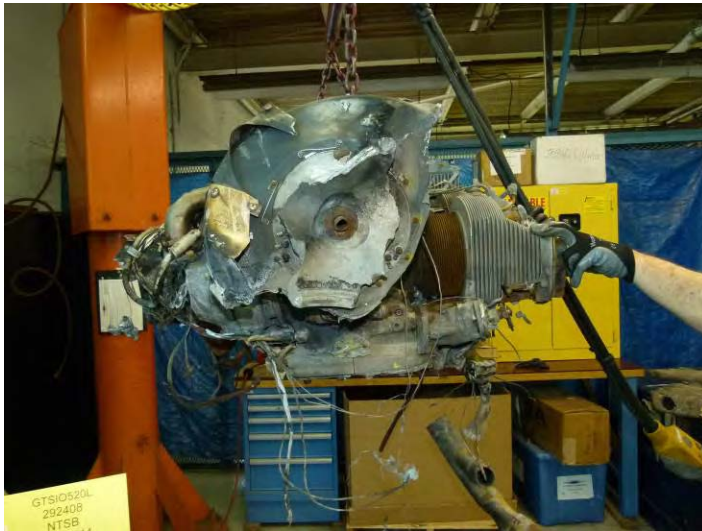
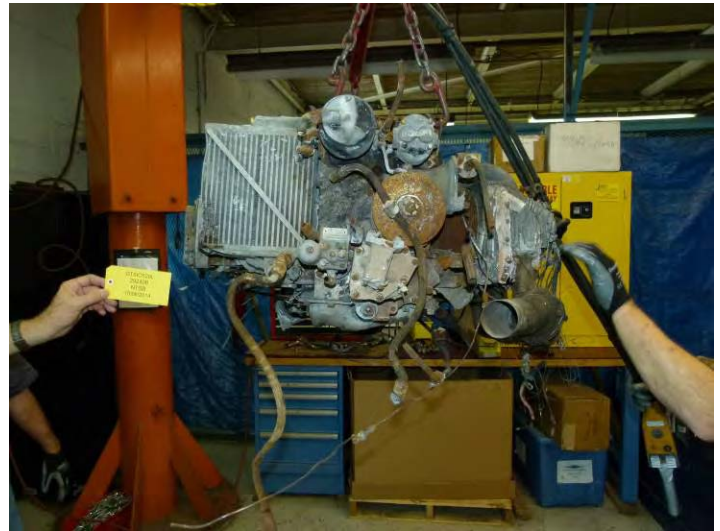
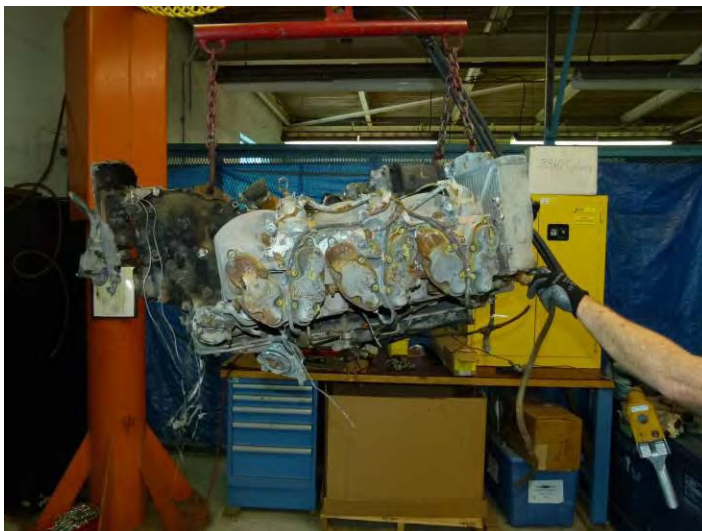
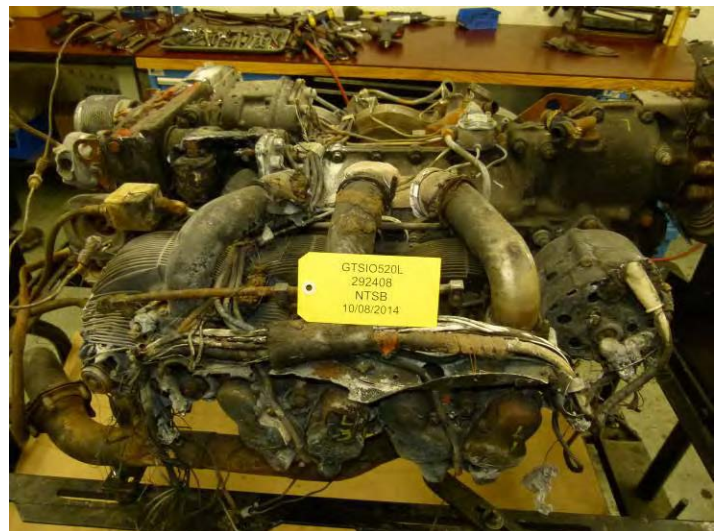
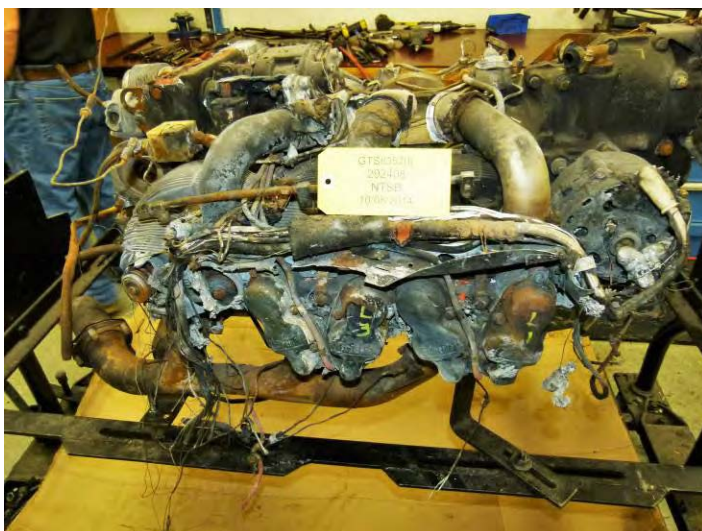
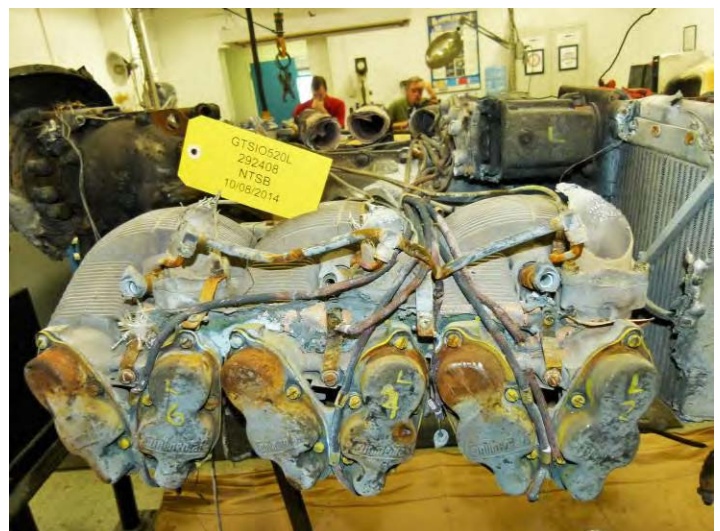
The engine exhibited fire and impact damage. The induction system and intercooler separated. All of the engine accessories were impact and thermally damaged. The right magneto case was melted exposing the internal components. The left magneto remained attached but exhibited thermal damage. The fuel pump was thermally damaged and remained attached to the engine, the drive coupling was intact. The alternator and propeller governor was thermally damaged and remained attached to the engine. The remainder of the external surfaces of the engine had varying degrees of impact and thermal damage.

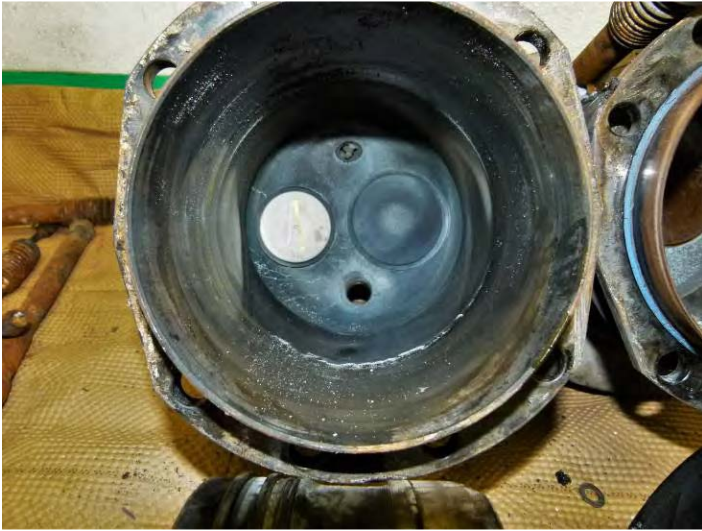
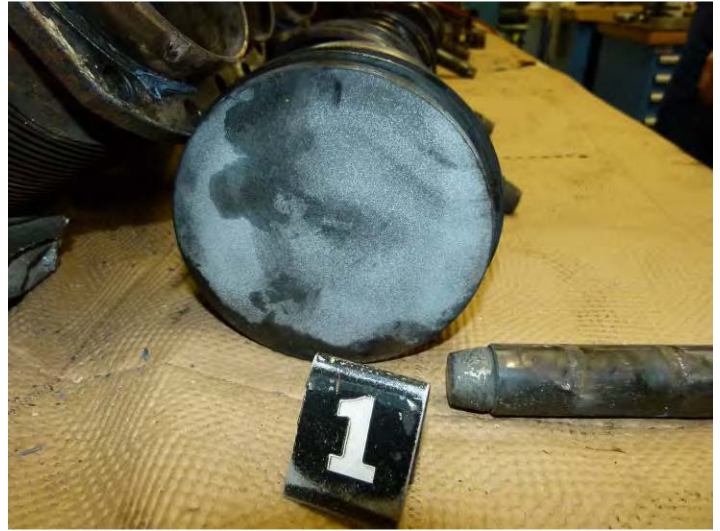
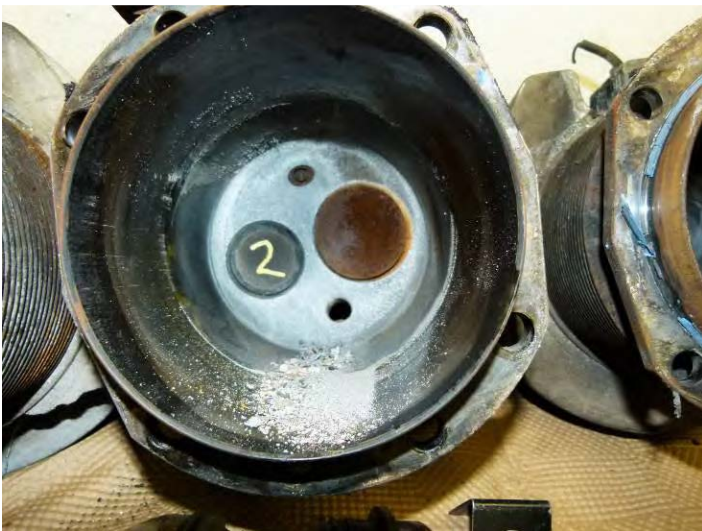
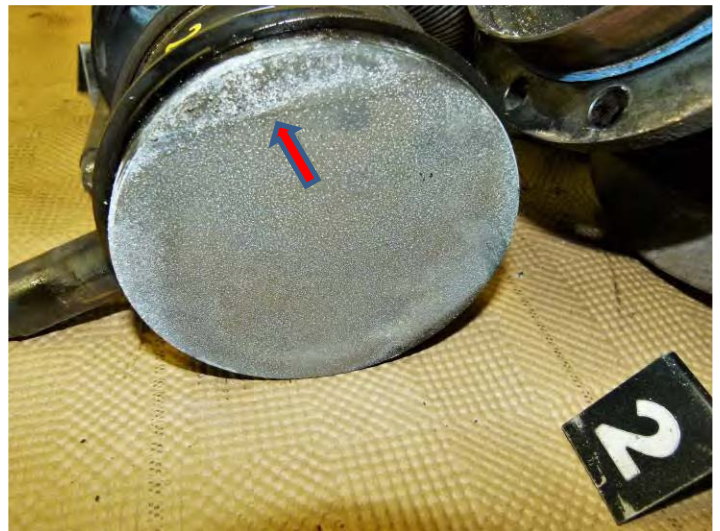
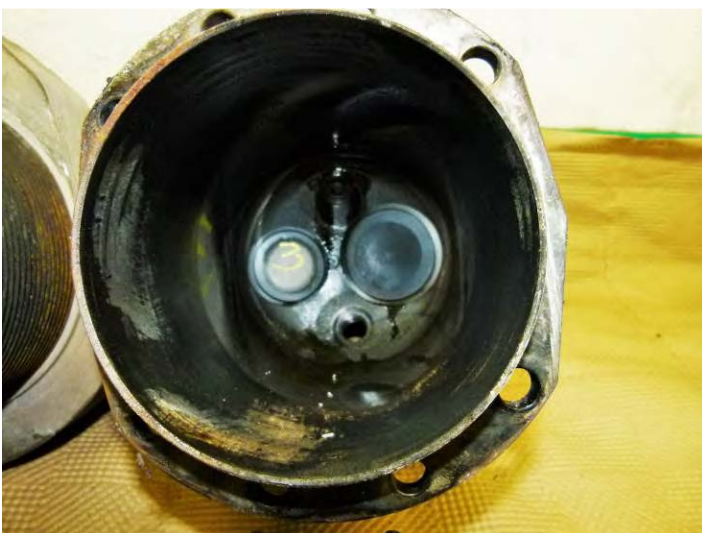
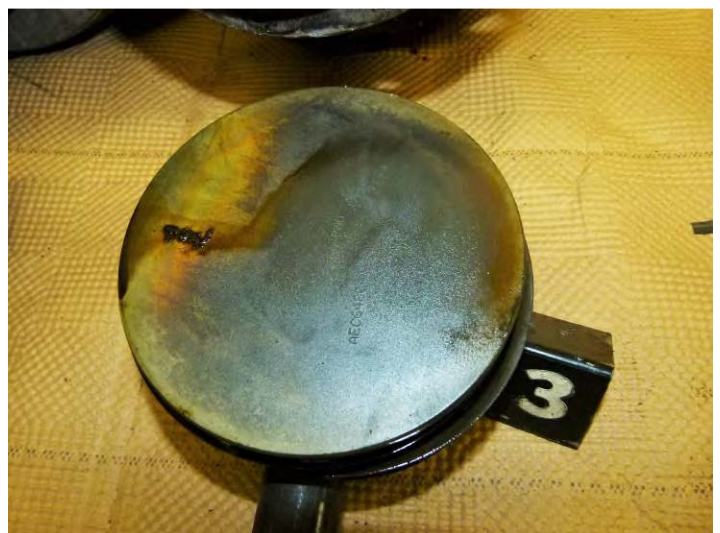
Cylinder one exhibited signatures of thermal damage with the lower portion of the cylinder head melted away. The engine oil sump melted away due to an extensive post impact fire. The internal components of the engine were thermally damaged. All of the internal components show signs of thermal damage but no signs of lubrication distress. The cylinders exhibited heat damage and detonation signatures. All pistons exhibited scuffing and heat signatures on the skirt. Pistons two, five and six exhibited detonation signatures on the face of the piston with portions melted away on the outer edge. The main and rod bearings exhibited normal operating signatures with thermal heat signatures from the post-crash fire. The crankshaft, camshaft, gears, connecting rods and reduction gears all exhibited thermal damage but normal operating signatures. The crankcase exhibited normal operating signatures along with impact and thermal damage. The fuel system components were impact and fire damaged. The engine accessories were intact and exhibited thermal damage. Only portions of the induction system remained attached to the engine. The remainder was melted away by the post-crash fire.
