**INCIDENT INVESTIGATION REPORT IIRN000101 Issue 1**

| MEGGITT RETURN No | RMA8905 | PART No | DAP00100-07 | QTY | 1 |
| AIRCRAFT | EMB-505 | DATE OF INCIDENT | 19/09/2014 | | |

**1. INTRODUCTION****Event Details as reported by the NTSB:**

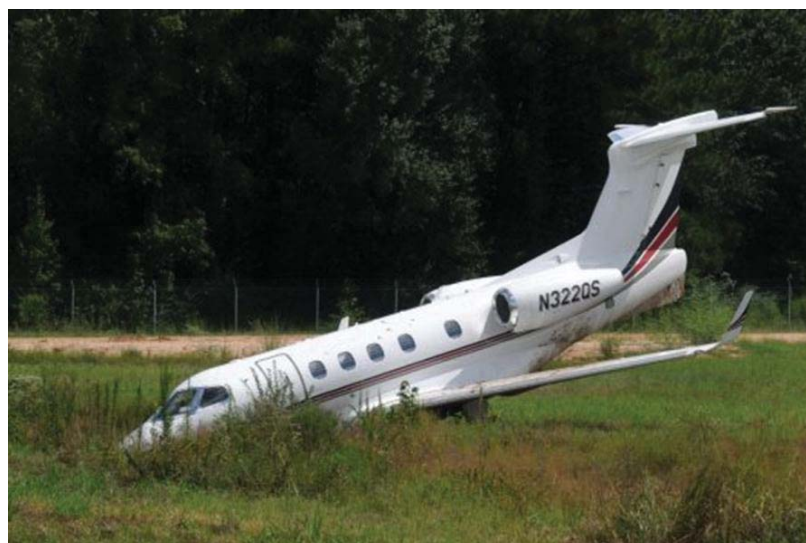
On September 19, 2014, about 0847 central daylight time, an Embraer EMB-505 airplane, N322QS, encountered soft terrain and mud after over running the runway while landing at the Lonestar Executive Airport (CXO), Conroe, Texas. Neither of the airline transport rated pilots on board were injured. The airplane was substantially damaged. The airplane was operated by NetJets as a 14 Code of Federal Regulations Part 91 positioning flight. Instrument meteorological conditions prevailed for the flight, which was operated on an instrument flight rules flight plan. The flight originated from the Nashville International Airport (BNA), Nashville, Tennessee, at 0710.

According to the air traffic controller who witnessed the accident, the pilots flew the area navigation (RNAV) runway 1 approach and broke out of the clouds at the minimums for the approach. The controller stated the airplane touched down just past the 1,000 foot marker on the runway and did not appear to decelerate as it continued down the runway. The airplane travelled off the departure end of the runway and continued about 400 feet through soft/muddy terrain before coming to rest half way down a ditch. The controller stated there was moderate to heavy rain at the time of the accident.

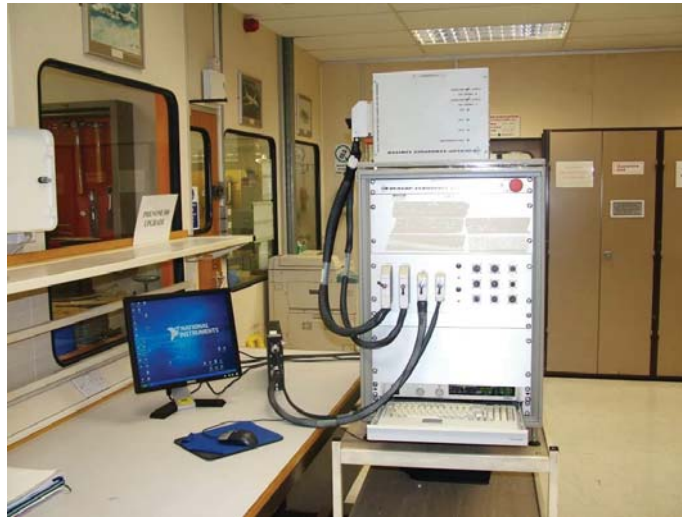
- BCUTE F2895
- BCU Main Connector Harness F2895\_1
- BCU Test Connector Harness F2895\_2
- Adaptor Module DAA05451-00
- Adaptor 1 Harness F2907\_1
- Adaptor 2 Harness F2907\_2
