# **NATIONAL TRANSPORTATION SAFETY BOARD**

## **MATERIALS LABORATORY FIRE FACTUAL REPORT**

Report No. 14-059

Place : Wapakoneta, Ohio  
Date : March 8, 2014  
Vehicle : Cessna 310  
NTSB No. : CEN14LA159  
Investigator : Courtney Liedler  
AS-CEN

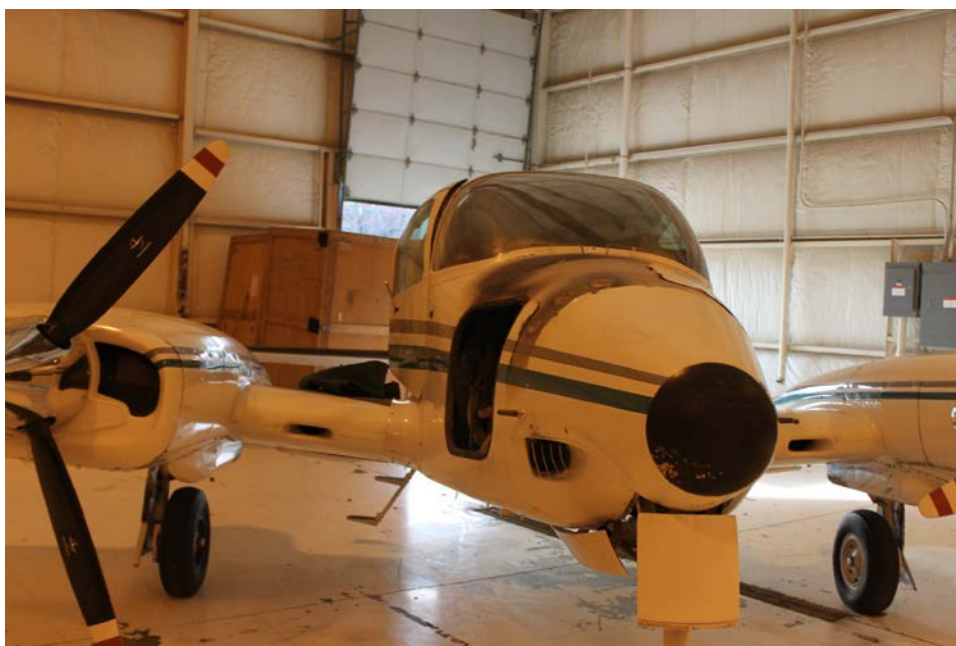
The accident aircraft is shown in Figure 1. The aircraft was intact and the fire damage was limited to the nose compartment and the lower forward portion of the instrument panels and cockpit. The exterior damage was located on the upper portion and right side of the nose compartment. The upper section of fuselage exhibited large areas of thermal discoloration of the exterior paint as well as bubbling and peeling of the outer layers of the paint as shown in Figures 2-4. This damage continued down the right side of the nose compartment. The lower right exhaust louvers and the fuselage skin near the heater exhaust exhibited sooting and some thermal discoloration as shown in Figure 5-7.

**Figure 1. Overall photograph of accident aircraft.**

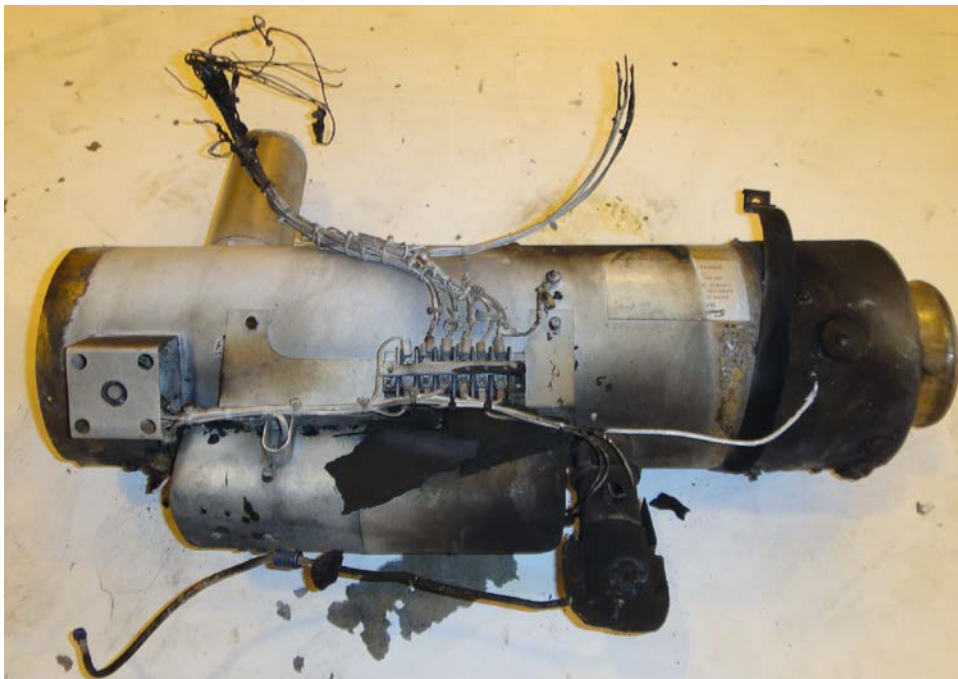
The heater installed in the accident aircraft was a Southwind 8240E. The heater after removal is shown in Figure 12. According to the aircraft logs and manufacturer information, this heater was installed at the time of the accident aircraft's manufacture and overhauled in 1997. A pressure decay test was done on the combustion chamber in 2003. The current owner had used the heater several times including the day of the accident.

**Figure 12. Close-up photograph of cabin heater after removal from accident aircraft.**

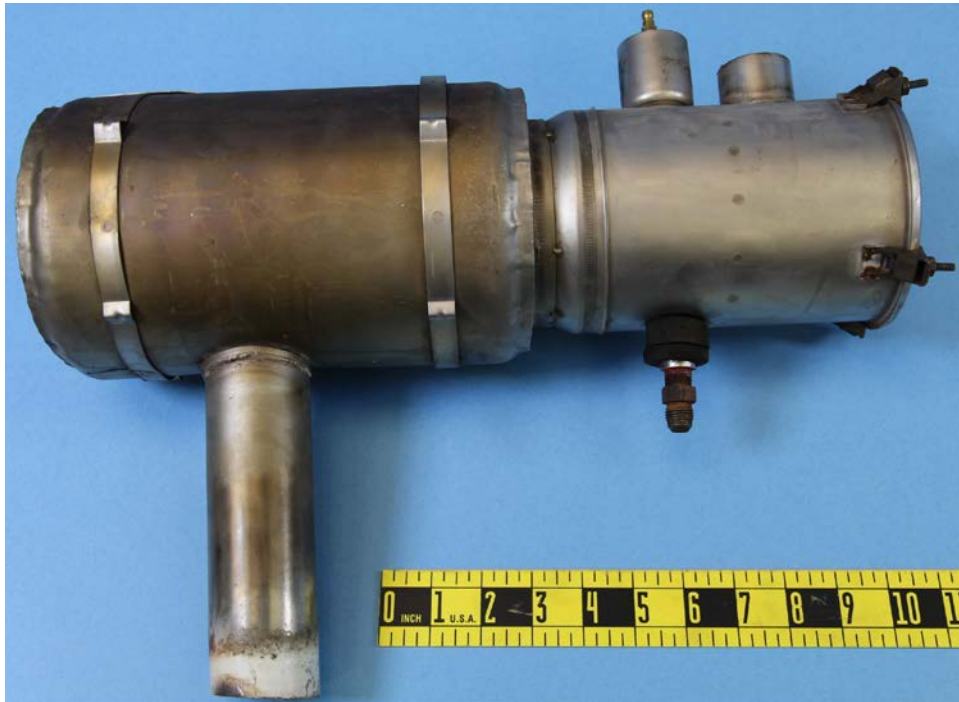
The exterior case of the heater was removed during the examination as shown in Figure 13. No anomalies were initially found during the removal. A pressure test of the combustion chamber and associated heat exchanger muff was then performed. Four separate leaks were found. One leak was found in the igniter plug port weld as shown in Figure 14. One leak was found in the heat muff end weld, as shown in Figure 15. Two leaks were found in the welds that attach the combustion chamber to the heat exchanger muff as shown in Figure 16. One of those leaks had a visible crack as shown in Figure 17.

**Figure 13. Photograph of cabin heater with outer cover removed.**
