## ENGINE EXAMINATION REPORT

| <b>ENGINE MODEL</b> | TSIO-550-C1B |
| <b>AIRCRAFT MAKE &amp; MODEL</b> | Piper PA46-310P |

| <b>EXAMINATION</b> | | <b>ACCIDENT DATA</b> | |
|---|---|---|---|
| <b>DATE</b> | 06/16/2016 | <b>NTSB ACCIDENT #</b> | CEN15FA008 |

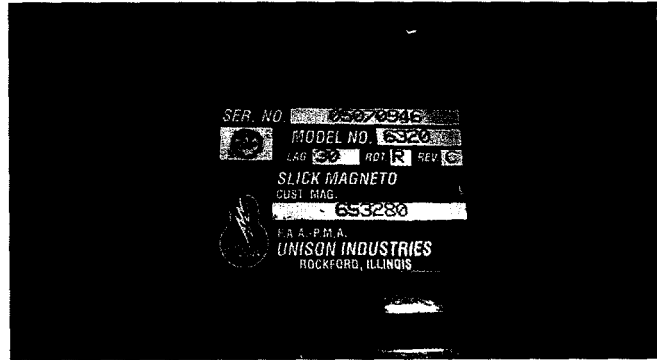
The left magneto was separated from this mounting pad and was returned in a box inside the shipping crate. The mounting flange was fractured. Manual rotation of the drive gear resulted in rotation of the drive shaft and an audible snap of the impulse coupling.

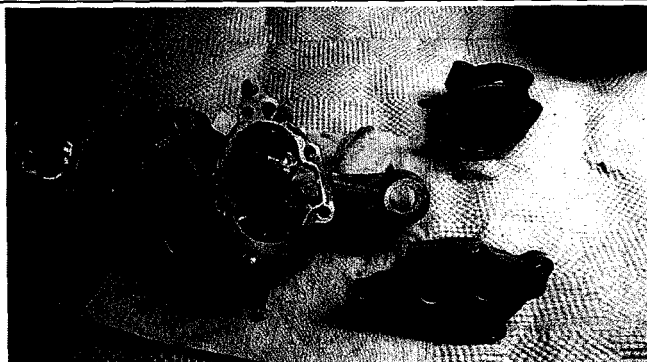
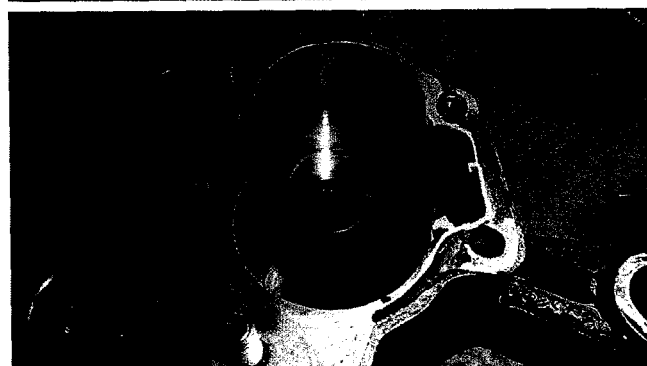
The oil pump remained attached to the backside of the engine. Removal of the pump revealed residual oil in the unit. The pump gears were intact with no signs of operational distress on the gears. The housing walls displayed two deep gouges that only extended through a short segment of the housing circumference.

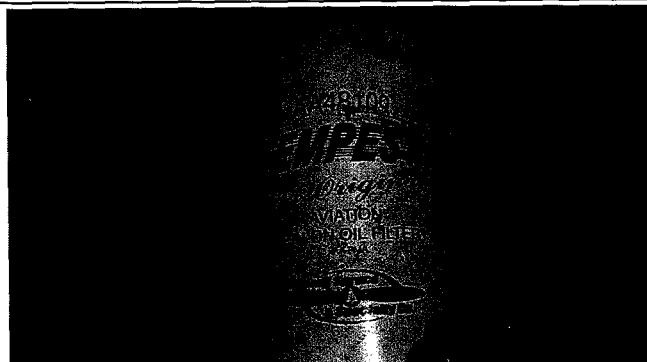
## OIL FILTER

The oil filter remained attached to its mounting pad and safety wire was present. The oil filter had the date and Hobbs time hand-written in as 7/28/14 and 4850.5, respectively. The filter was dented but no pre-accident anomalies were noted. The oil filter was opened and no visible contaminants were observed.

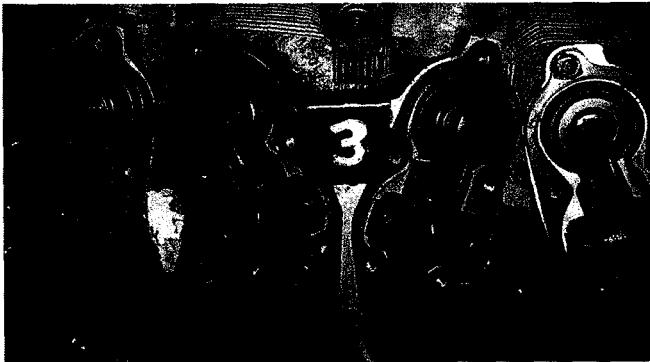
The cylinder remained attached to the crankcase with no external signs of operational distress noted. The rocker covers were removed and the rockers and springs were intact and appeared to be well lubricated. The cylinder was removed and oil coated the interior components. No pre-accident anomalies were noted with the valves, valves seats, barrel or cylinder head.

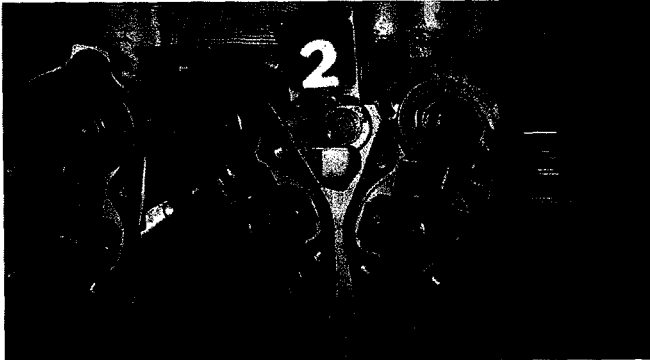
The cylinder remained attached to the crankcase with no external signs of operational distress noted. The rocker covers were removed and the rockers and springs were intact and appeared to be well lubricated. The cylinder was removed and organic debris and rust were noted internally. No pre-accident anomalies were noted with the valves, valves seats, barrel or cylinder head.

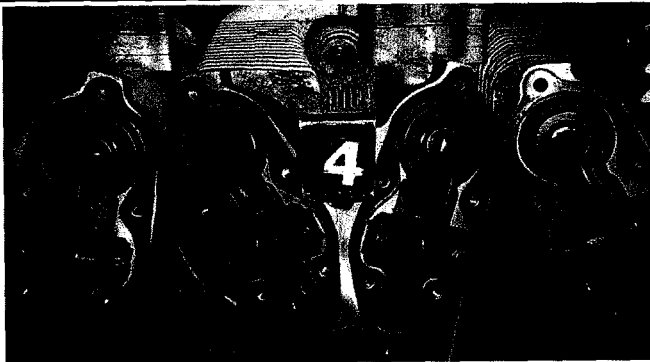
**CYLINDER #4**

The cylinder remained attached to the crankcase with no external signs of operational distress noted. The rocker covers were removed and the rockers and springs were intact and appeared to be well lubricated. The cylinder was removed and organic debris and rust were noted internally. No pre-accident anomalies were noted with the valves, valves seats, barrel or cylinder head.

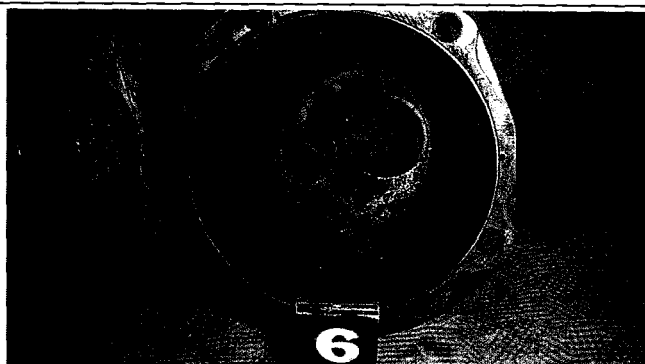
The cylinder remained attached to the crankcase with no external signs of operational distress noted. The rocker covers were removed and the rockers and springs were intact and appeared to be well lubricated. The cylinder was removed and organic debris and rust were noted internally. No pre-accident anomalies were noted with the valves, valves seats, barrel or cylinder head.

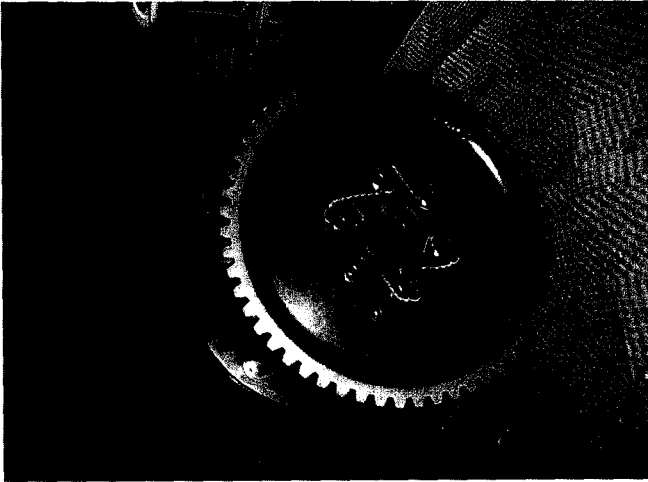
The crankshaft was intact with no pre-accident anomalies noted with the main or connecting rod journals. Residual oil coated the entire crankshaft and the crankshaft gear remained in place and all the bolts' safety-wire was intact.

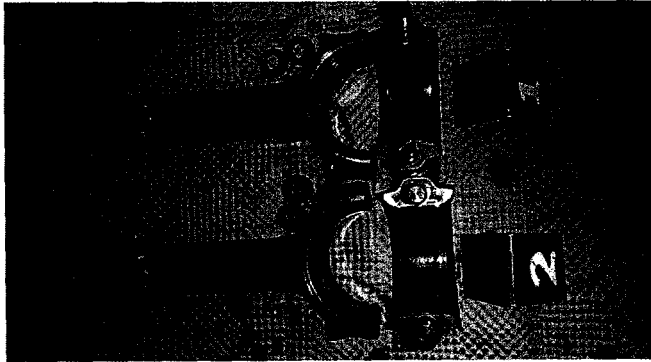
**Condition:** The bearing was in place and showed normal signs of wear. No pre-accident anomalies were noted.

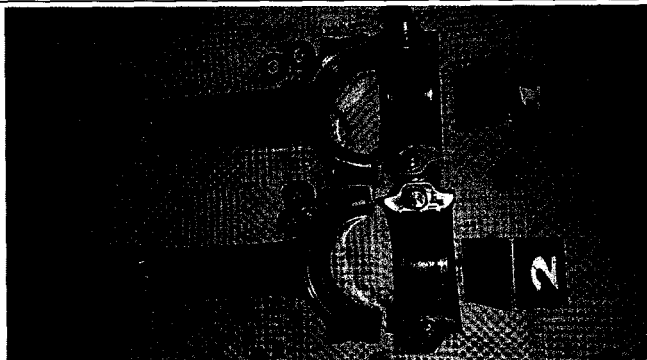
Condition: The bearing was in place and showed normal signs of wear. No pre-accident anomalies were noted.

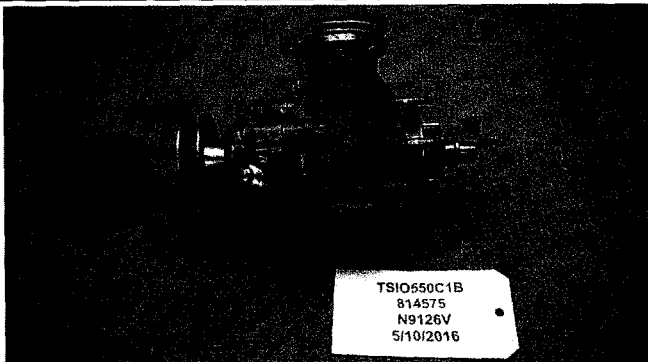
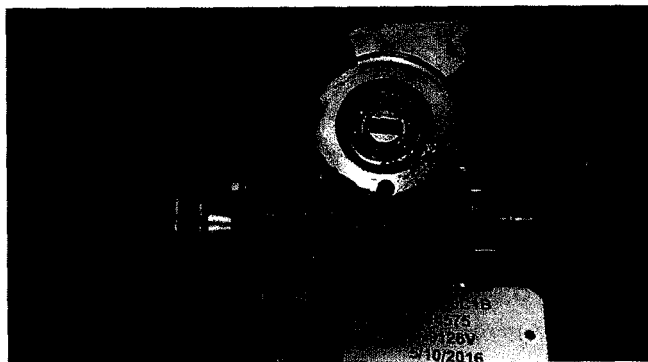
The starter adapter remained attached to the backside of the engine and the starter motor mounting pad was fractured. The starter gear was intact with no pre-accident anomalies noted.

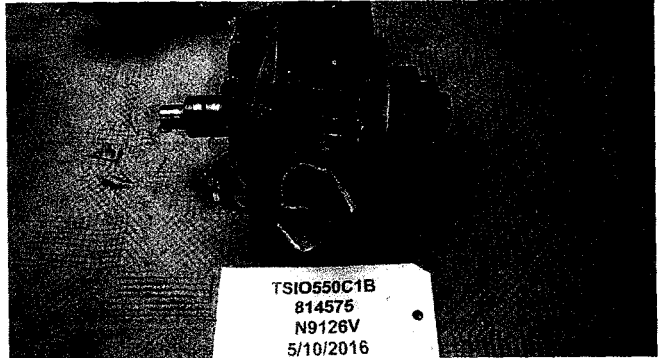
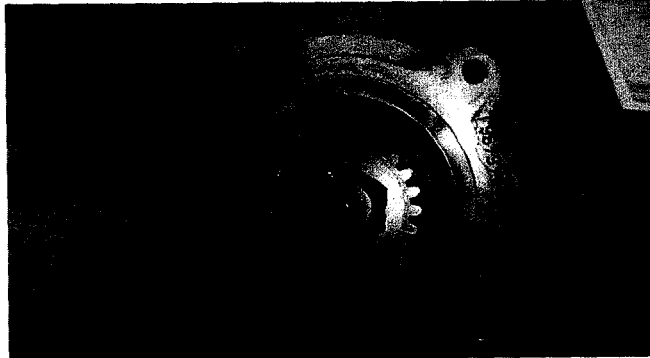
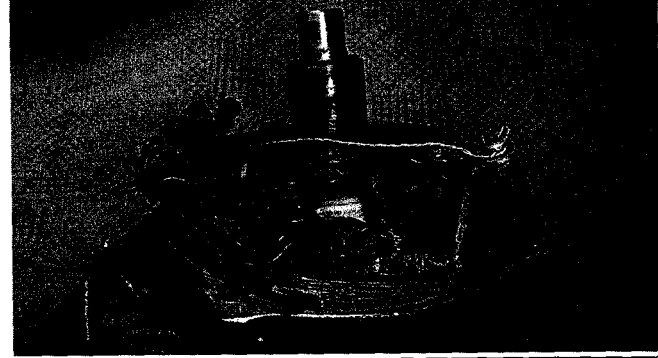
The gear-driven alternator remained attached to the mounting pad but the housing sustained impact damage that destroyed the outer components and bent the drive shaft. The alternator drive clutch was intact and secured to the shaft. The alternator face gear remained secured to the crankshaft.

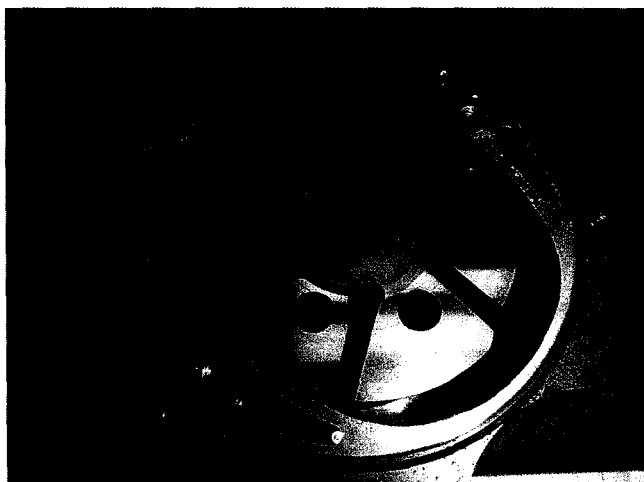
The vacuum pump was separated from the engine and was found in a box located in the shipping crate. The housing sustained impact-related damage. Disassembly of the unit revealed that the vanes were intact and the rotor was fractured. No pre-accident anomalies were noted with the unit.

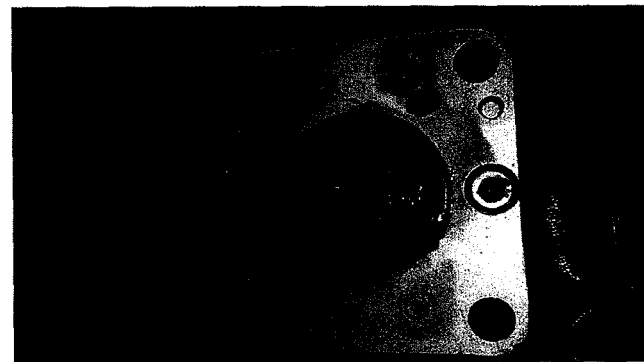
The propeller governor remained attached to the front left side of the engine. The control cable end remained attached to the control lever and the lever was free to rotate. Removal of the propeller governor from the engine revealed that the screen gasket was free from contaminants or obstructions. Rotation of the drive gear resulted in rotation of the drive shaft and the pumping of residual oil from the housing.

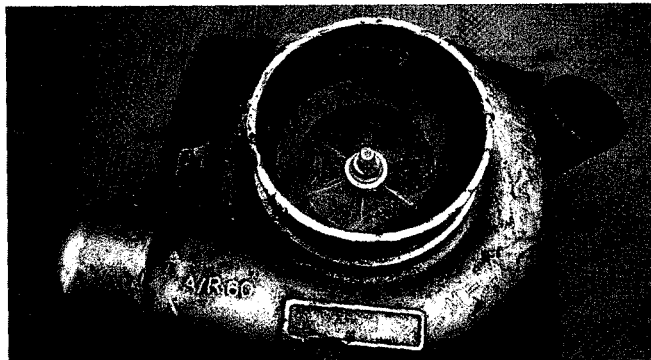
Condition: The left turbocharger was separated from the engine and was lying in the shipping crate. A letter "L" was written on the turbocharger shroud and it is assumed that it was the left turbocharger. Mud was impacted into the compressor impeller and rotation of the turbine and compressor was not possible. Rotational scoring was noted on behind the turbine. The compressor impeller blades were deformed.
