SITE PHYSICAL ADDRESS

[REDACTED]  
St. Louis (St. Louis Co.), MO 63110

DATE OF INSPECTION

April 16, 2015

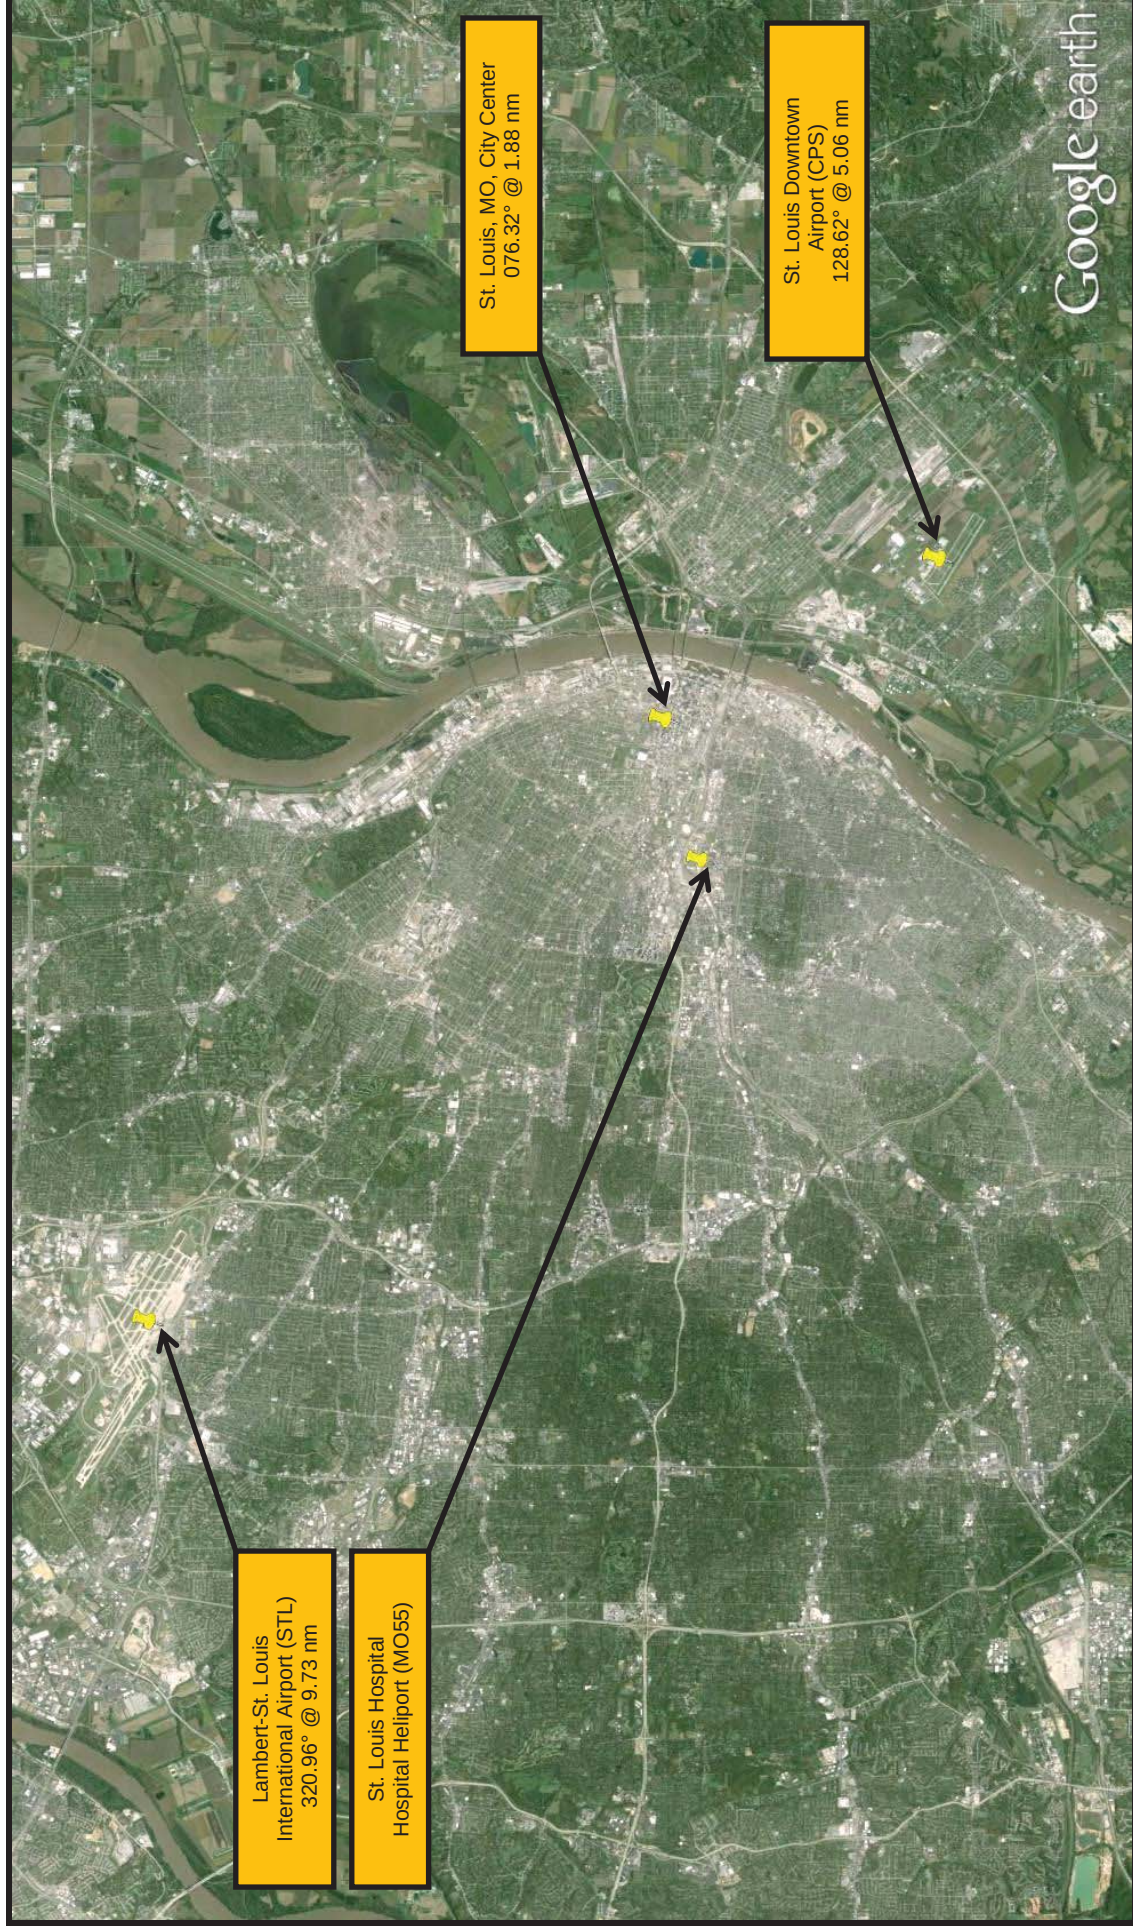
Figure 1: Area Overview

The St. Louis University Hospital Heliport is a private (PPR) landing site located atop the hospital building; 1.88 nm WSW of the center of St. Louis, MO, on a true north bearing (*from* the city center) of 256.32°. The entire area surrounding the hospital complex is densely residential and mixed use with a scattering of vacant lots to the N. Other than the hospital itself, and surrounding clinical facilities, no especially noise sensitive areas are identified.

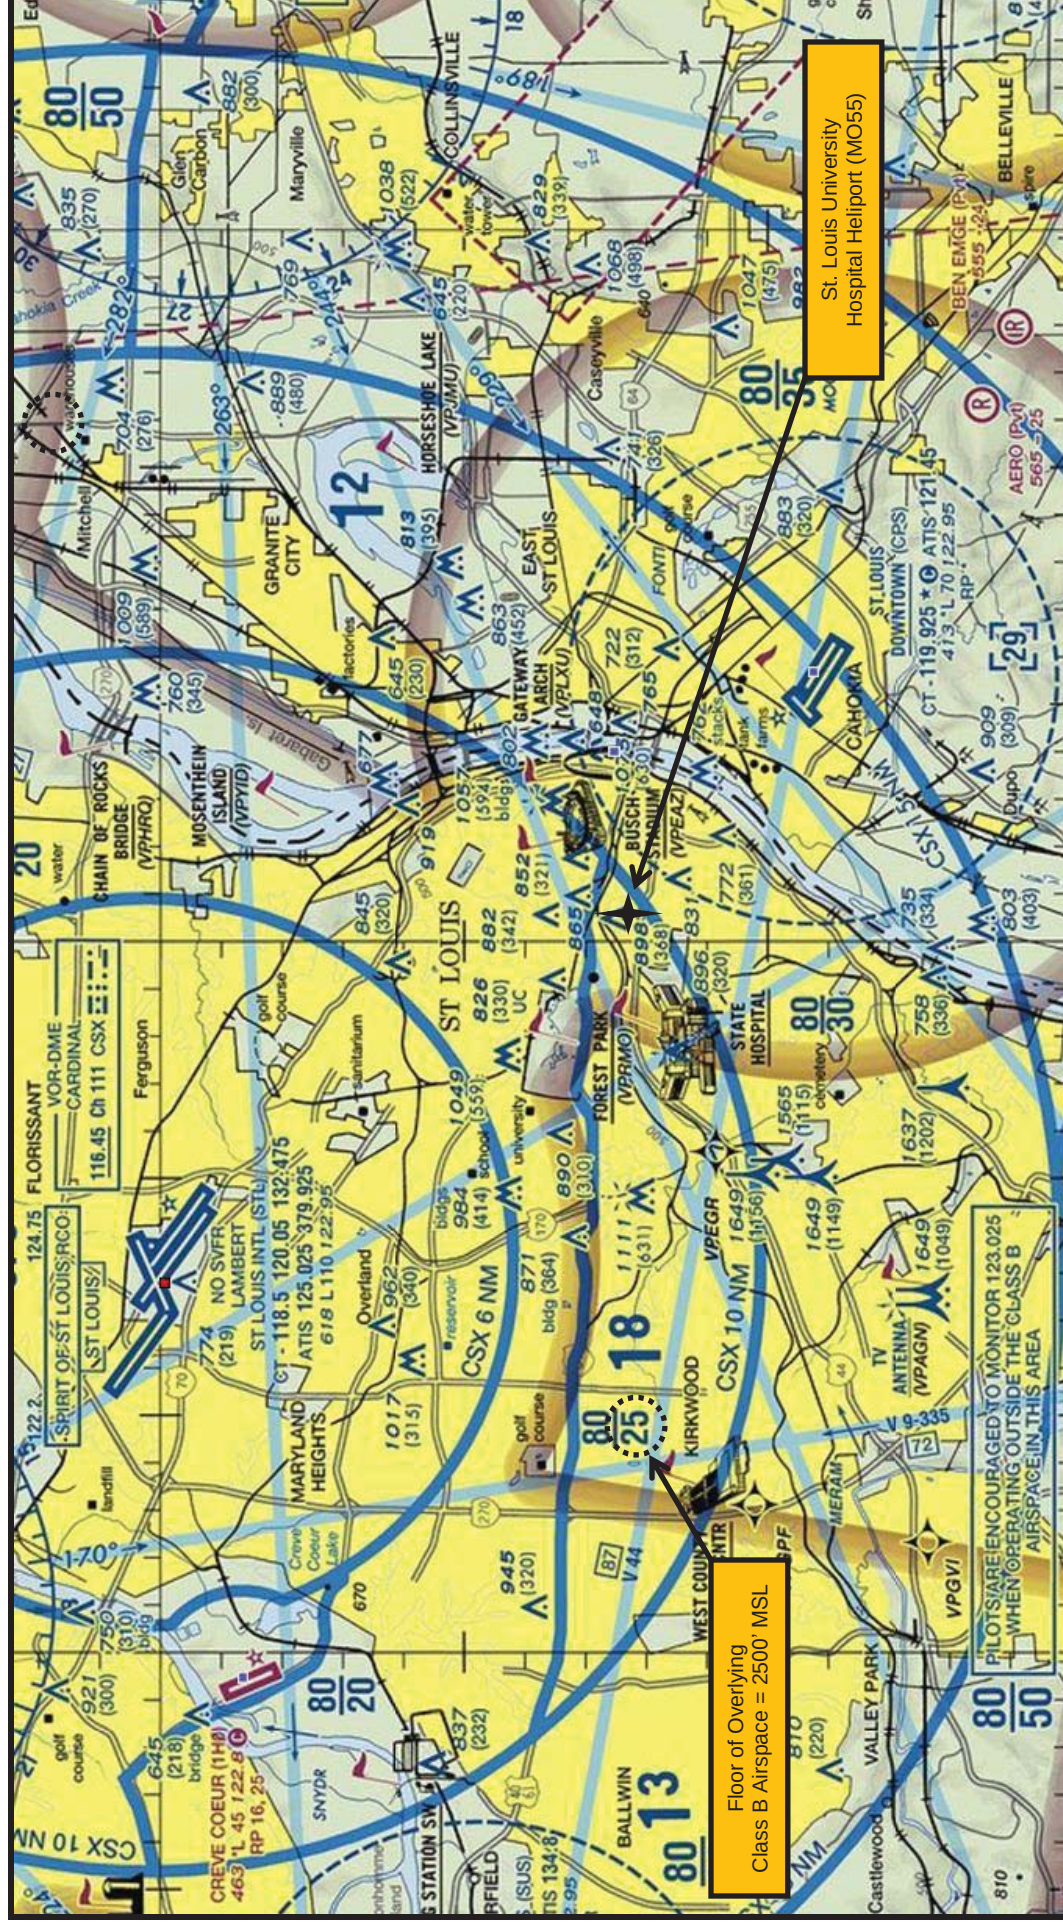
Figure 2: Airspace Overview

The site is located 9.73 nm SE of Lambert-St. Louis International Airport and underlies the 2500-foot floor of the St. Louis Class B airspace area. There are numerous PPR heliports in the vicinity.

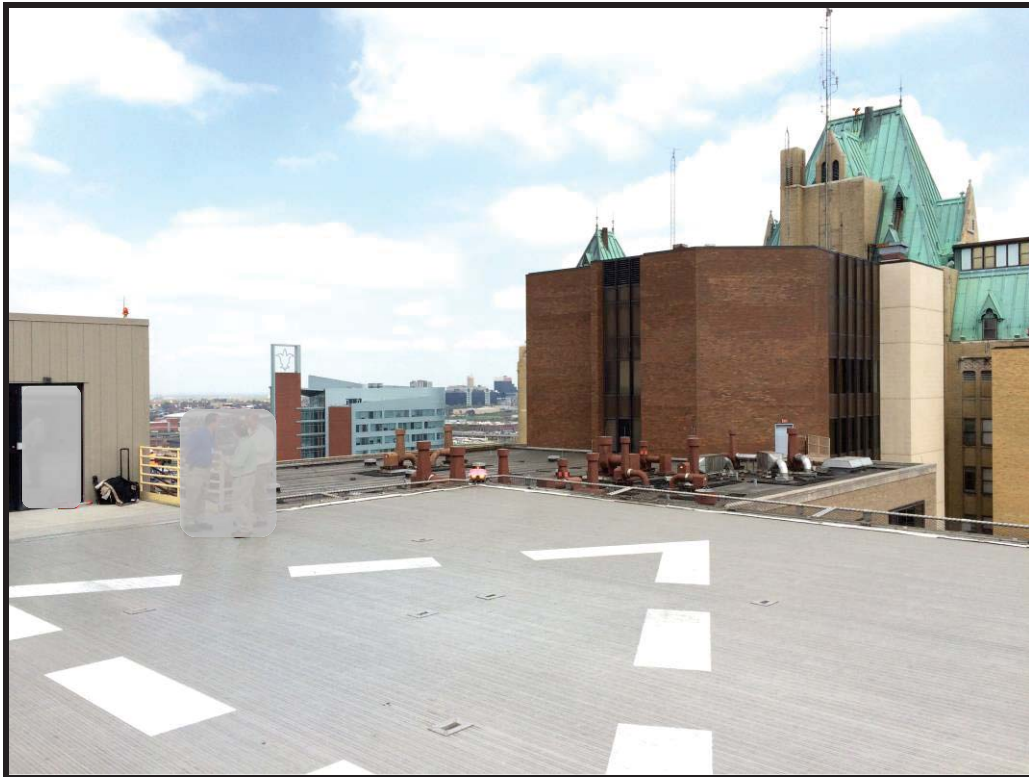
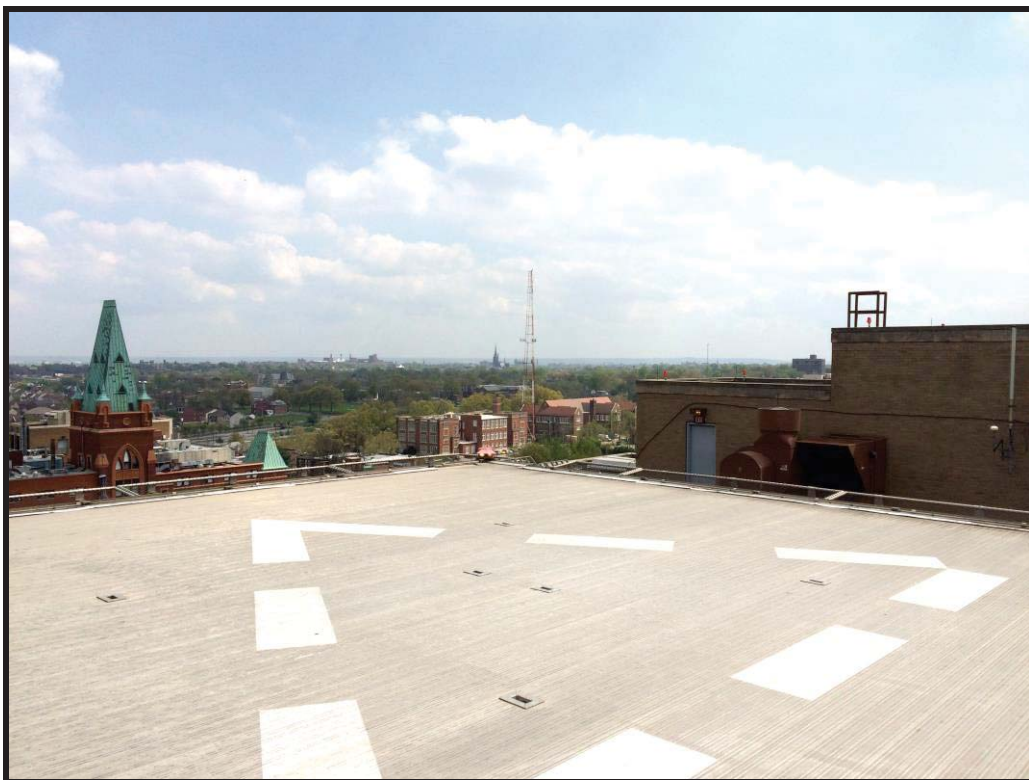
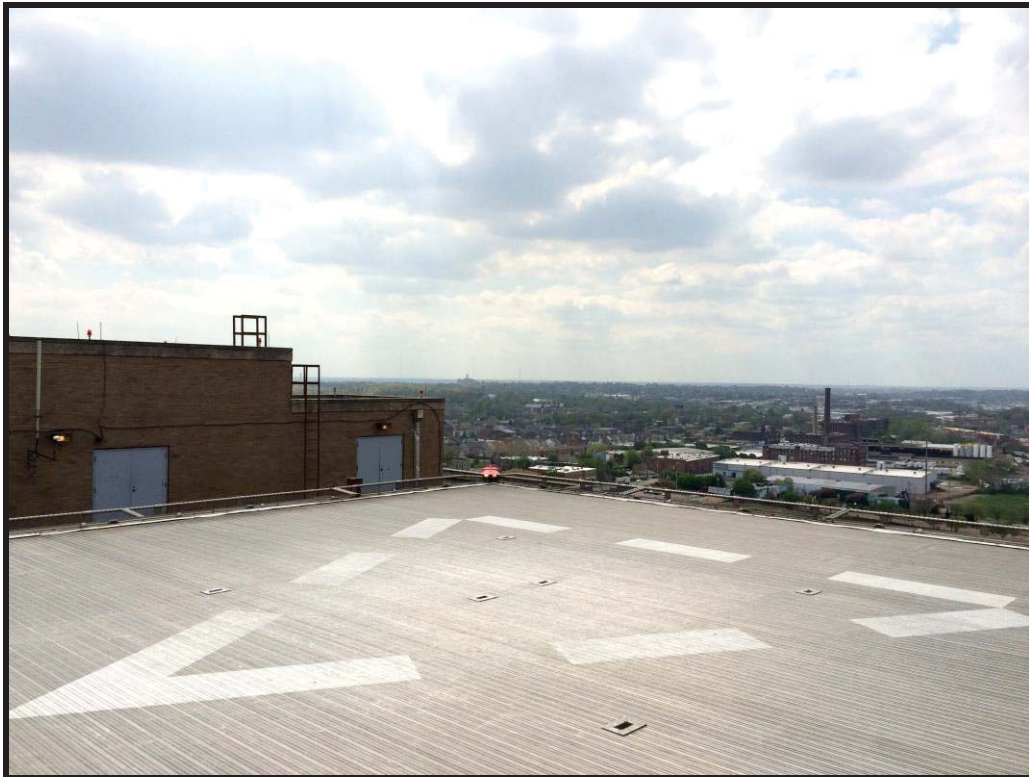
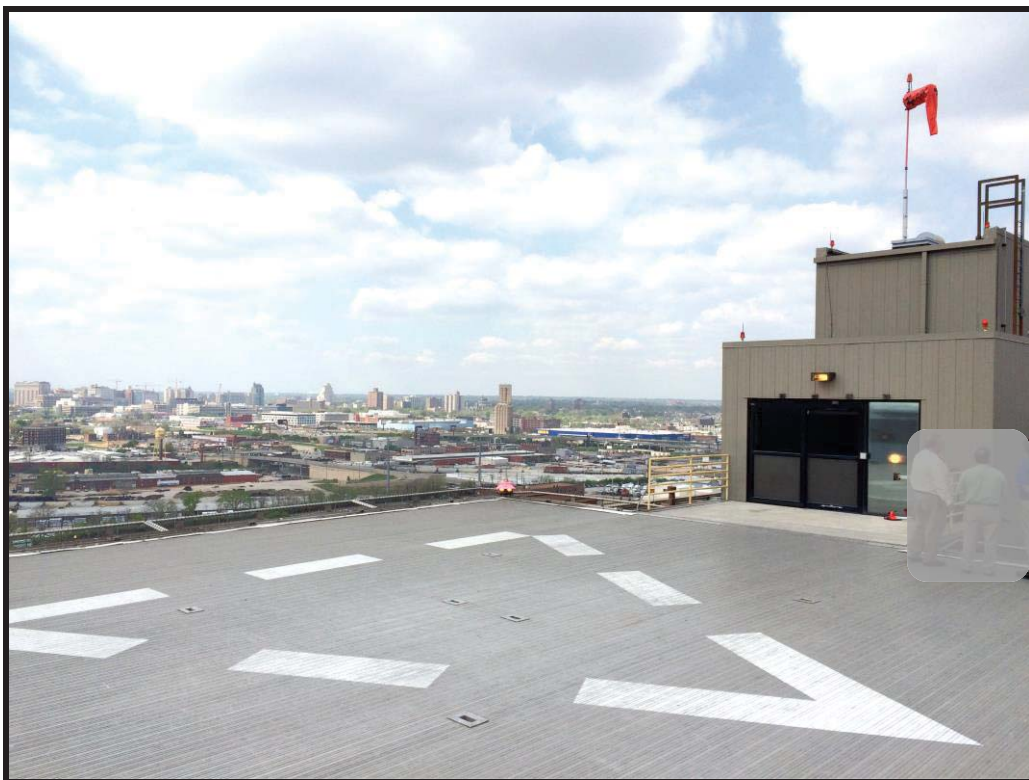
The helipad is a 47.5-foot-square unpainted aluminum plank surface elevated to approximately 178 feet above the street, atop a multi-story building. It is surrounded on all sides by a 4.5-foot chain link safety net. The landing surface is in good condition. The design helicopter is the Eurocopter BK–117 (D = 42.7'; RD = 36.1'; MGTOW = 7,385 lbs.).

Except for walkway access, the entire surface of the structure comprises the TLOF and is marked with a non-standard white triangle. There is no hospital cross, “H” symbol, size/weight limitation box, or TDPC. The TLOF perimeter is marked with a dashed white line which appears to have—at one time—incorporated non-standard internal lighting (not functioning at the time of inspection). The triangle marking is in fair condition; the perimeter marking is in poor condition. The TLOF is oriented 015°–195° & 105°–285°, relative to true north. The TLOF corners are lighted with perimeter/flood lights incorporating 2 flood lamps and one amber

perimeter lamp in a single unit (4 total units; one in each corner). The TLOF surface also contains 6 flush-mounted aircraft tie-down fixtures.

NOTE: For the purposes of this study, it is assumed that the proponent would be willing to repaint the TLOF surface to conform to the recommendations of AC 150/5390–2C, Par. 414, and associated figures. The minimum TLOF recommended by the advisory circular for an elevated heliport is 1 times the overall length of the design helicopter (D), or 42.7 feet (4.8 feet smaller than the currently marked space). Since the size of the FATO/safety area, and obstruction penetrations calculated from them, are based on the size of the TLOF, use of the absolute minimum affords the greatest advantage to the proponent.

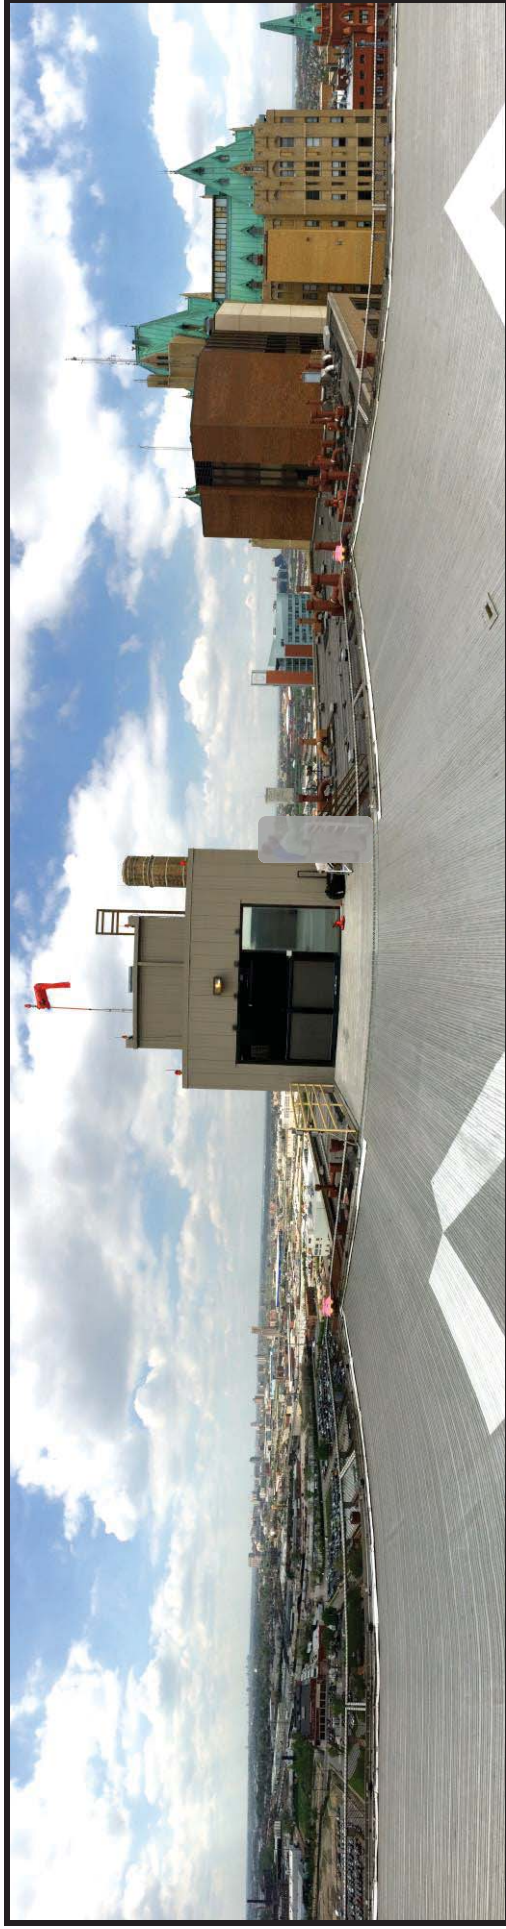
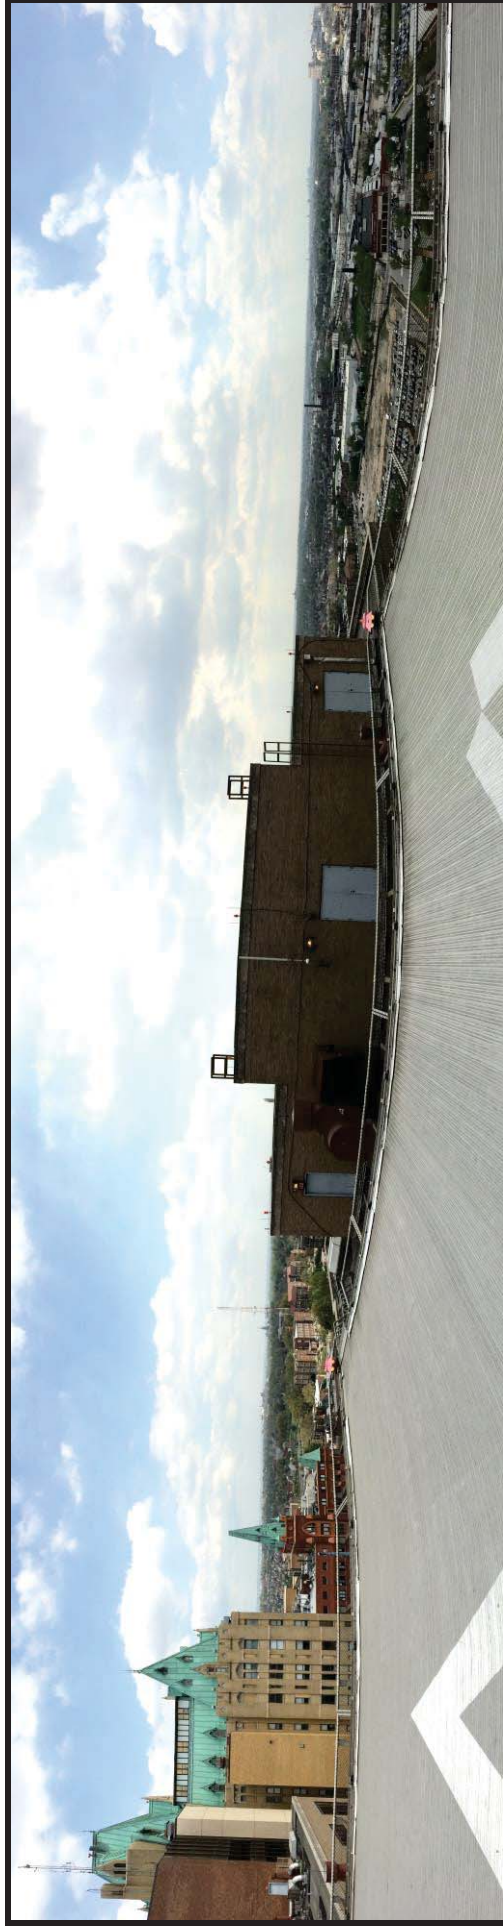
The heliport FATO/safety area is obstructed by permanent and semi-permanent objects that pose a serious hazard to helicopter operations. The most serious obstructions cannot be easily lowered or removed. Flight Standards cannot recommend an approach/departure route into or out of a hazardous area that does not appear to have reasonable alternatives for mitigation. Therefore, no recommendation for ingress/egress is made in this case.
