# Turbomeca On Site Examination Report

**CEN15FA171**

**AS350B2**

**Arriel 1D1**

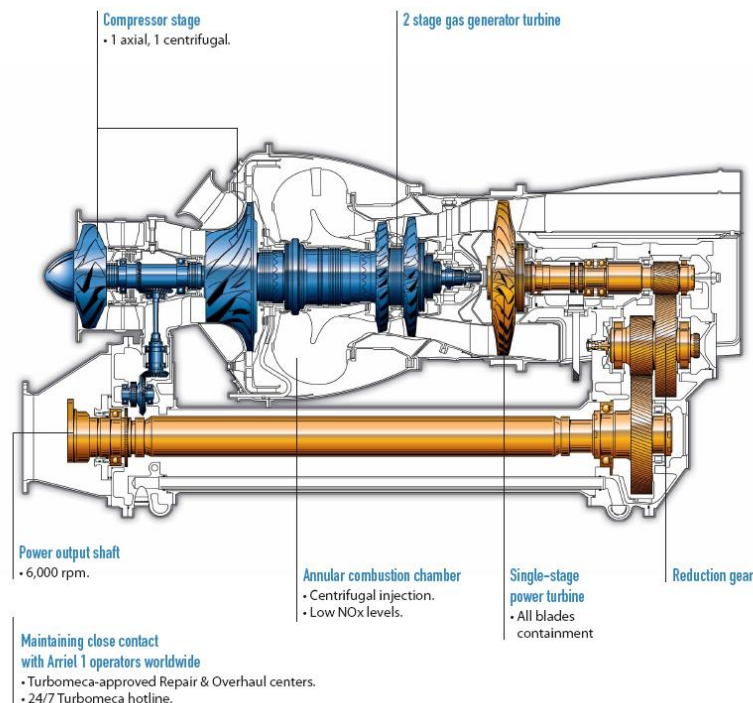
**Engine as found with no blade shedding encountered**

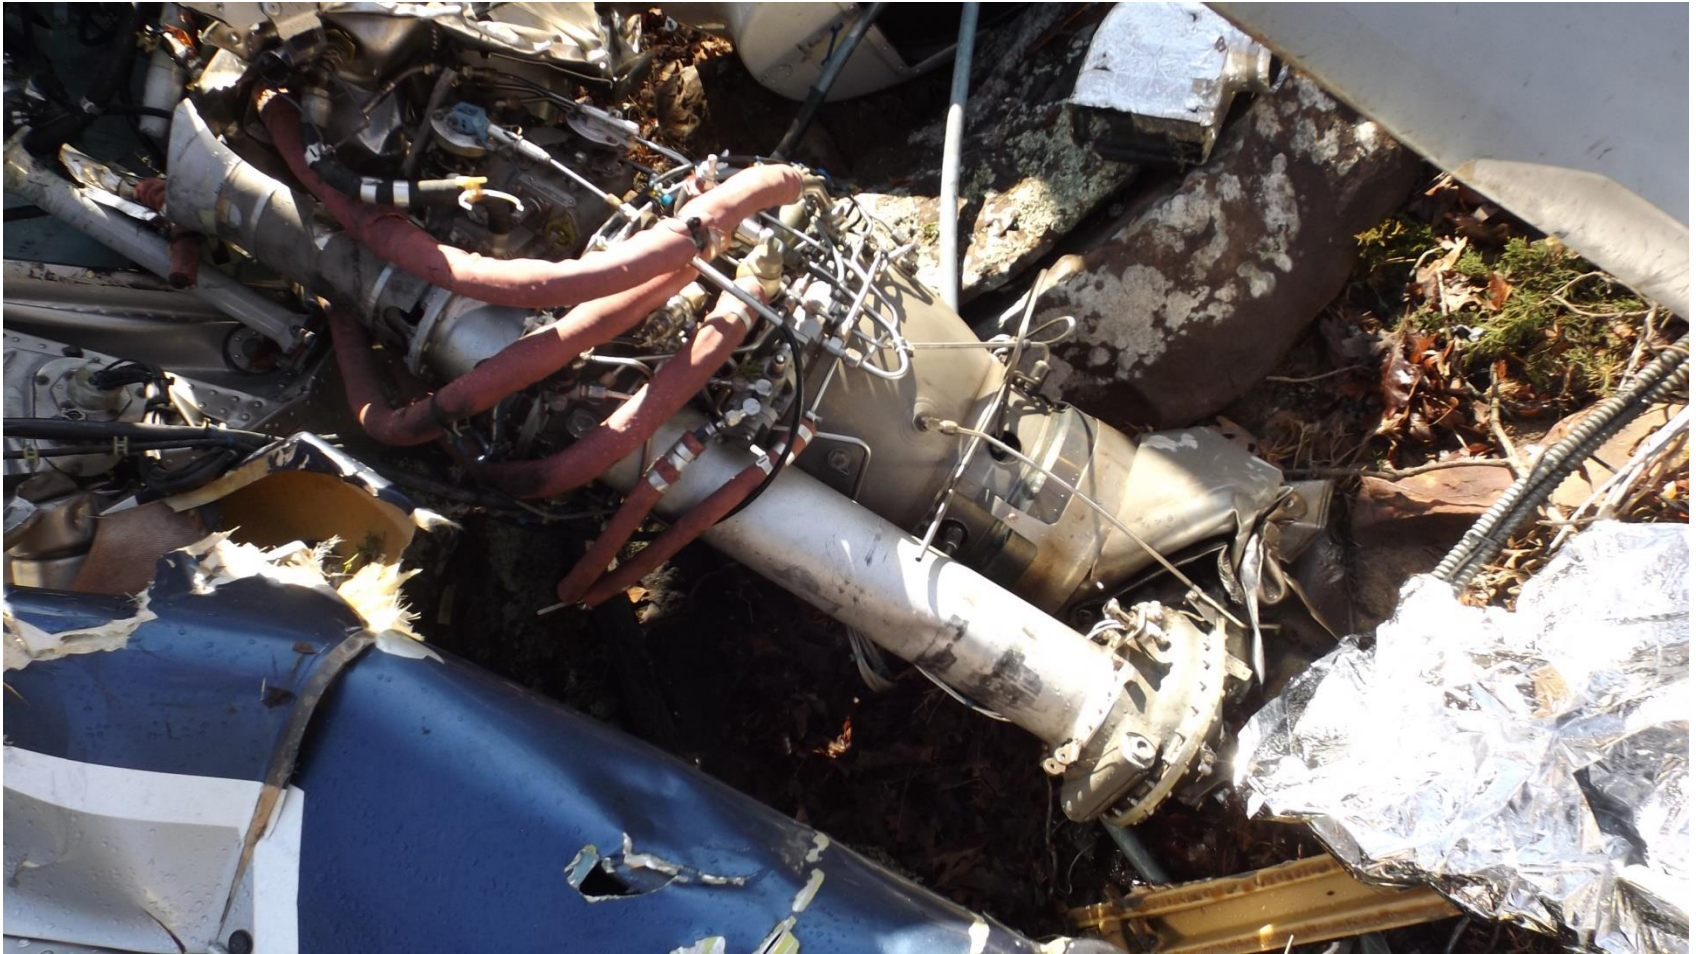
## Overall Engine

**The engine as found was partially separated from the airframe and sustained impact damage on the turbine case, linking tube, and exhaust pipe.**

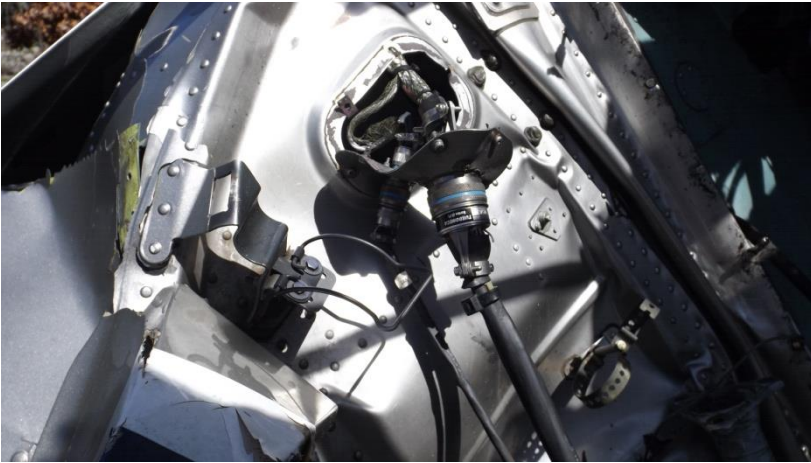
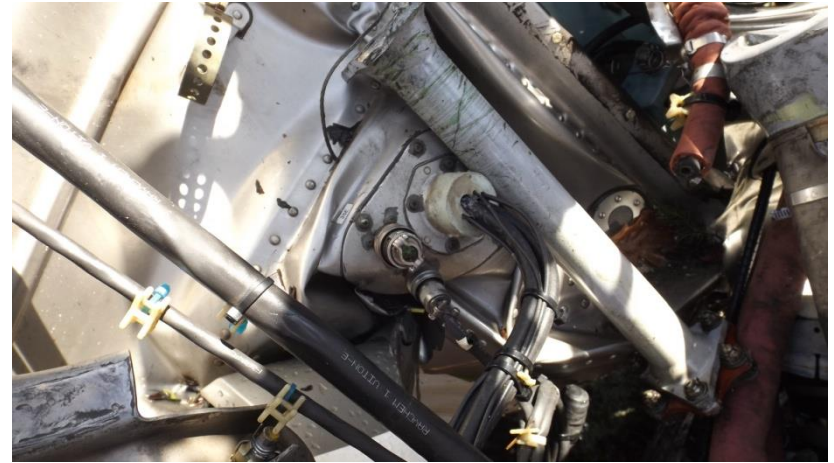
## Engine Electrical Connections

**All fuel, oil, and air connections were found installed with the proper safety wire.**

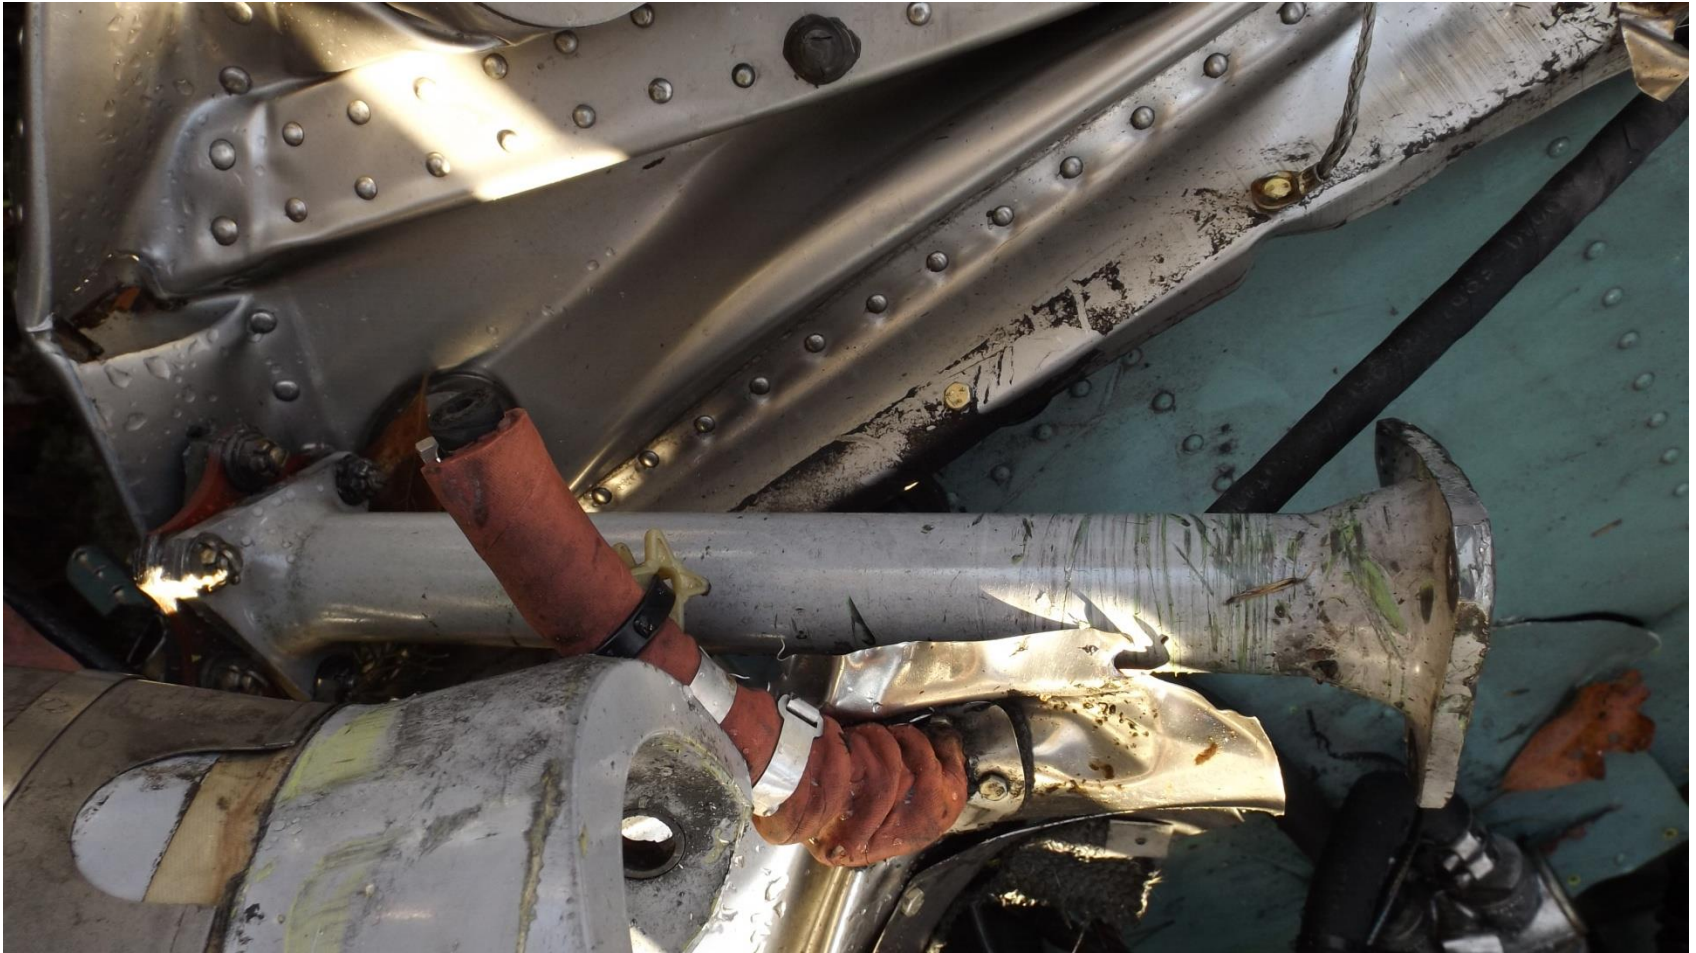
## Engine/Transmission Shaft

**The free turbine could not be seen due to the crushed exhaust pipe, however the freewheel shaft could be turned by hand to confirm continuity through the reduction gearbox to the free turbine. Proper freewheel operation was confirmed.**

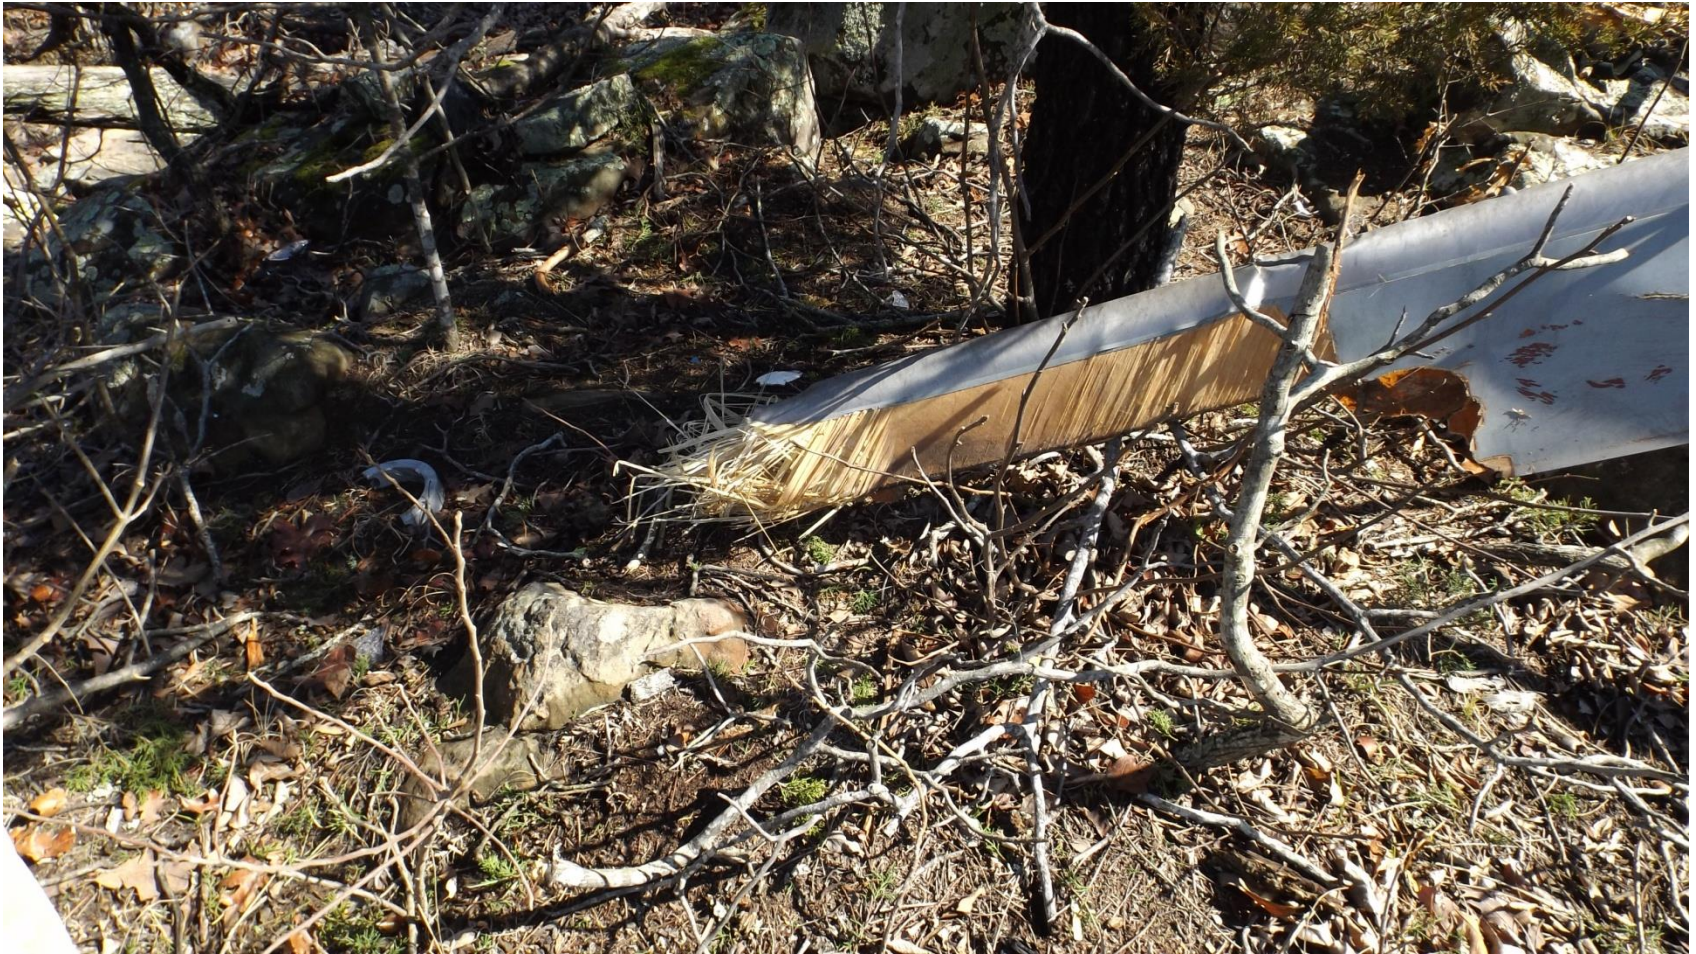
## Main rotor blade

**The input pinion alignment mark showed a misalignment of 1.5mm in the overtorquing direction consistent with the engine producing power at the time of a main rotor blade strike.**
