CESSNA AIRCRAFT COMPANY

Model No.: 310Q

Report No.: 02-87-017

Examination of a Damaged Elevator Trim Tab Assembly from a Crashed  
M310Q Aircraft, N7648Q

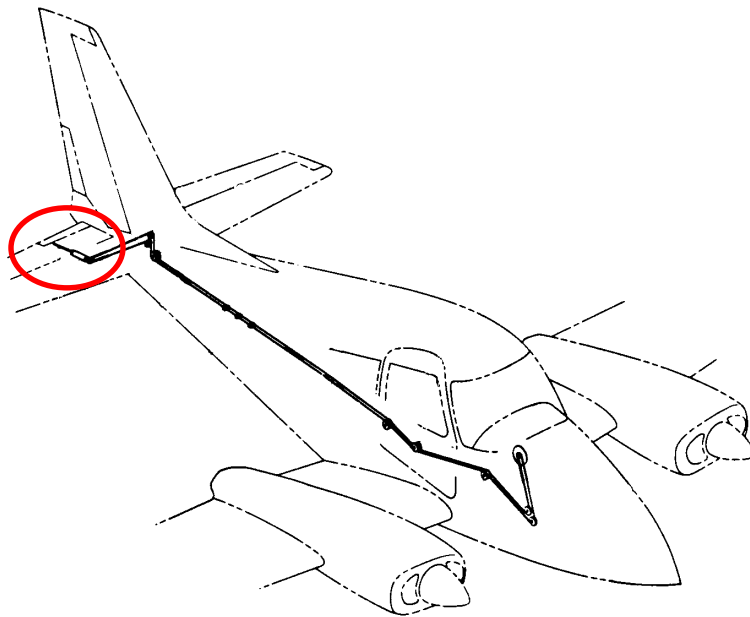
The elevator trim tab assembly is located on the RHS elevator as shown in Figure 1. The sample which was submitted to M&P consisted of a portion of the elevator and trim tab approximately 8 inches wide, along with the push-pull rod and the trim tab actuator outer housing, as shown in Figure 2. The 8 inch wide sample was heavily damaged, exhibiting torn and bent metal components and an overall soiled appearance with light corrosion of the internal areas.

Figure 1. Diagram showing the elevator trim tab control mechanism in a M310 aircraft. The location of the actuator and push-pull rod are circled.
