## REPORT 1508-3

- 1.0 SCOPE: This report describes the engine tear-down accomplished on the Lycoming IO-360-B1E S/N L-4412-51A from Pi-180 S/N 28R-30255 that had been involved in an engine failure accident.

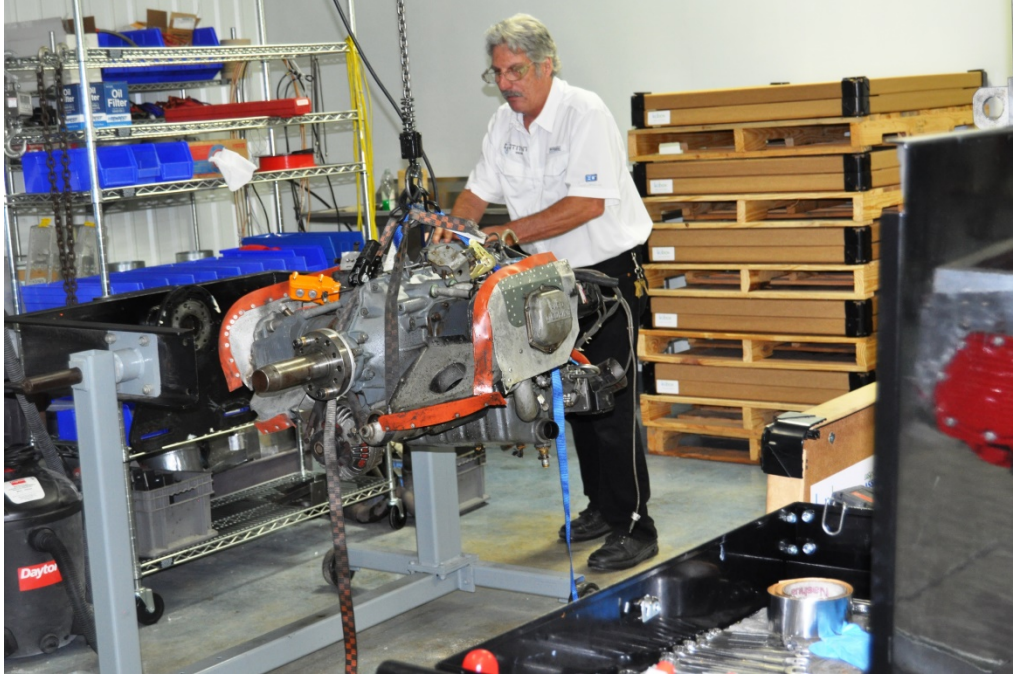
Photograph 2

. This image shows cross sections and an image of cracks in the piston while it was still in the cylinder.

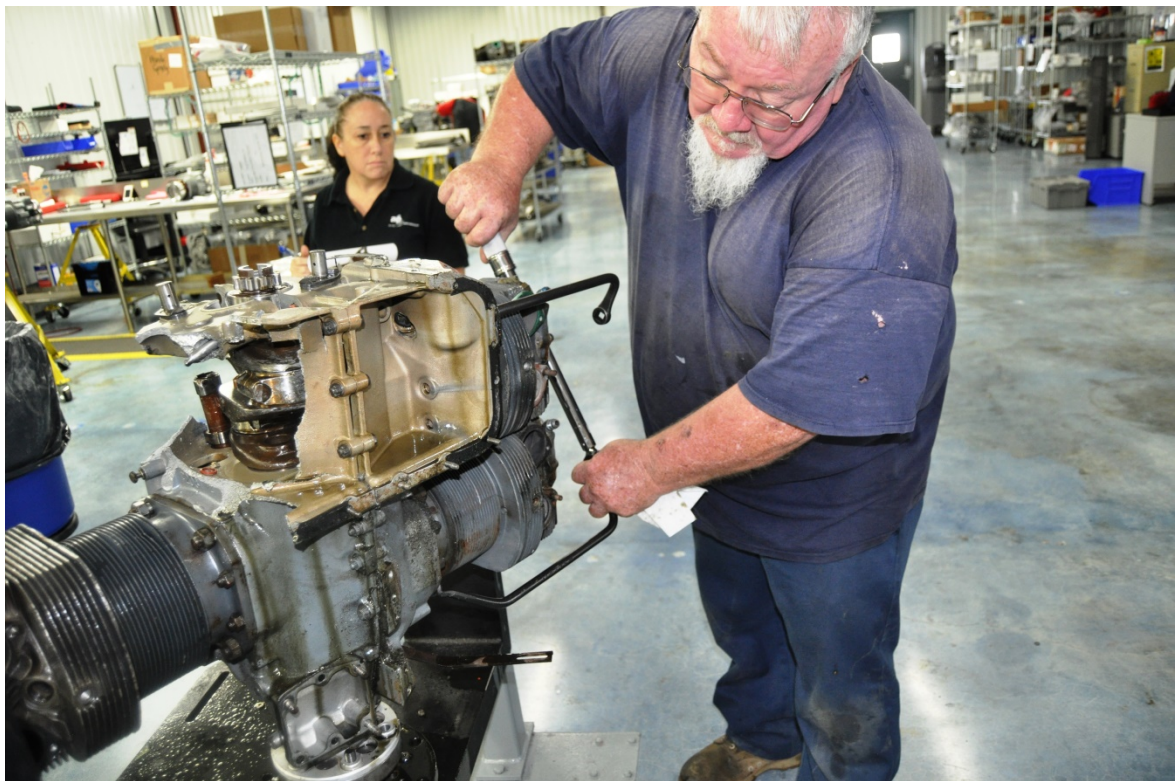
Photograph 3  
Engine being installed on engine stand after removal from crate

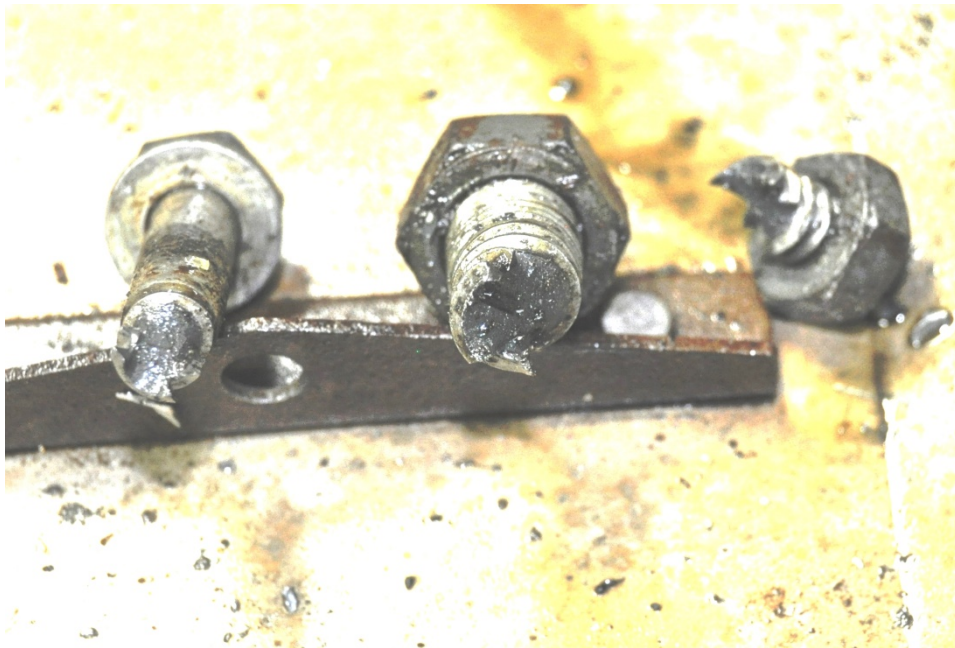
Photograph 9

- 4.4 The Number 4 cylinder deck (upper broken out section) shows some fretting, with some more at the upper right anchor thrubolt. The body fit hole at the parting line on the broken out section of the crankcase above the #4 cylinder has significant deformation.

Crankcase parting line at #4 cylinder anchor stud hole. Some parting line fretting and distortion around and in the anchor thru-bolt hole are visible.

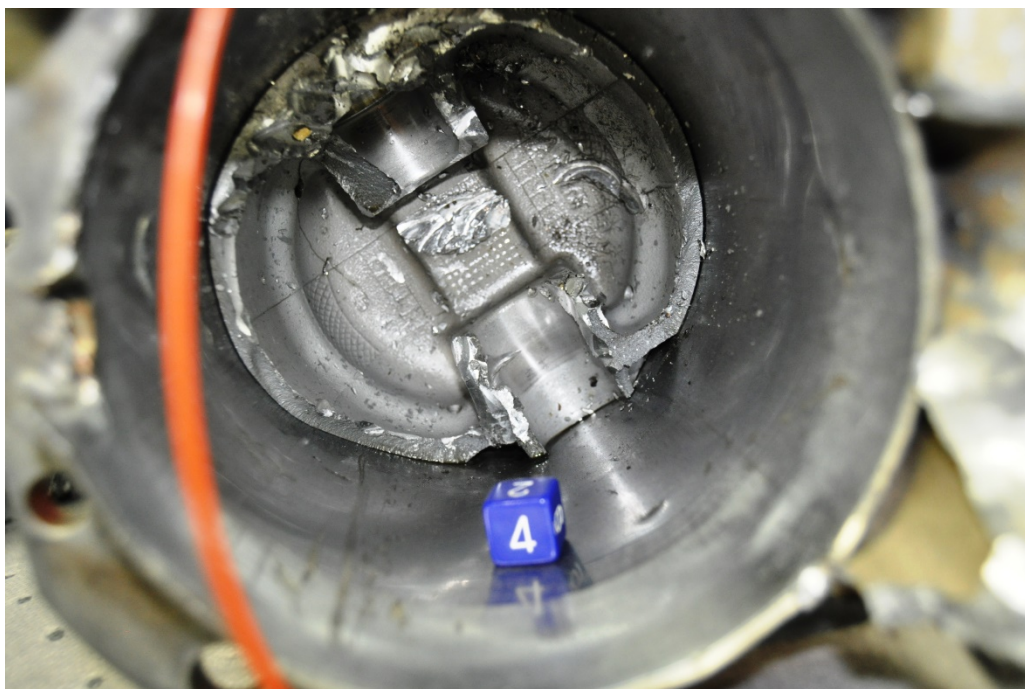
Photograph 11

#4 deck section showing fretting and wear at the upper thru-stud.

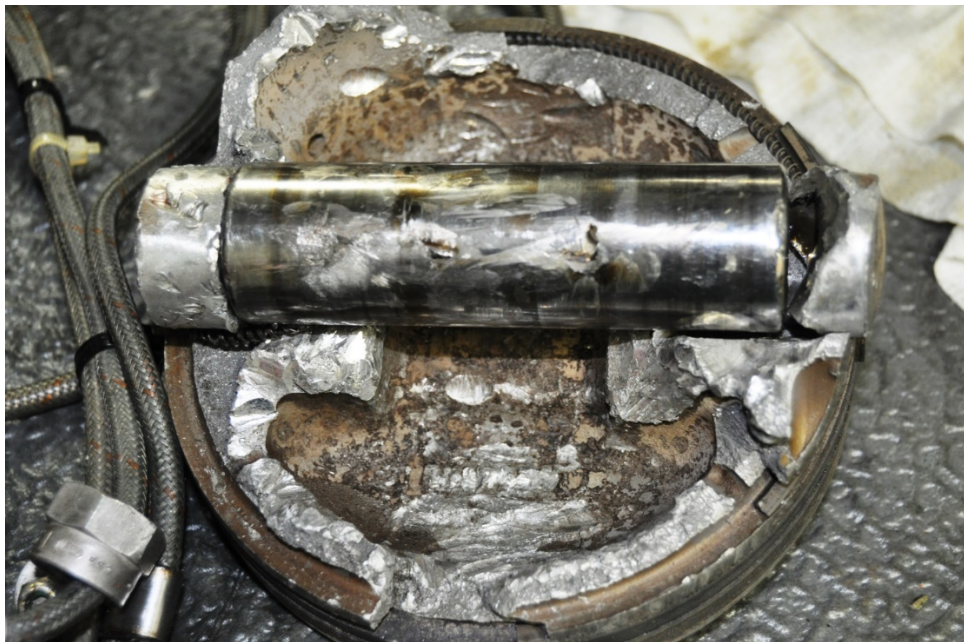
Photograph 17

The threads on the rod bolt are stripped and there is some damage to the thrust faces of the #4 connecting rod

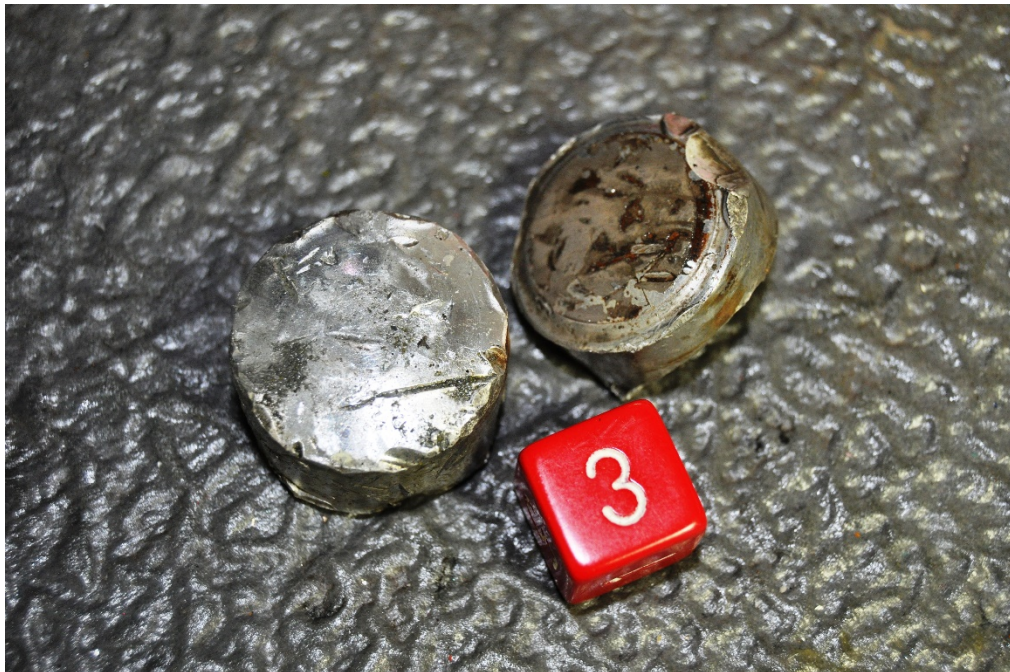
Photograph 19

- 4.8 Cylinders #1 through #3 all showed some degree of bore glaze (coating of carbonized oil), but the worst was cylinder #3.
- 4.9 The #3 cylinder bore had score marks in line with the piston pin plugs. The piston pin plugs had damage, and one of them had a wear ridge around the outer periphery. There was additional damage to the #3 cylinder bore that could not be matched to geometry of the piston pin while it was in the operation position in the piston.

The bore of the #3 cylinder shows evidence of blow-by during operation and scar marks from the piston pin plugs.

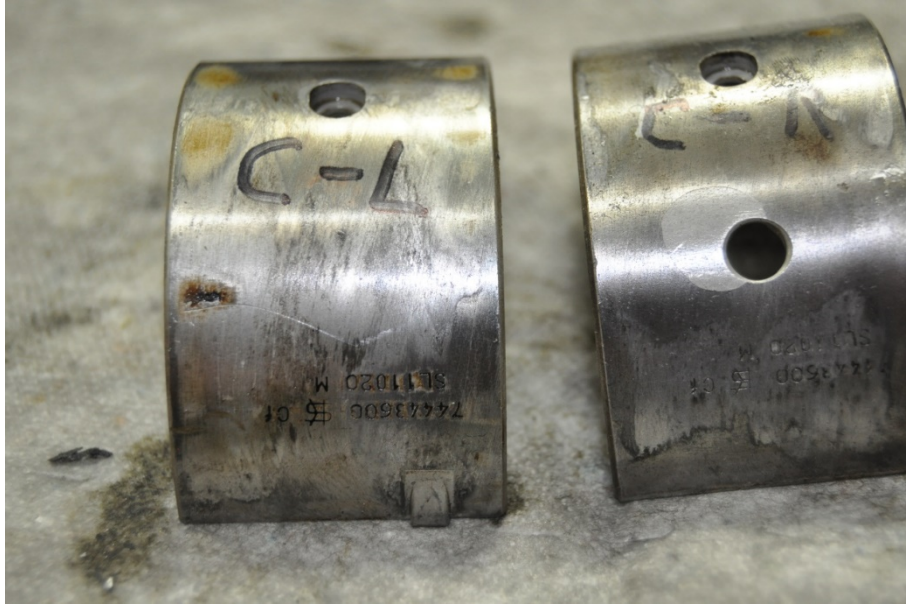
Photograph 27

Center main bearings: Normal appearance on backs for the time in operation
