## **INVESTIGATION REPORT**

| <b>Aircraft Model:</b> | Clipper 582 | <b>Aircraft S/N</b> | Unknown |

| <b>Engine Type:</b> | Rotax 582 Mod 90 | <b>Engine TTSN</b> | Unknown |

| <b>RFS File number:</b> | 2015-030 | | |

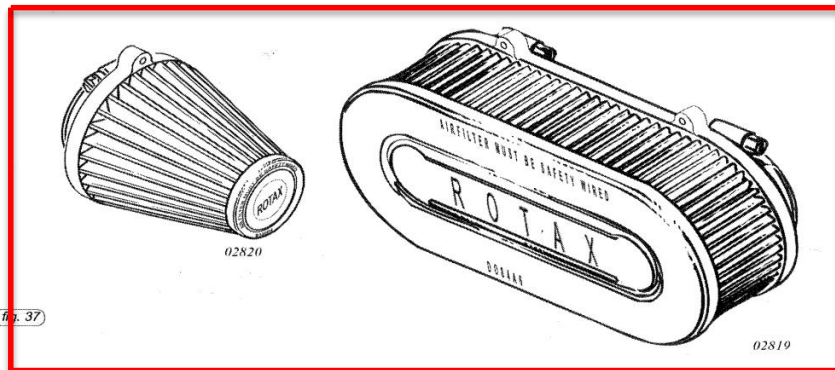
The air filter was found to be a non conforming air filter with no lock wire fixation tabs. In the Rotax installation manual section 17,2) **Air filter** it states that only air filters approved by Rotax are permitted for use. The air filters specified by Rotax are special K&N air filters, with fixation tabs for proper security.

■ **WARNING:** Always secure air filters against loss.

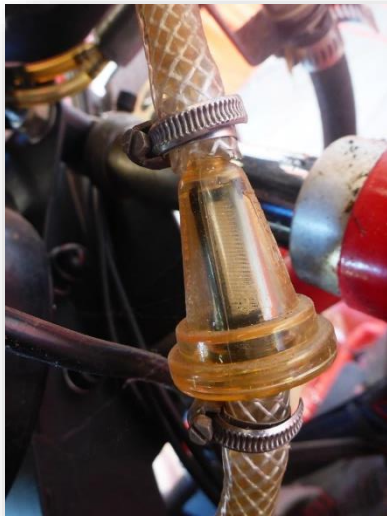
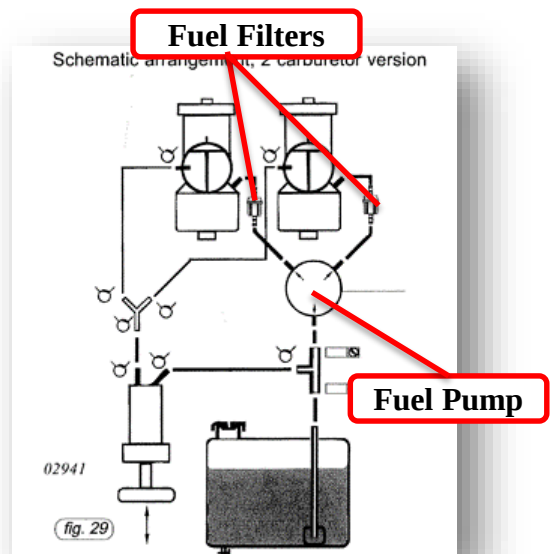
**Fuel Lines (Continued)** In the Rotax installation manual section 15) Fuel System, page 15-2, it states that "A suitable fuel filter of 0.15mm mesh size must be fitted between fuel pump and the carburetor. No fuel filter was found installed between the fuel pump and Carburetor.

There was only one fuel filter installed on this aircraft ( 2 are required for dual carburetor set up). The fuel filter was examined for proper type and obstructions. No obstructions were seen. No further anomalies were seen with the fuel filter.

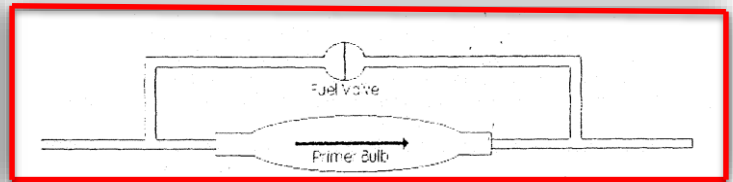
**Fuel Lines (Continued)** The fuel system was equipped with a primer bulb between the fuel tank and the fuel pump. Rotax does not state the use of a primer bulb in the Rotax installation manual. Primer bulb check valves can fail causing a blockage of fuel to the engine. It is standard practice and recommended that a by pass system be installed around the primer bulb with the use of a fuel valve as seen in the diagram below.

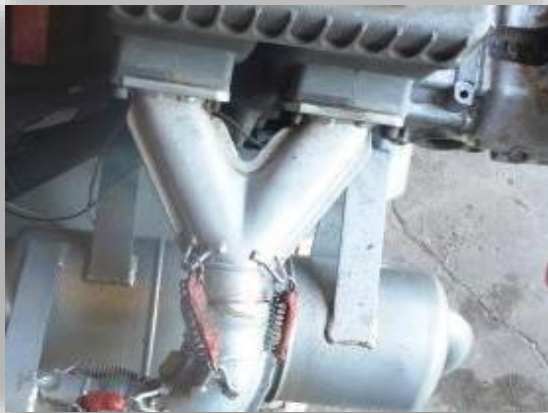
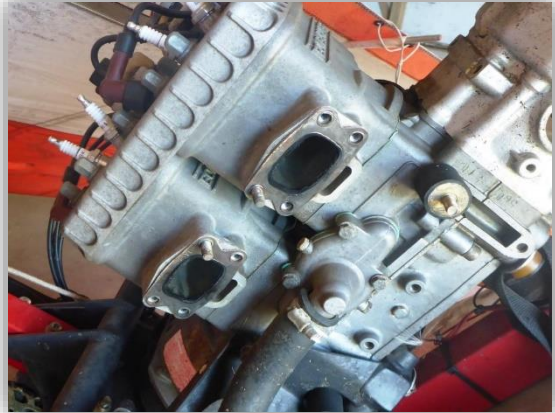
### **Piston Examination**

The exhaust Y pipe was removed to expose the exhaust side of the piston's for seizure and metal transfer marks.

The Power take-off piston rings were free in there respective ring land grooves and were in good overall condition. No anomalies were found on the exhaust side of the PTO piston.

The MAG piston rings were free in there respective ring land grooves and were in good overall condition. No anomalies were found on the exhaust side of the MAG piston.
