| <div style="display: inline-block; vertical-align: middle;"> Rolls-Royce Corporation<br/> P.O. Box 420<br/> Indianapolis, Indiana 46206-0420 USA </div> | | <div style="display: flex; justify-content: space-between;"> <div> PAGE<br/><b>1</b> </div> <div> OF<br/><b>83</b> </div> </div> | <div style="text-align: center;"> REPORT NO.<br/> <b>15FA8-072-PR</b> </div> |
| <b>TITLE</b><br><br>METALLURGICAL INVESTIGATION OF A THIRD STAGE TURBINE WHEEL P/N 23065818 REMOVED FROM M250-C20J ENGINE CAE832989 OPERATED BY FLY HANGAR 13 LLC. | | PREPARED<br><br><div style="text-align: center;"><i>Signatures on File</i></div> | |

**Part Name:** Third Stage Turbine Wheel  
**Part Number:** 23065818  
**Part S/N:** X597059  
**Total Part Time:** 930 Hours (TSO)  
**Engine Model:** M250-C20J  
**Engine S/N:** CAE832989  
**Removal Station:** Rolls-Royce Corporation, Indianapolis, IN.  
**User:** Fly Hangar 13 LLC

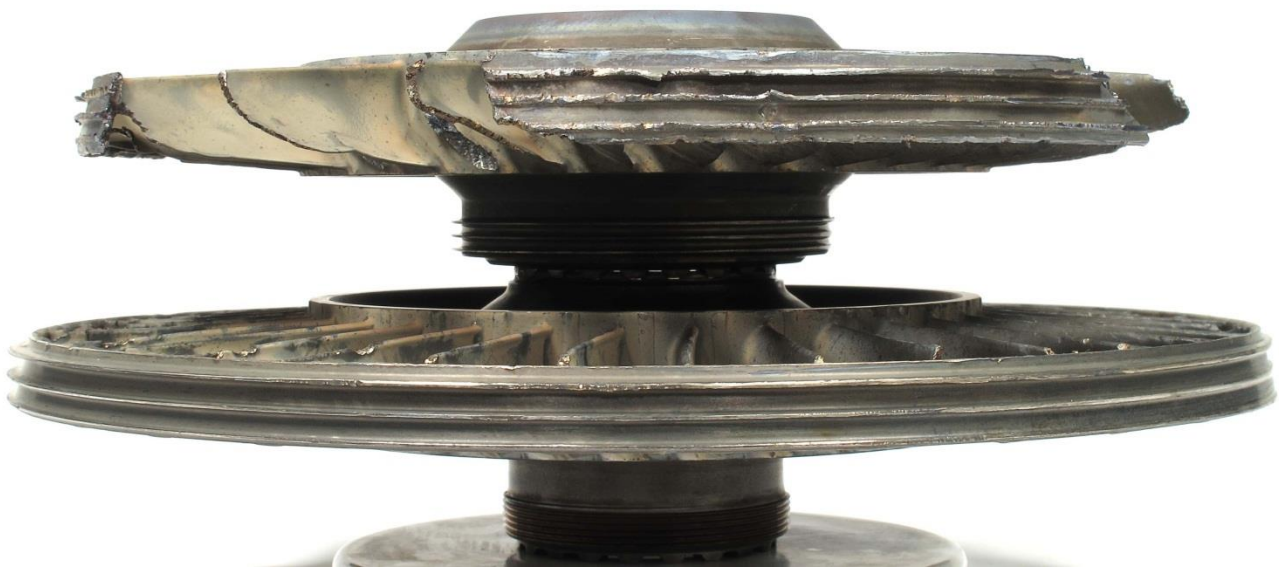
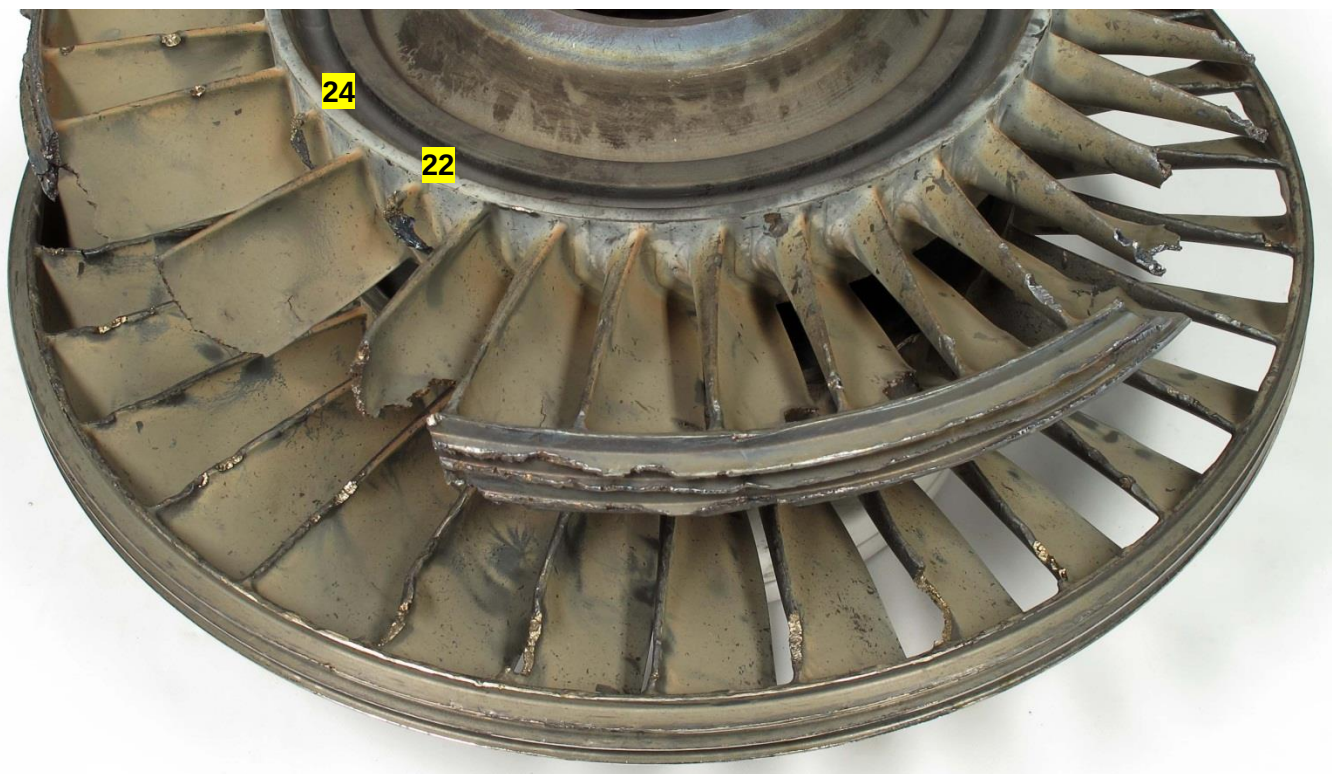
90-degrees

**Figure 5.** Photographs of the third and fourth stage turbine wheels positioned together based on the alignment marks on the hub.

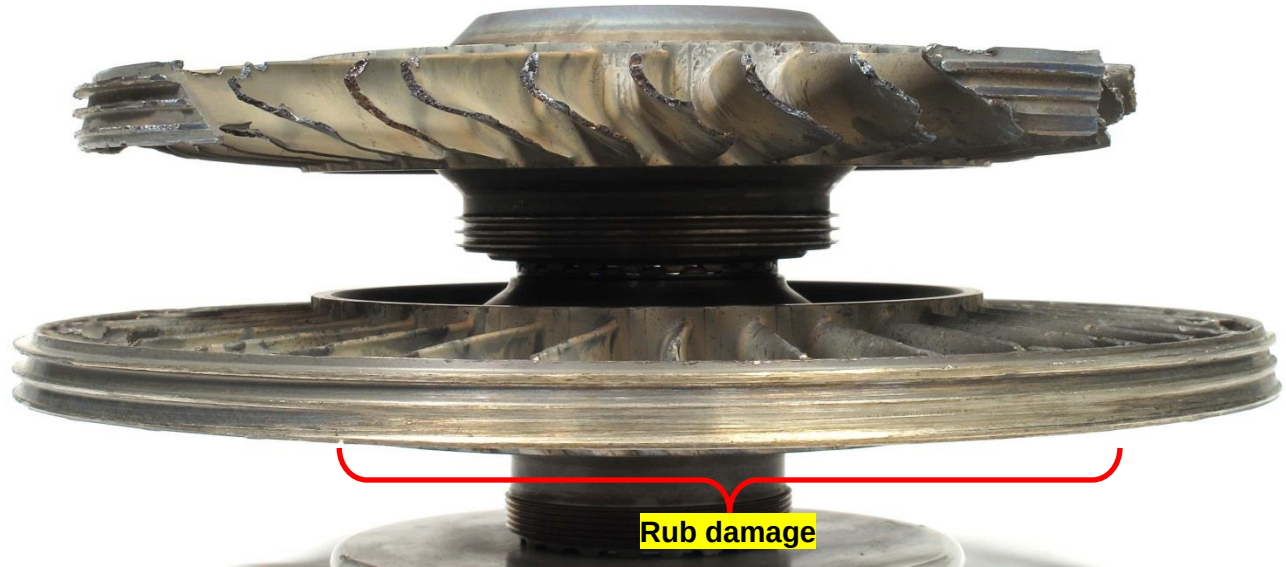
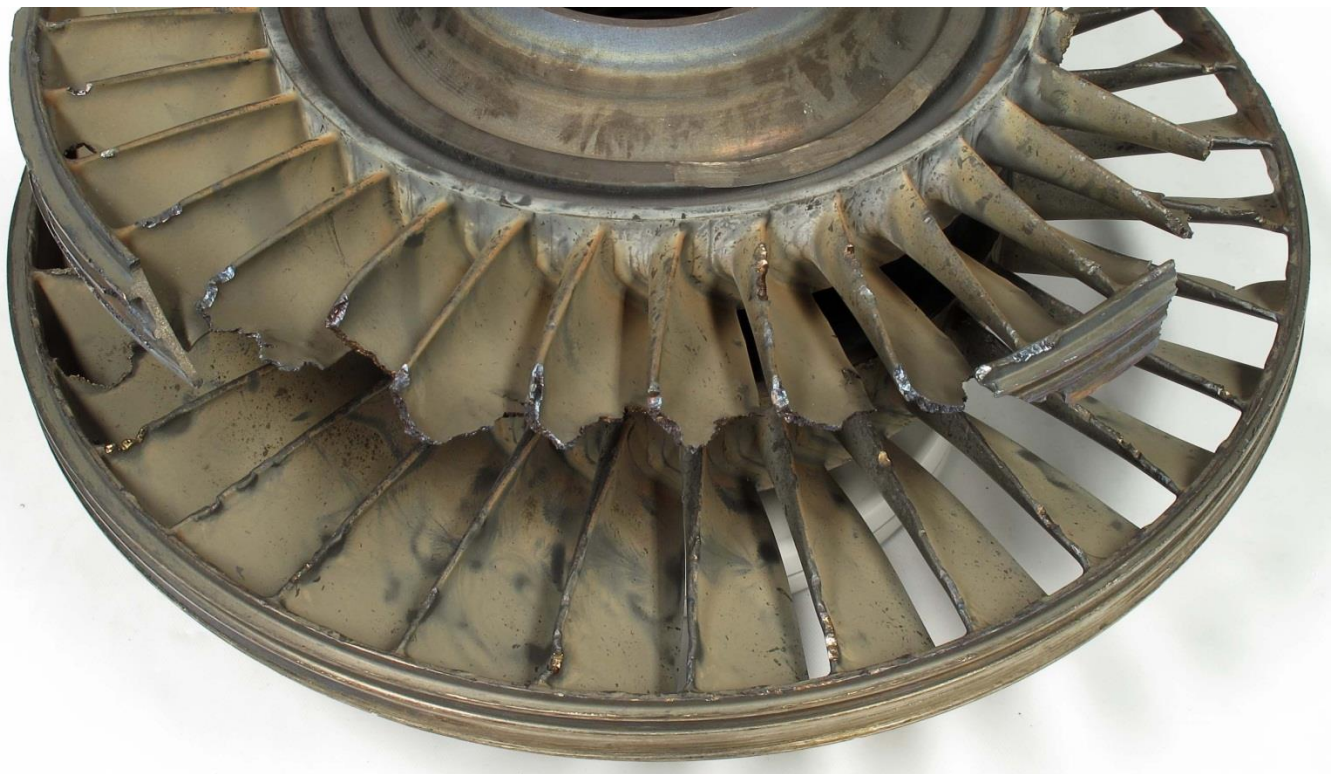
180-degrees

**Figure 6.** Photographs of the third and fourth stage turbine wheels positioned together based on the alignment marks on the hub.

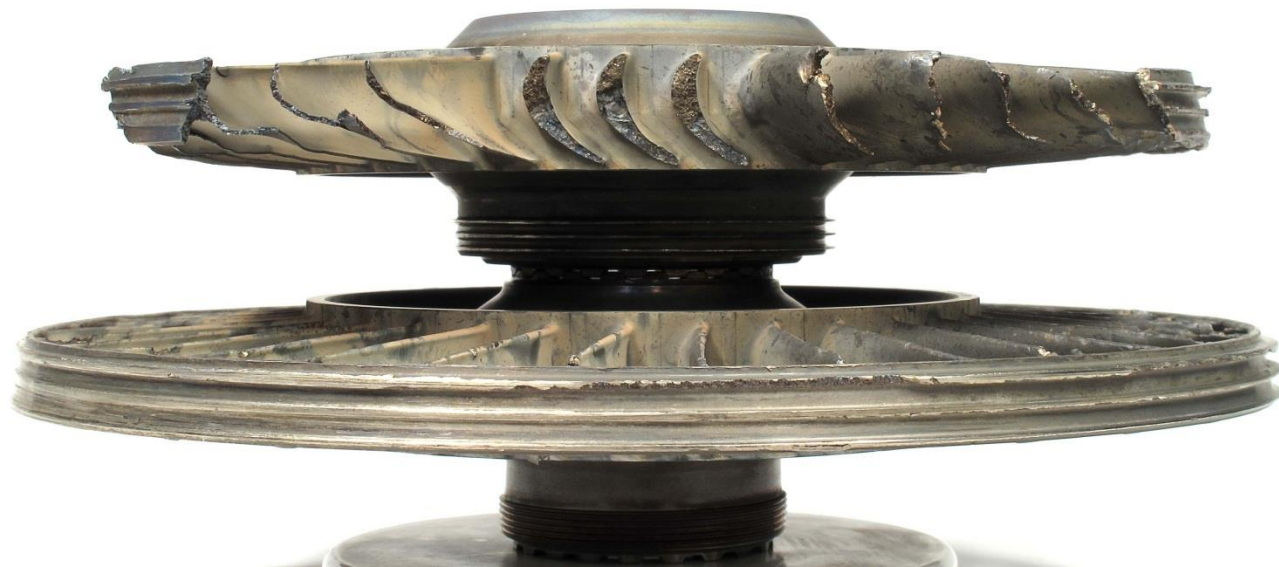
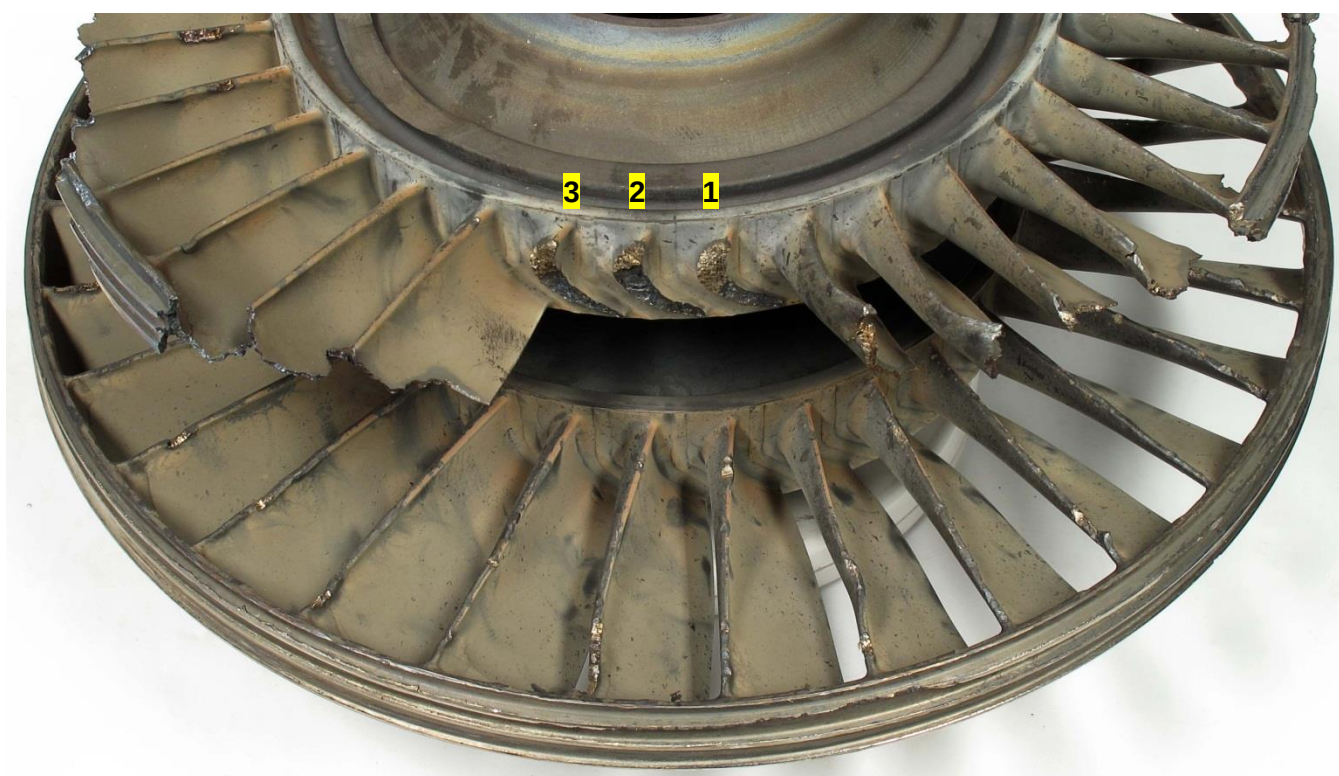
270-degrees

**Figure 7.** Photographs of the third and fourth stage turbine wheels positioned together based on the alignment marks on the hub.

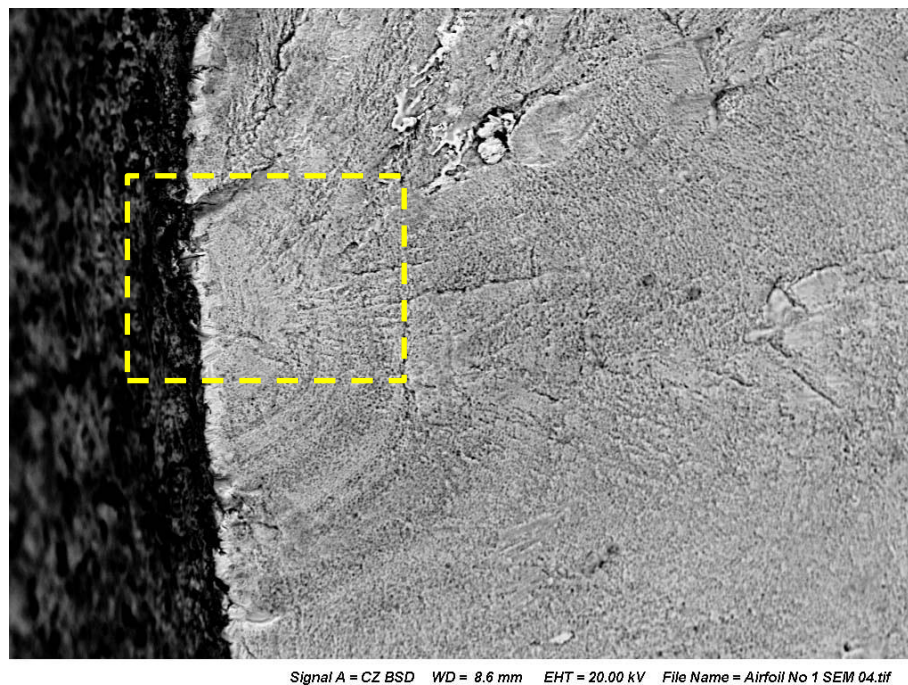
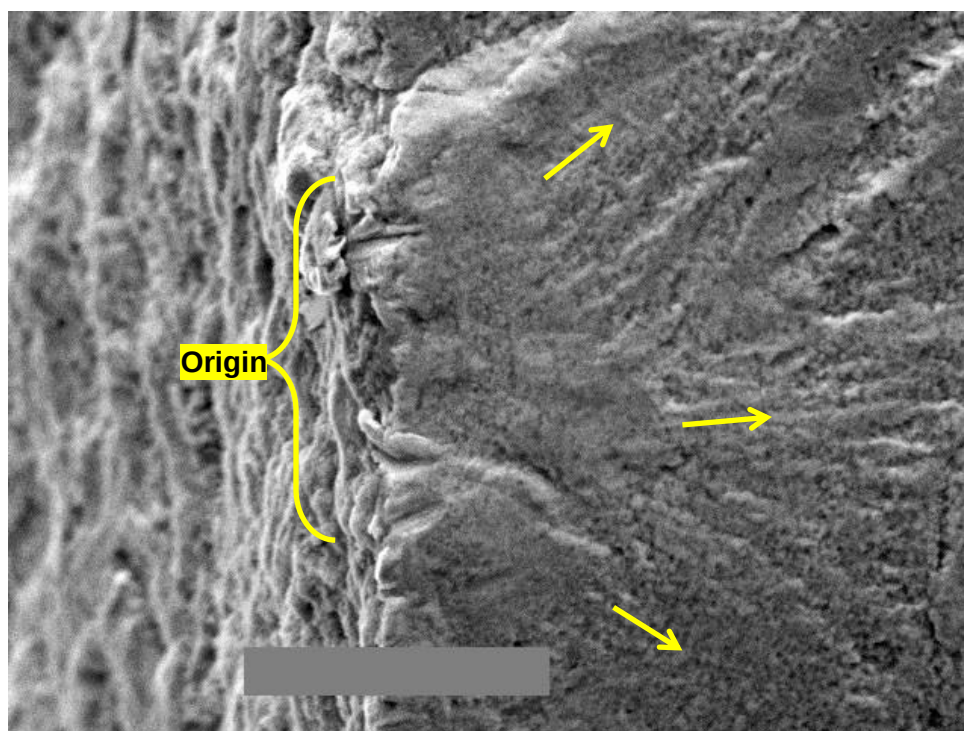
Figure 13. Detailed views of the airfoil No. 1 fatigue origin. The upper photograph is a backscatter image.

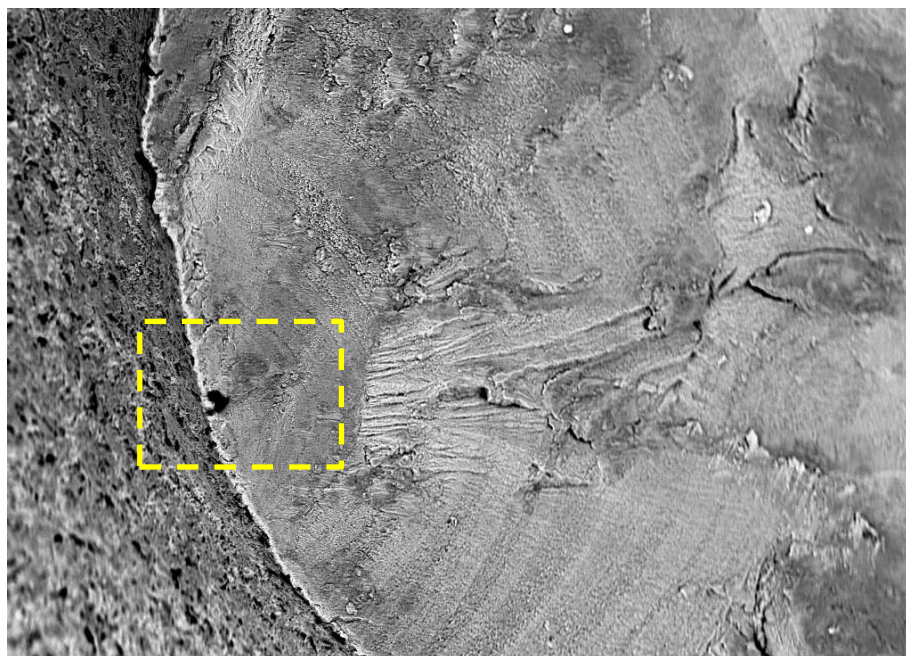
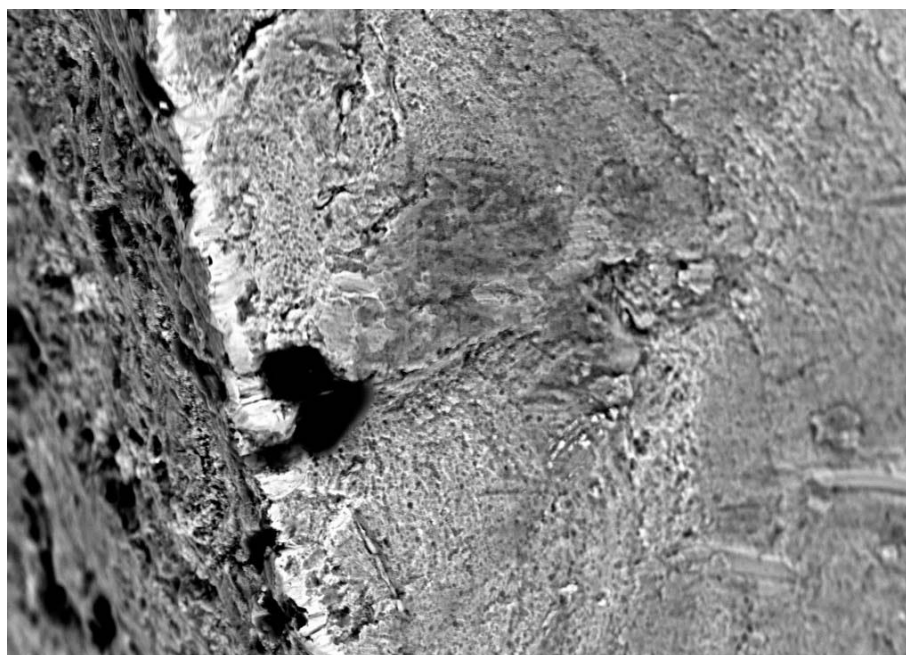
Figure 19. Backscatter electron images of the airfoil No. 2 fatigue origin.

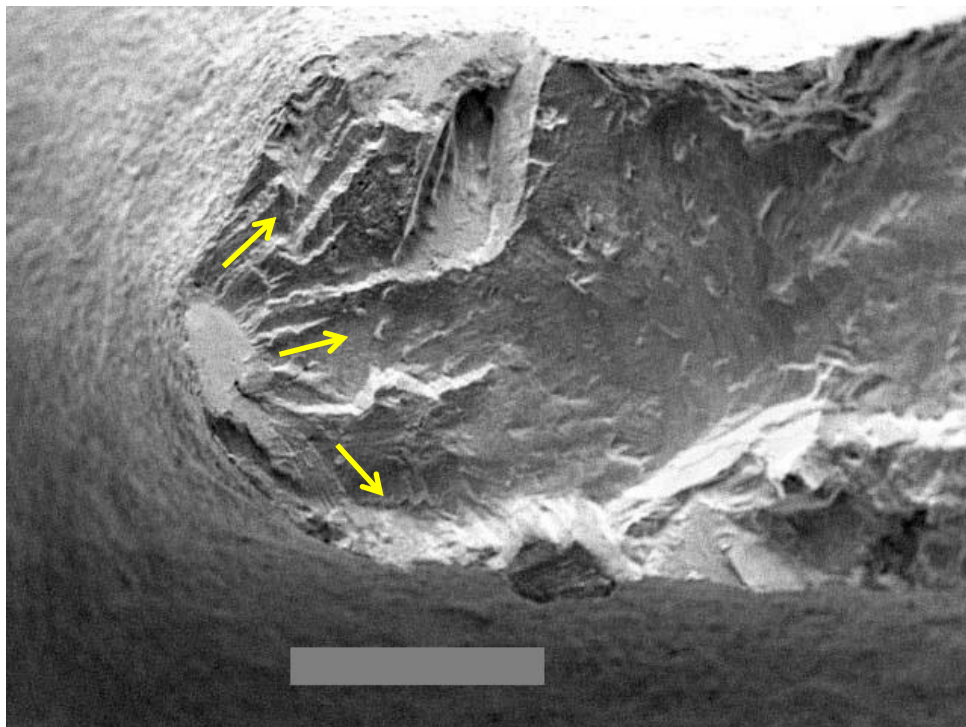
**Figure 23. SEM photograph of the airfoil No. 3 crack origin area. The arrows show the crack propagation directions. A detailed view of the fatigue origin is shown in the following figure.**

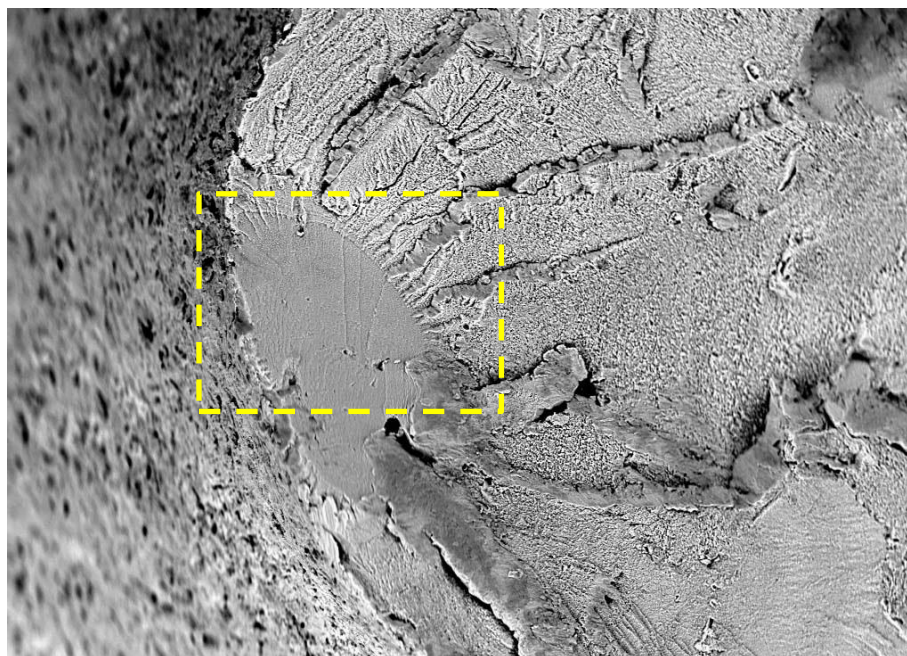
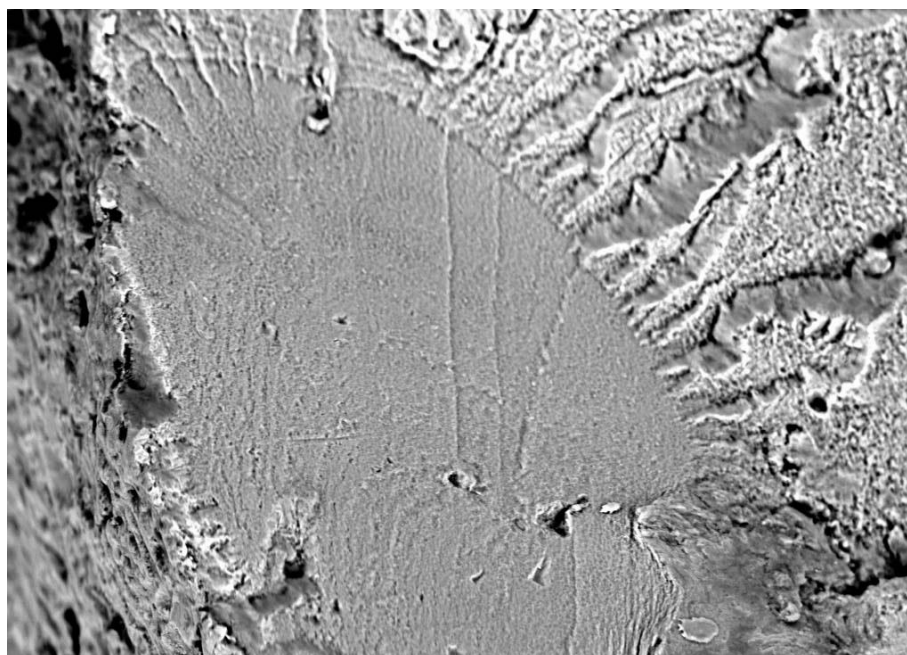
**Figure 25. Backscatter electron images of the airfoil No. 3 fatigue origin.**

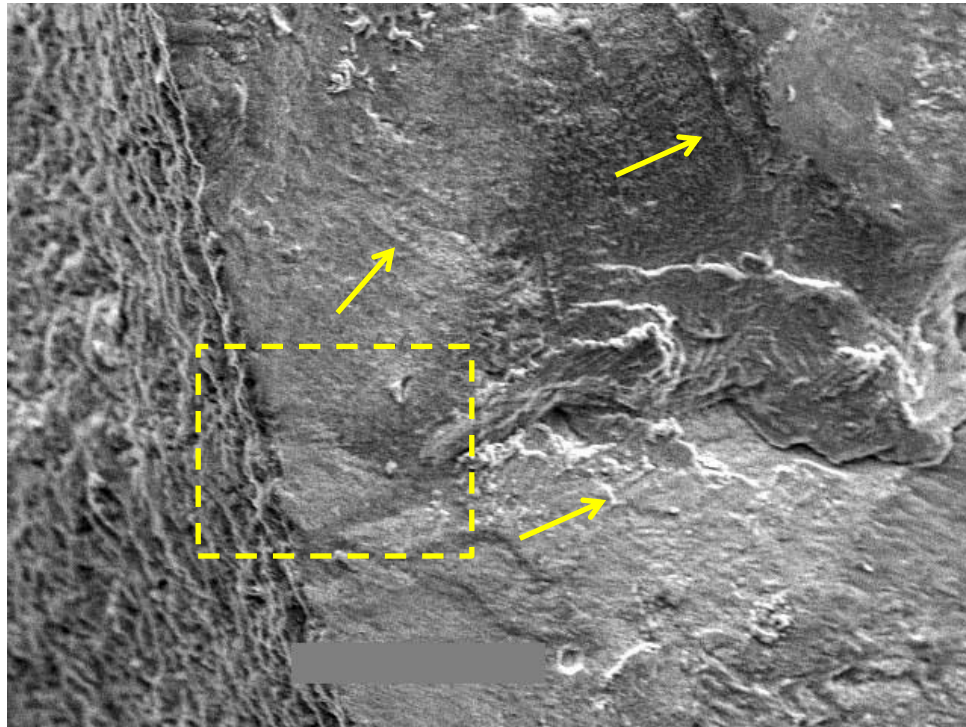
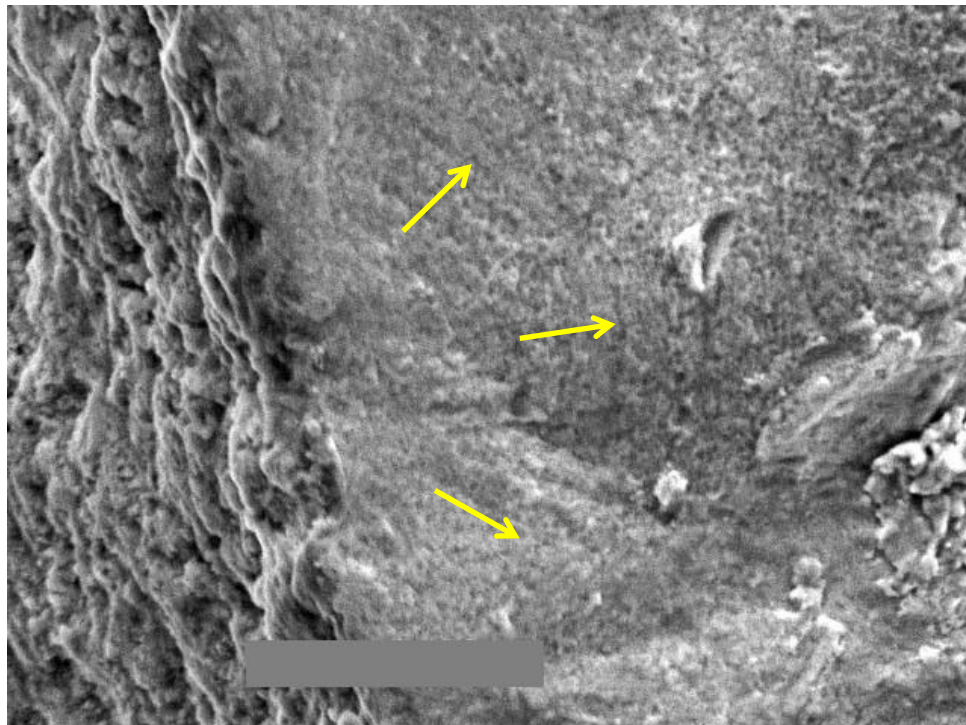
**Figure 30. Detailed views of the airfoil No. 22 fatigue origin.**

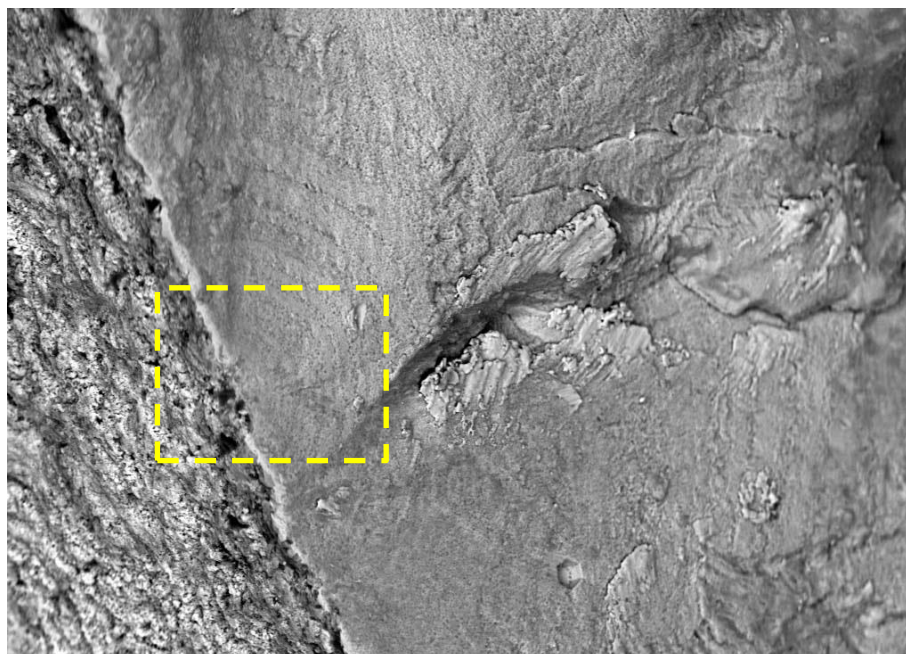
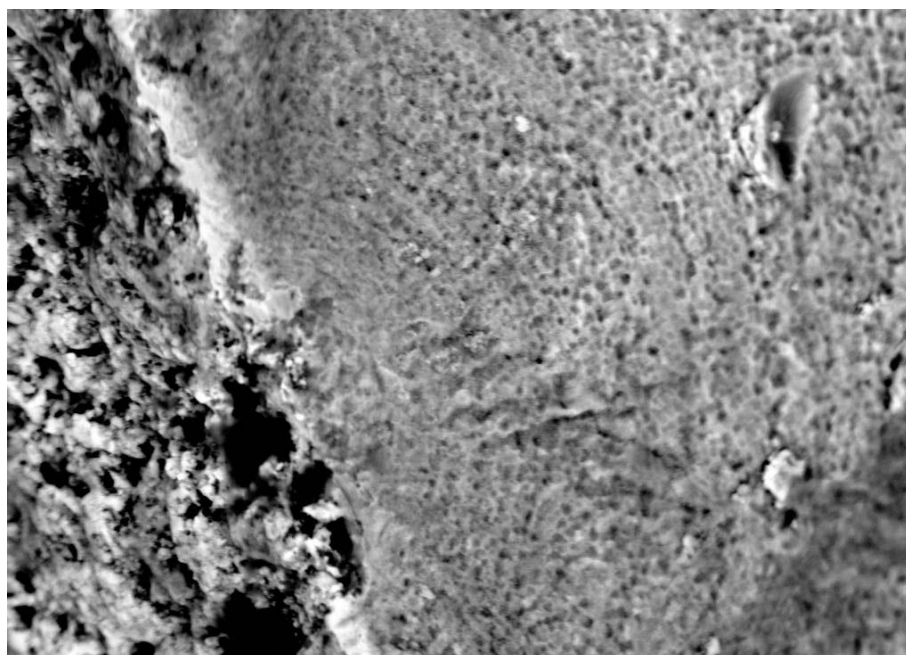
Figure 31. Backscatter electron images of the airfoil No. 22 fatigue origin.

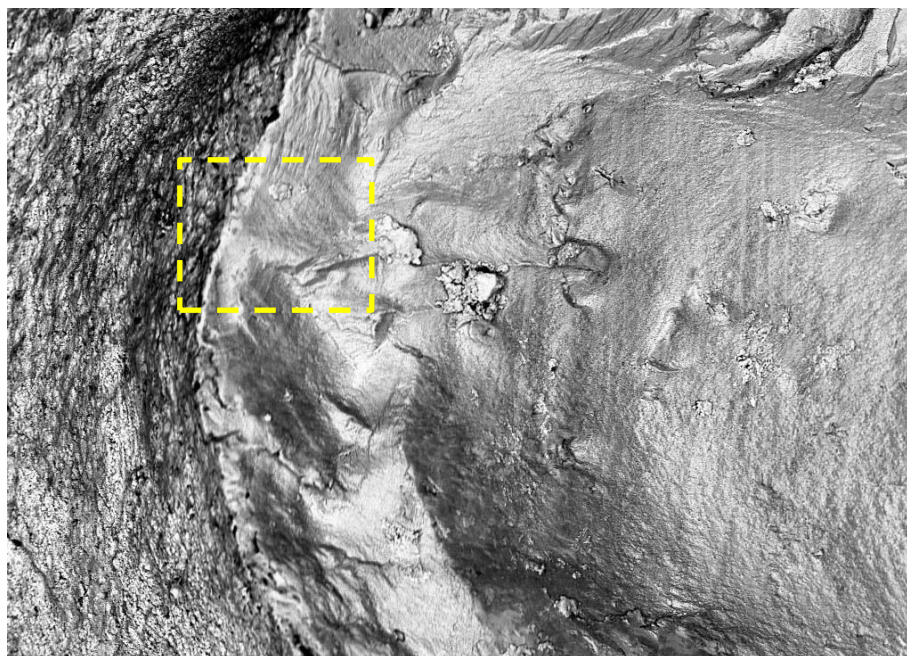
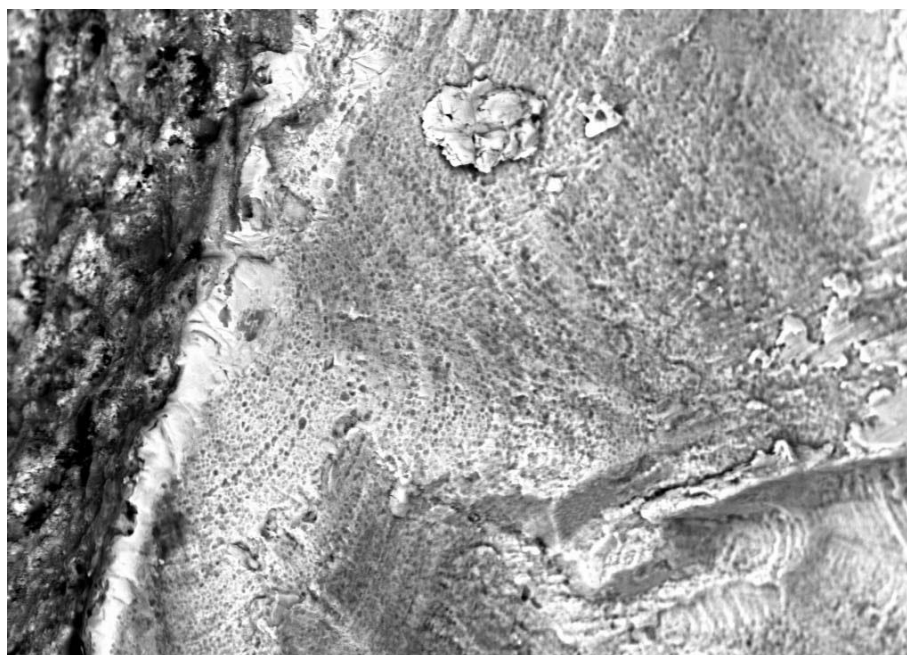
Figure 32 shows a radial view of the airfoil No. 24 fracture. The crack initiated from the trailing edge and progressed approximately 0.55 inch long in fatigue before final fracture occurred in overload. The rim surface was low angle lit to show the casting wax weld location in relationship to the airfoil trailing edge (Figure 33). The crack initiated approximately 0.026 inch above the rim and angled inward toward the rim as illustrated in Figure 34. Scanning electron microscope (SEM) images of the origin area are shown in Figure 35 through Figure 37. No obvious material anomalies were observed at the origin.

Figure 37. Backscatter electron images of the airfoil No. 24 fatigue origin.

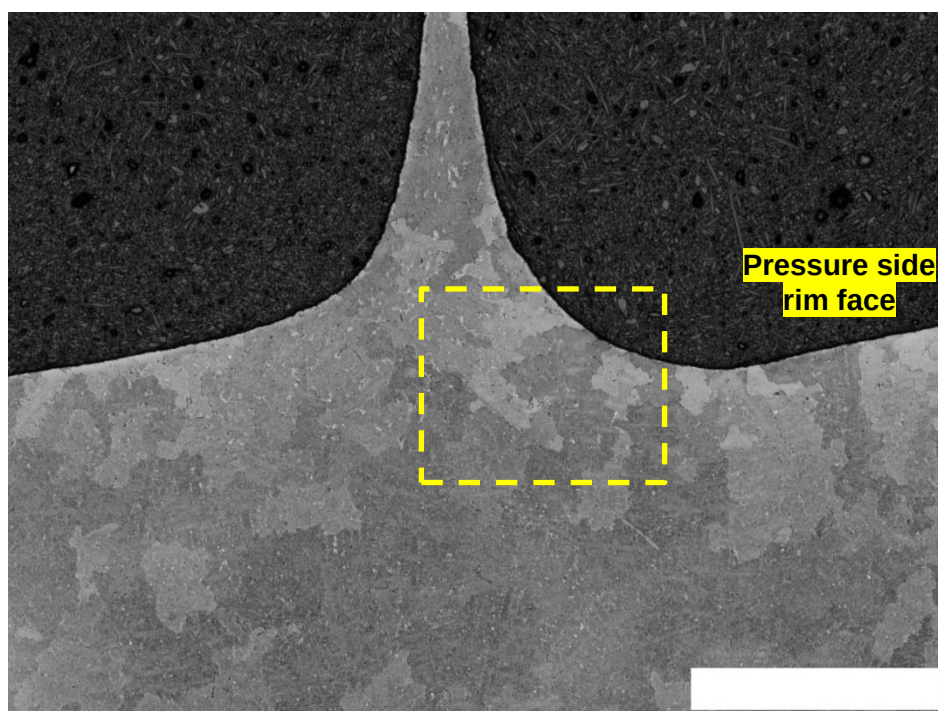
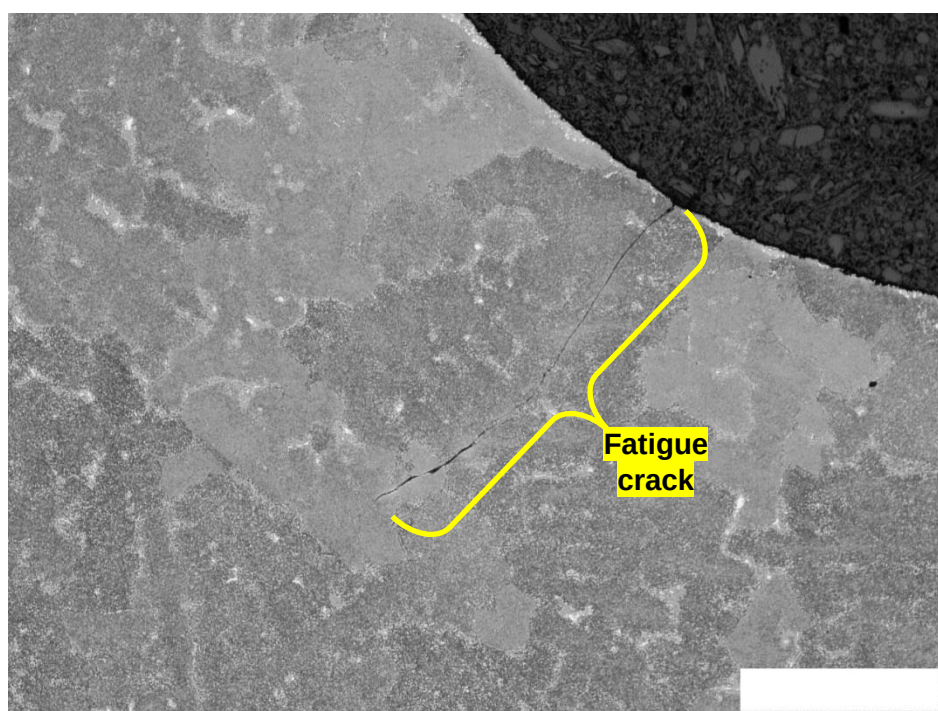
A rim crack measuring approximately 0.05 inch long and oriented radially was observed near the trailing edge root area of airfoil No. 8 as shown in Figure 38. A cross-section through the crack is shown in Figure 39 and Figure 40. The crack length measured 0.022 inch. The crack was transgranular and oxidized but no alloy depletion was observed along the crack path.

Figure 39. Photographs showing the fatigue crack just outboard of the rim surface. Etchant: MT

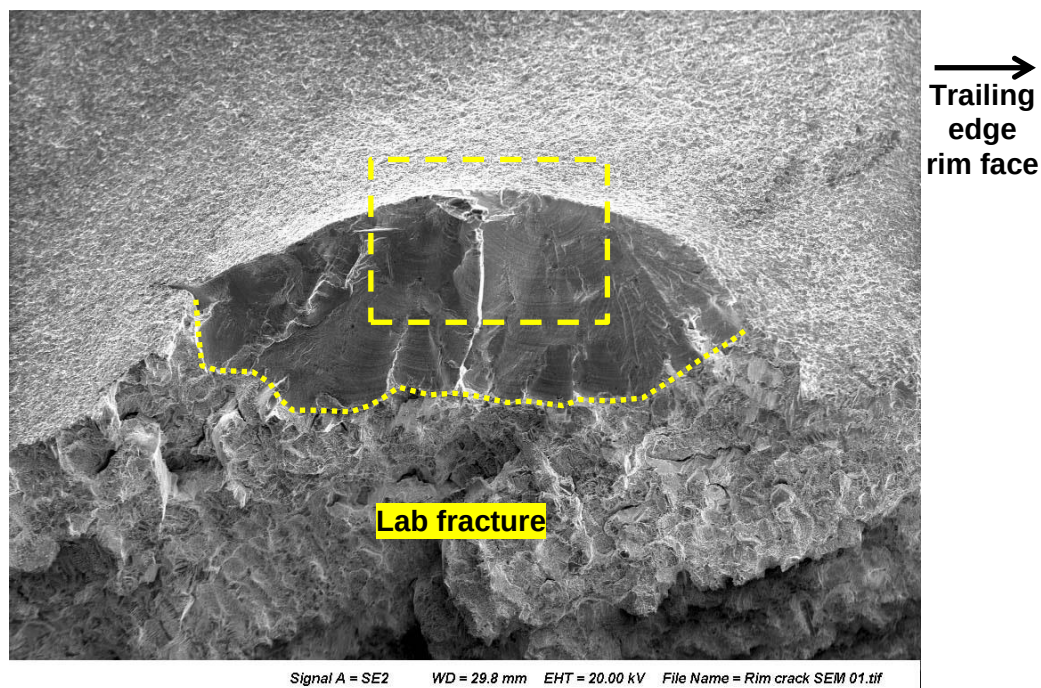
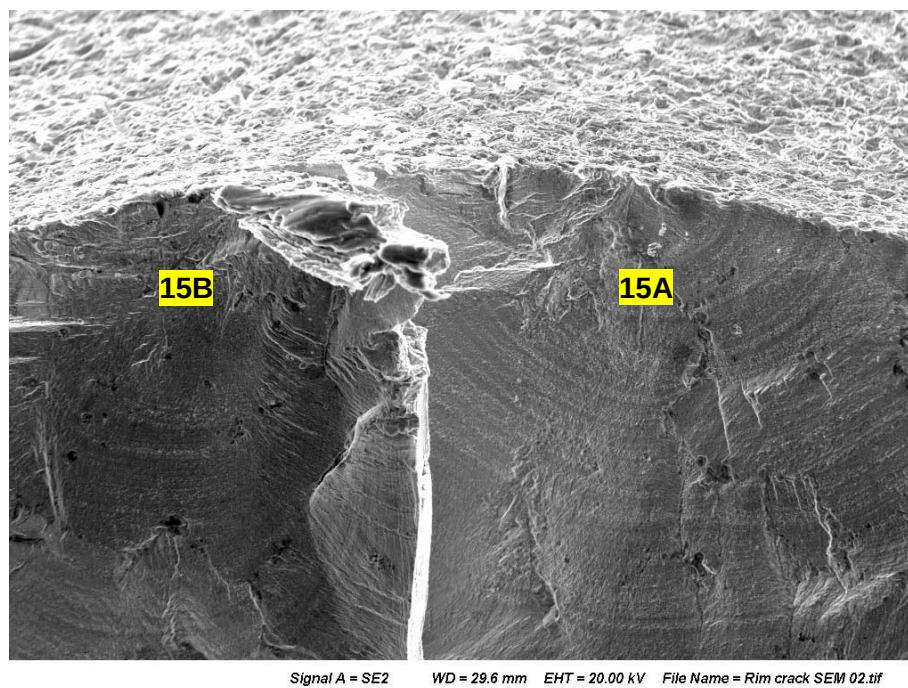
Another rim crack was observed near the trailing edge root area of airfoil No. 15 as shown in Figure 41. The crack was opened in the laboratory and is shown in Figure 42 and Figure 43. Two cracks initiated on two parallel planes and the total crack width measured 0.056 inch and the total depth measured 0.022 inch.

**Figure 42. SEM photographs of the rim crack at airfoil No. 15 (see previous figure). Two cracks initiated on parallel planes. The combined crack size was approximately 0.063 inch wide by 0.021 inch deep. Detailed views of 15A and 15B are shown in the following figure.**

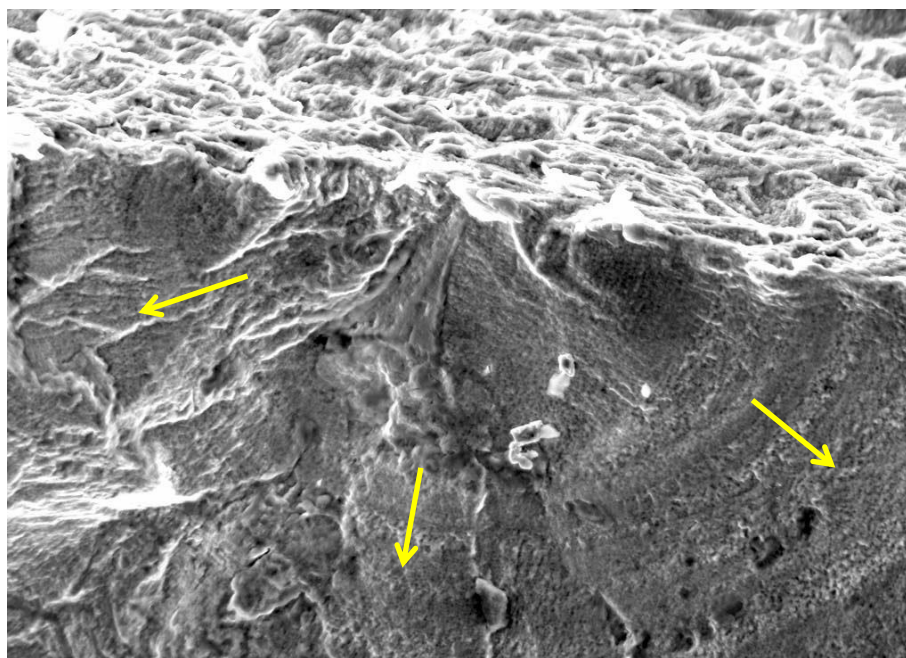
**Location 15A**

**Figure 43. Detailed photographs of the fatigue origins at locations 15A and 15B. The origin at location 15B was damaged during the opening of the cracks. The arrows indicate the crack propagation directions.**

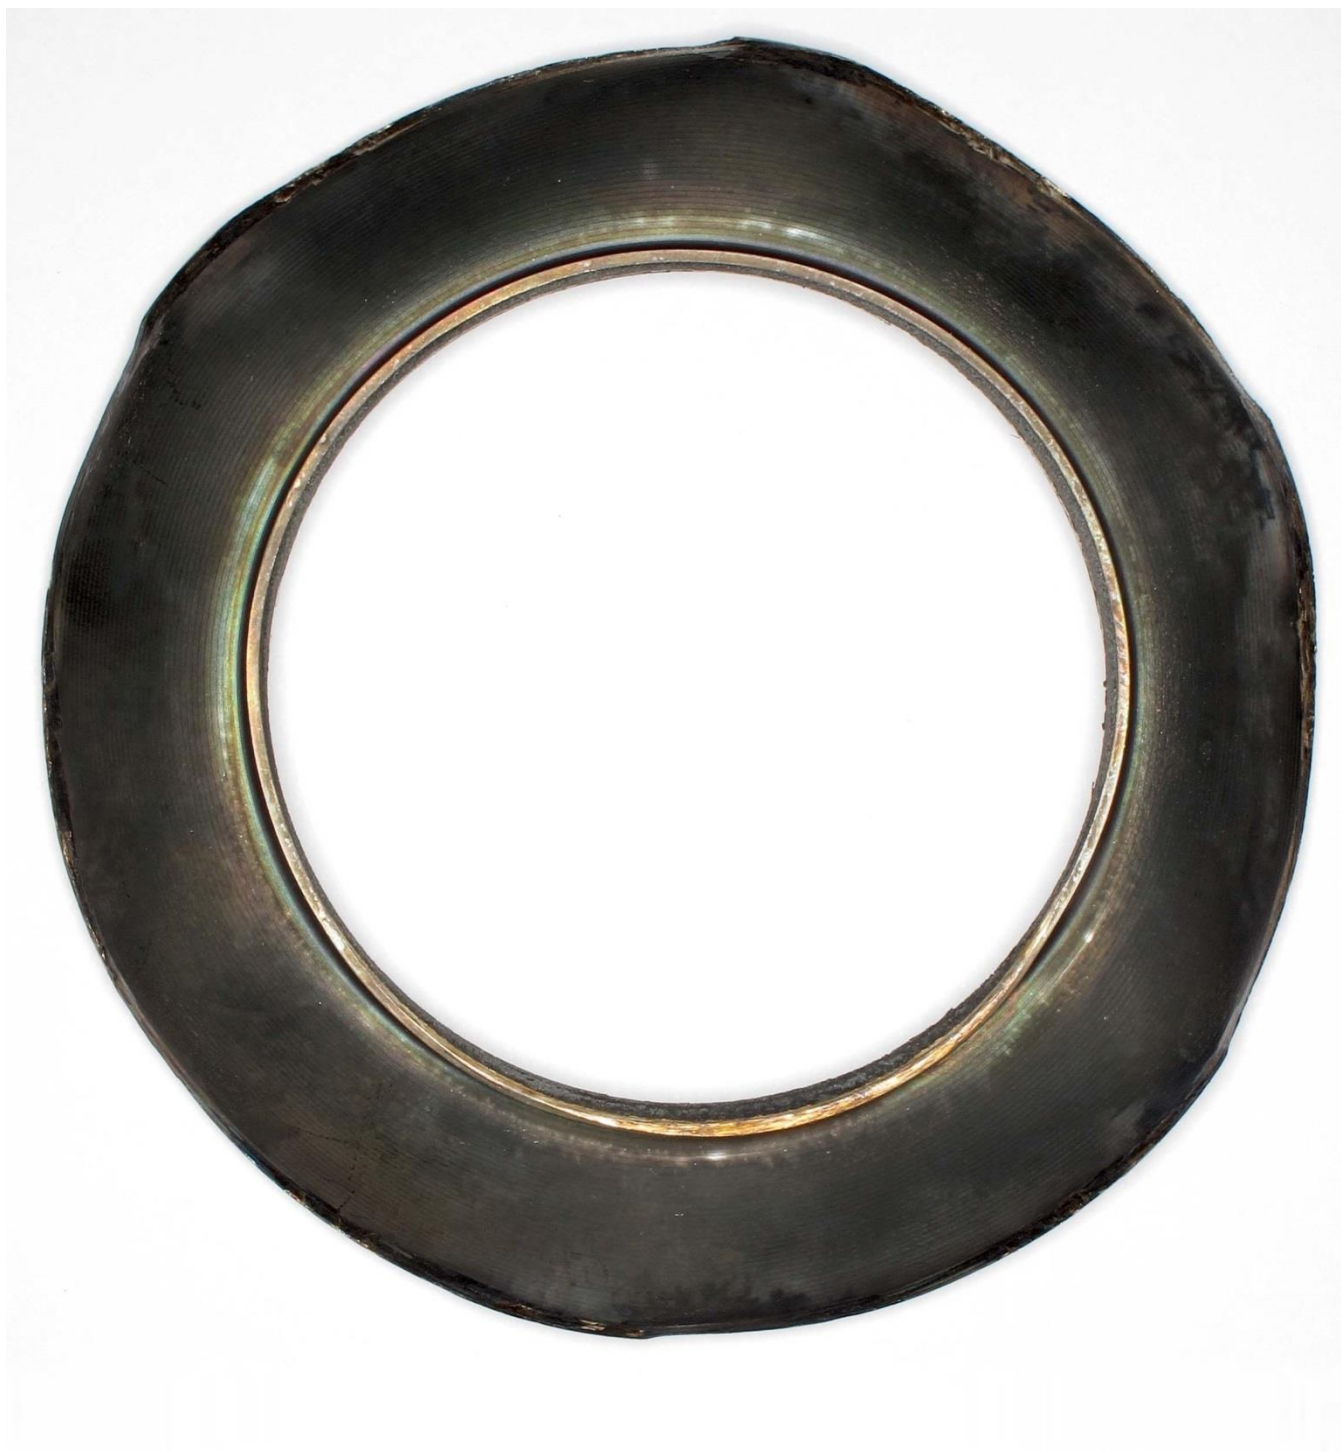
Impact damage was also observed on the eight positioning tabs around the outer diameter as illustrated in Figure 49. The damage is located on the side of the tang opposite the direction of the power turbine rotation. In addition, the diaphragm detached from the bore and is shown in Figure 50 through Figure 52.

**Figure 51. Photograph of the diaphragm that detached from the bore of the fourth stage turbine nozzle (forward looking aft view).**

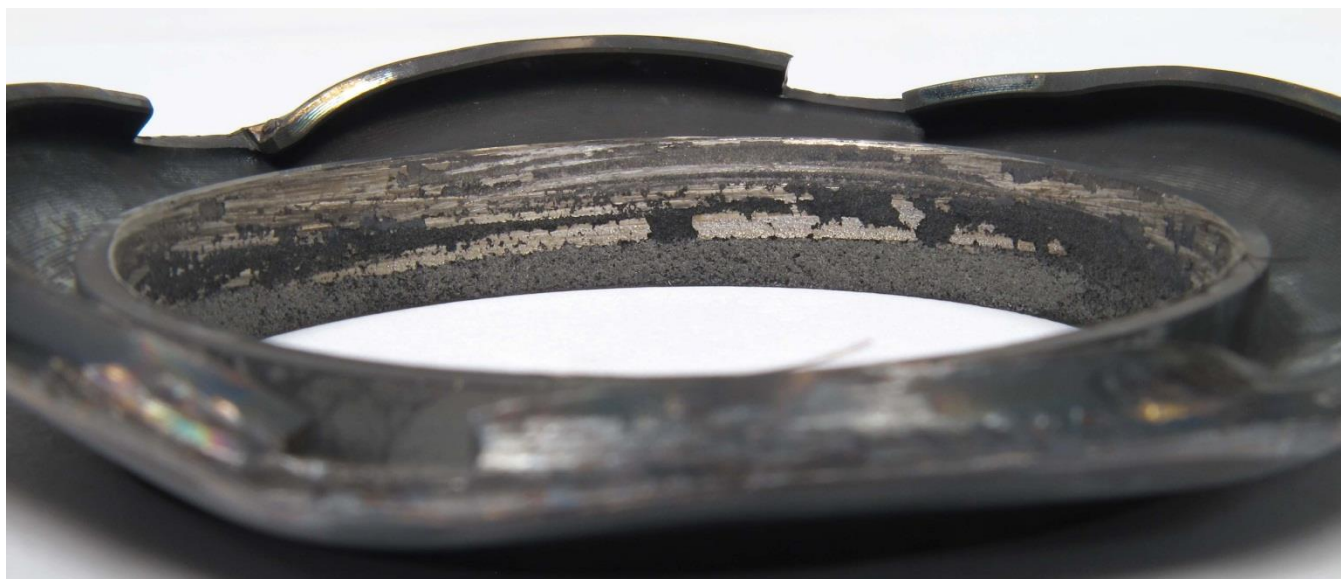
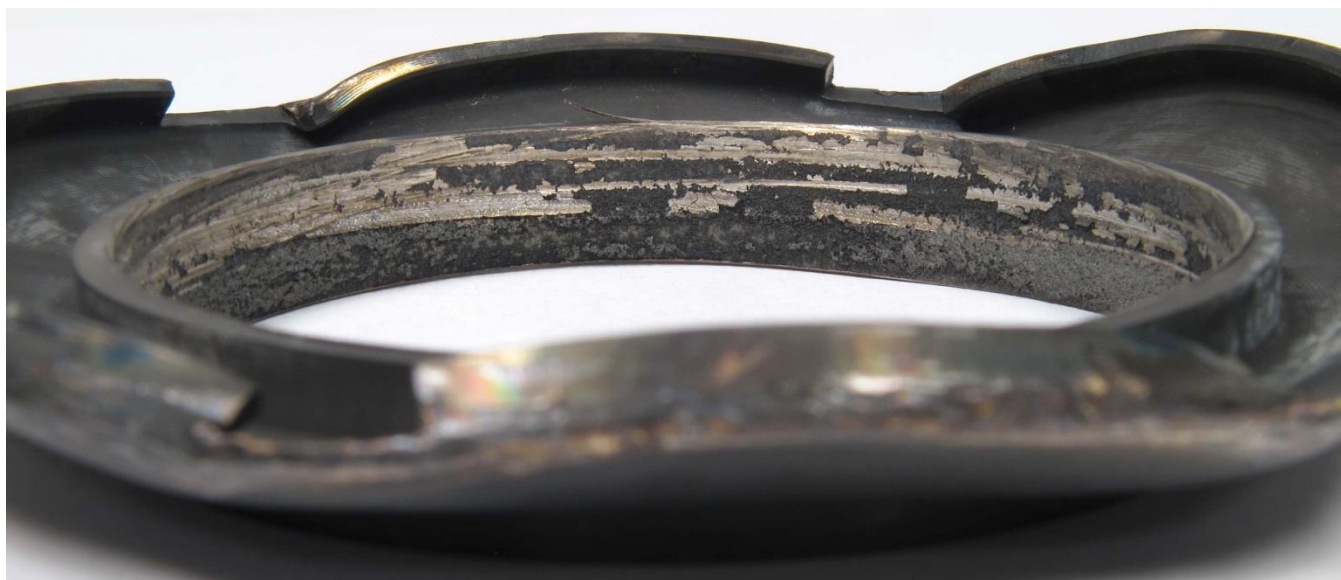
**Figure 52. Detailed views showing the rub damage to the bore of the fourth stage turbine wheel diaphragm.**

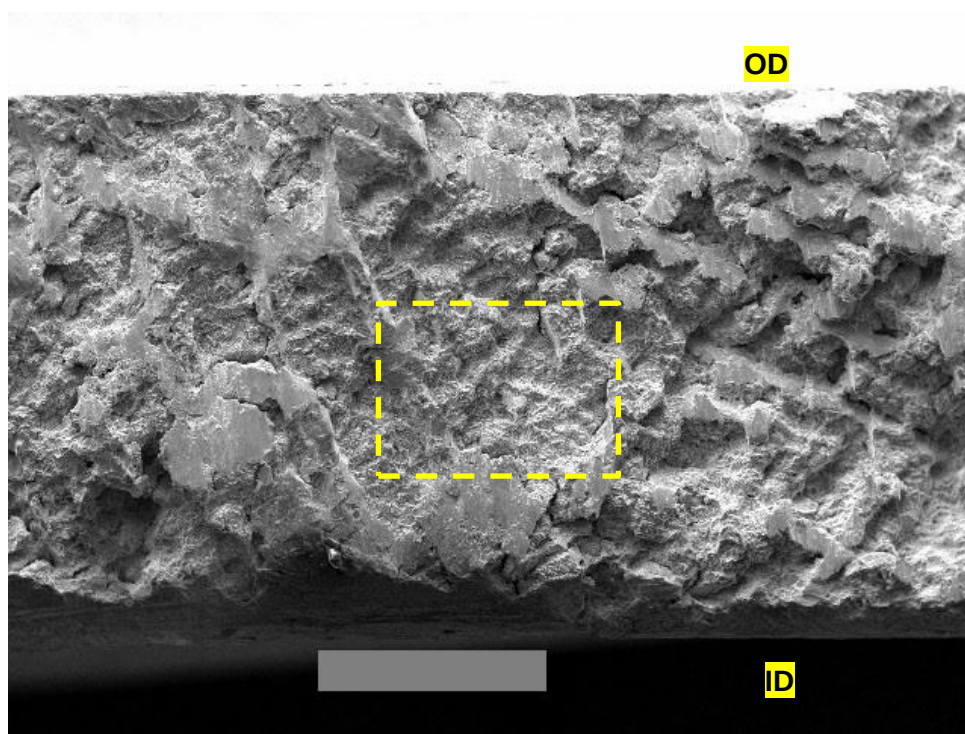
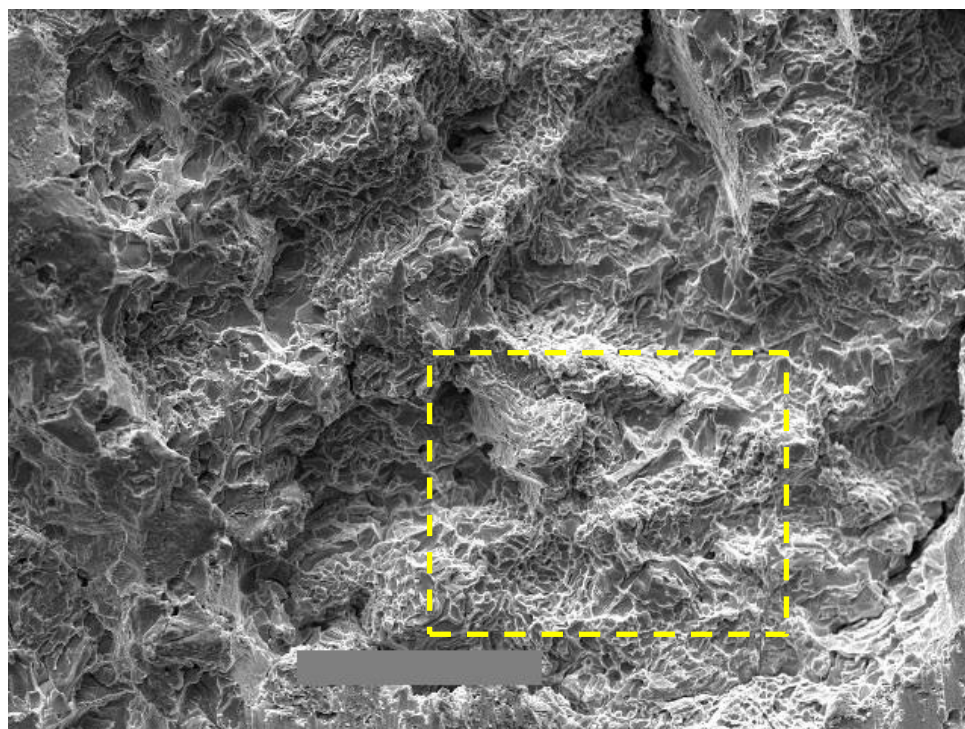
A section of the exhaust collector flange was removed and examined using the SEM. Representative SEM images of the fracture are shown in Figure 57 and Figure 58. The fracture features were a mixture of cleavage and equiaxed ductile dimples. The fracture features were consistent with overload. The fracture was a few inches aft of the weld joint.

**Figure 57. Representative SEM photographs documenting the exhaust collector flange fracture. The features were consistent with tensile overload.**
