| <div style="display: inline-block; vertical-align: middle;"> Rolls-Royce Corporation<br/> P.O. Box 420<br/> Indianapolis, Indiana 46206-0420 USA </div> | | <div style="display: flex; justify-content: space-between;"> <div> PAGE<br/><b>1</b> </div> <div> OF<br/><b>83</b> </div> </div> | <div style="text-align: center;"> REPORT NO.<br/> <b>15FA8-072-PR</b> </div> |
| <b>TITLE</b><br><br>METALLURGICAL INVESTIGATION OF A THIRD STAGE TURBINE WHEEL P/N 23065818 REMOVED FROM M250-C20J ENGINE CAE832989 OPERATED BY FLY HANGAR 13 LLC. | | PREPARED<br><br><div style="text-align: center;"><i>Signatures on File</i></div> | |

**Part Name:** Third Stage Turbine Wheel  
**Part Number:** 23065818  
**Part S/N:** X597059  
**Total Part Time:** 930 Hours (TSO)  
**Engine Model:** M250-C20J  
**Engine S/N:** CAE832989  
**Removal Station:** Rolls-Royce Corporation, Indianapolis, IN.  
**User:** Fly Hangar 13 LLC

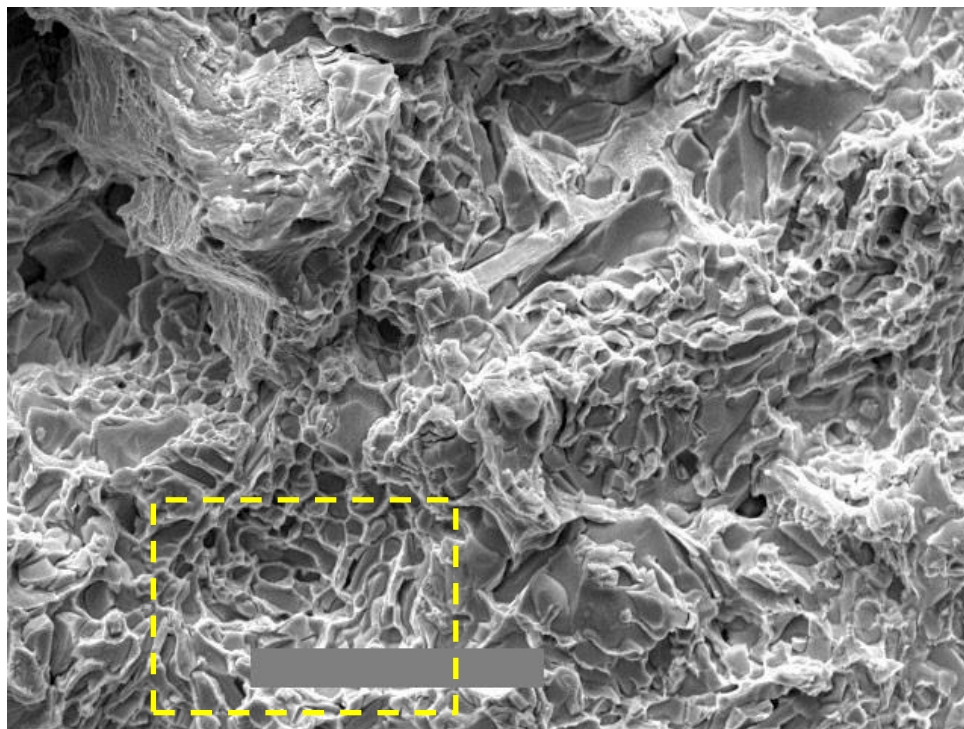
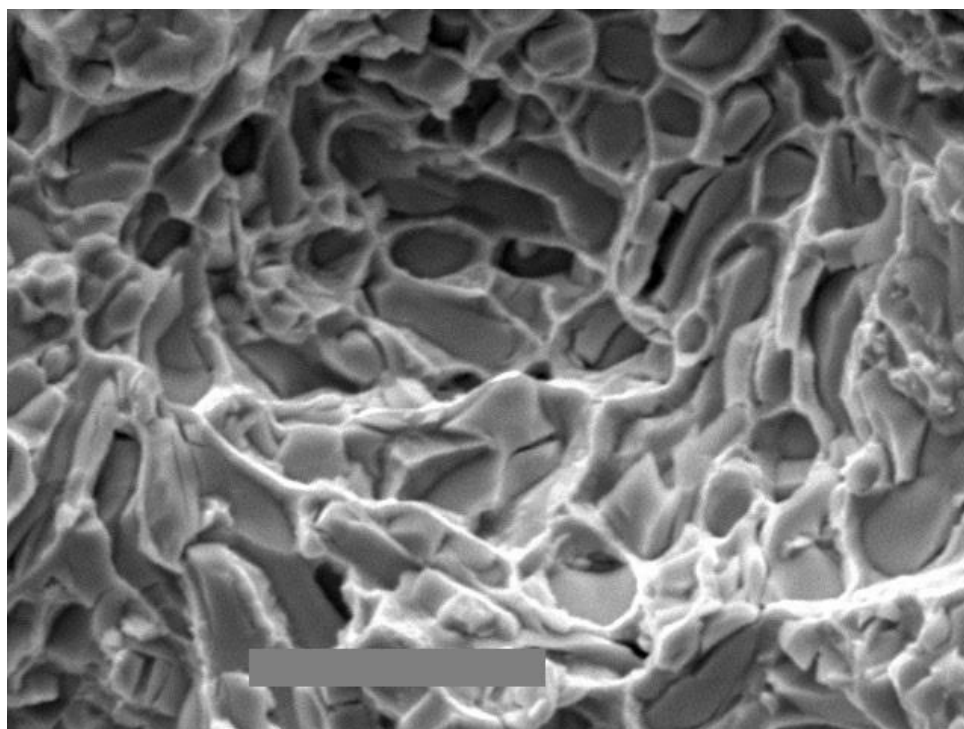
A section of the exhaust collector flange was removed and examined using the SEM. Representative SEM images of the fracture are shown in Figure 57 and Figure 58. The fracture features were a mixture of cleavage and equiaxed ductile dimples. The fracture features were consistent with overload. The fracture was a few inches aft of the weld joint.

**Figure 58. Representative SEM photographs documenting the exhaust collector flange fracture. The features were consistent with tensile overload.**

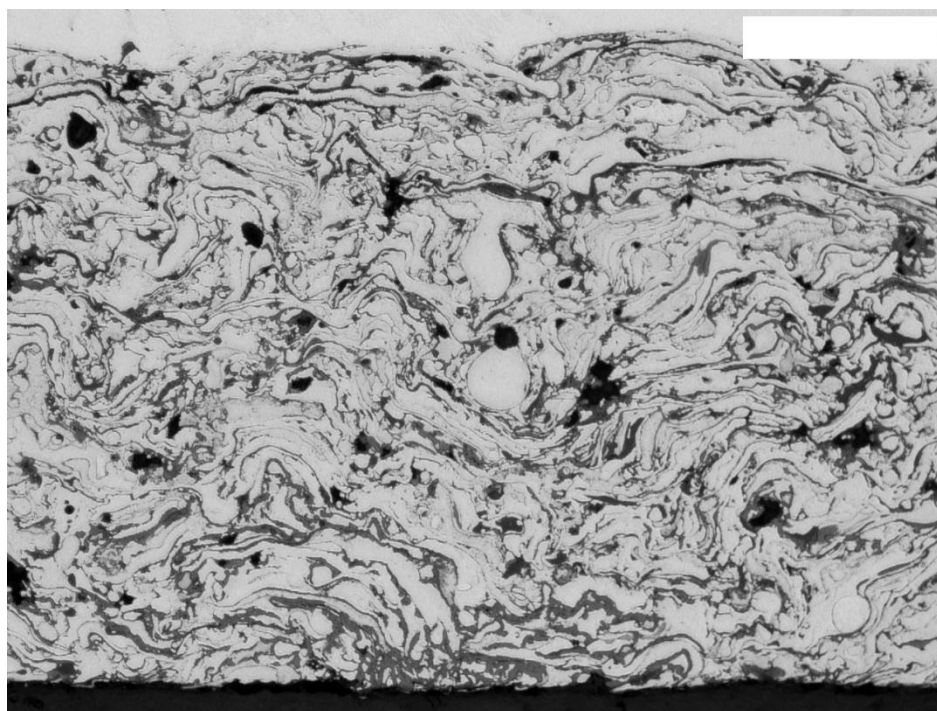
A cross-section through the flange is shown in Figure 59. The aft surface and ID surface of the flange had been dimensionally restored with thermal spray. The parent material in the flange wall was slightly tapered and measured 0.0936 inch thick near the inboard portion of the flange and 0.0970 inch thick near the outer diameter. The ID wall thickness was also tapered and measured 0.0347 inch near the fracture and 0.0370 inch thick adjacent to the flange fillet radius. A representative photograph of the thermal spray microstructure is shown in the lower image in Figure 60. There were a few cracks in the thermal spray coating and along the OD surface of the wall, forward of the flange.

**Figure 60.** The upper photograph shows the wall thickness of the exhaust collector dash 2 detail. The lower photograph shows a representative photograph of the thermal spray material used for dimensional restoration.

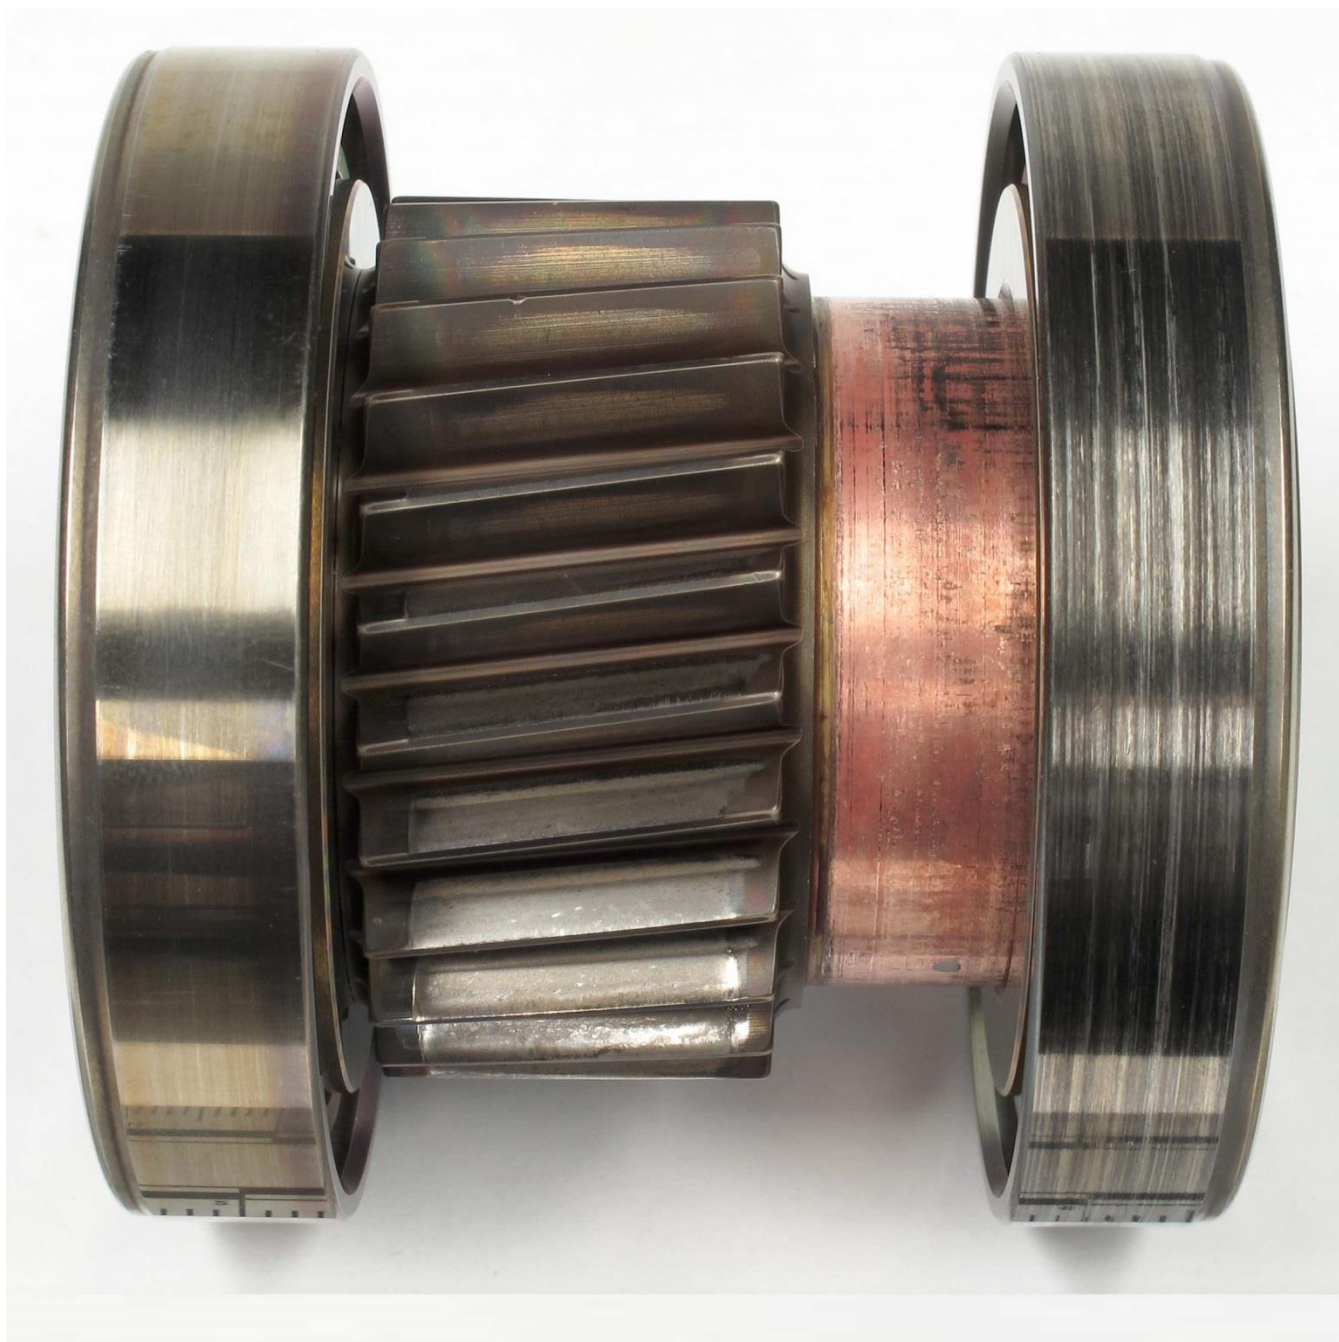
The No. 4 bearing was removed from the pinion gear as shown in Figure 61. End views of the bearing (Figure 62 and Figure 63) revealed the separator was fractured and the aft side end wall from one of the aft pockets liberated (Figure 62). The liberated section was one of the six (6) scalloped pocket that was slightly smaller (radial thickness) than in other areas. This fractured and liberated section was recovered. The forward side rail was also cracked at the same pocket location (Figure 63), but was not liberated. The OD surface of the outer ring exhibited circumferential score marks (Figure 64).

**Figure 61. Photograph of the No. 3 bearing, pinion gear, and No. 4 bearing (after removal from the pinion gear).**

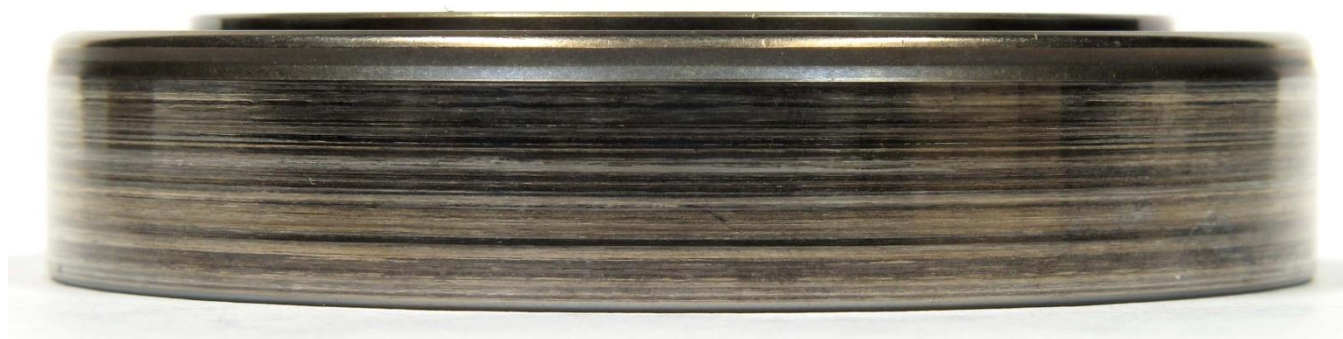
**Figure 64. Photograph of the outer ring OD surface showing circumferential score marks.**

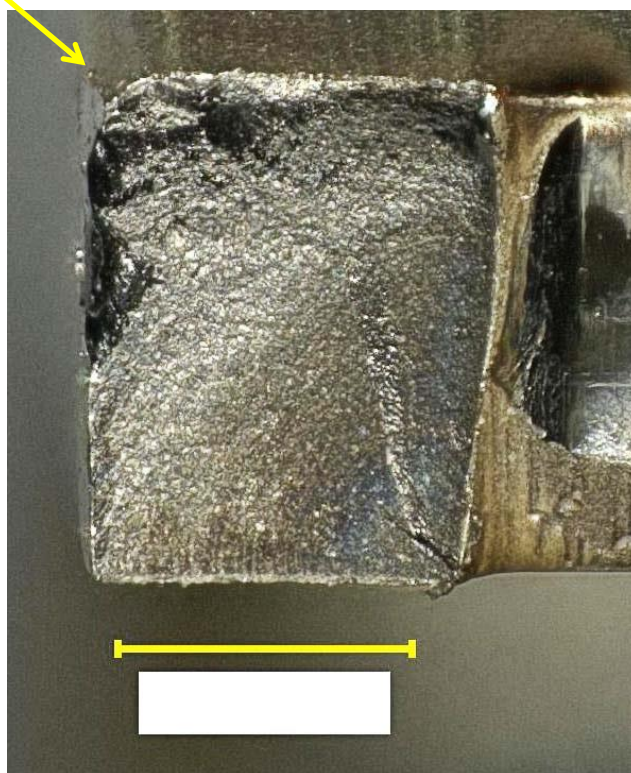
The bearing was disassembled and the separator fractures are shown in Figure 65 and Figure 66. The fracture showed beach marks consistent with fatigue progression. Detailed fractographic evaluations of the fractures were not conducted.

Figure 66. Photographs documenting the No. 4 bearing separator fractures.

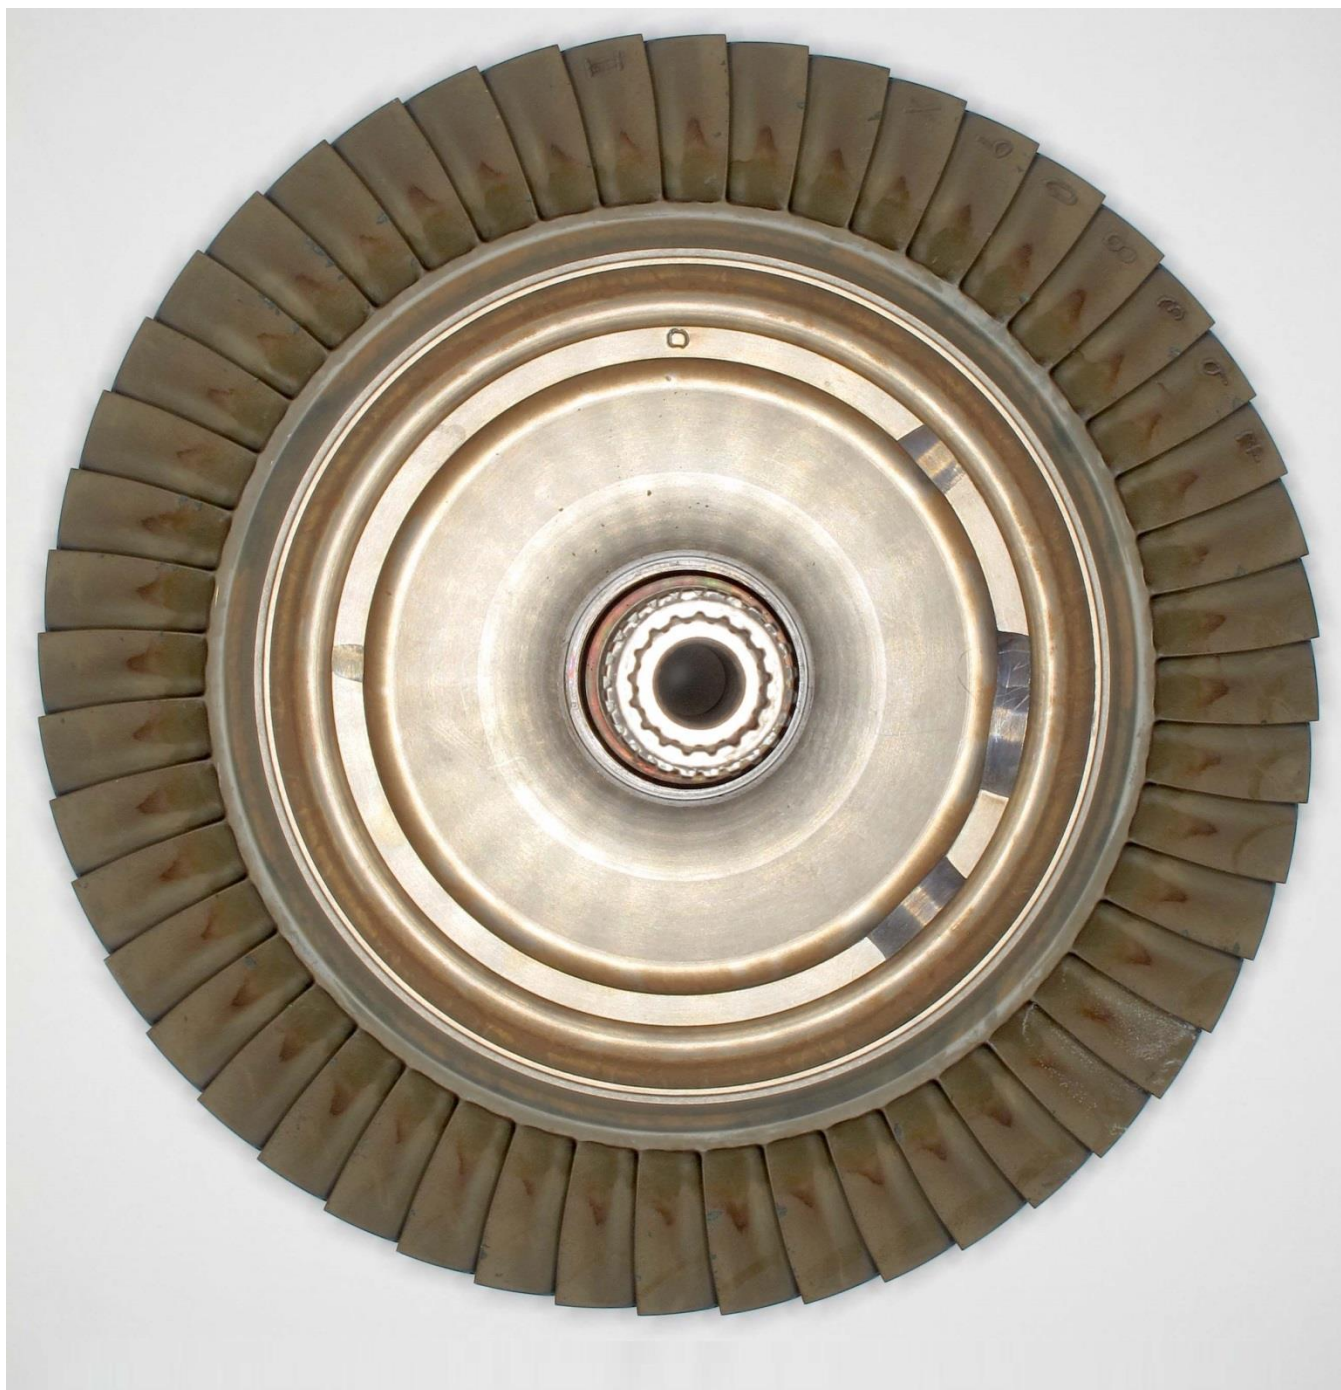
Figure 70 shows a trailing edge (forward looking aft) view of the second stage turbine wheel. All of the airfoils were intact and no obvious thermal distress or damage was observed on any of the airfoils. No destructive evaluations of the second stage turbine wheel were conducted.

**Figure 70. Forward looking aft view of the second stage turbine wheel.**

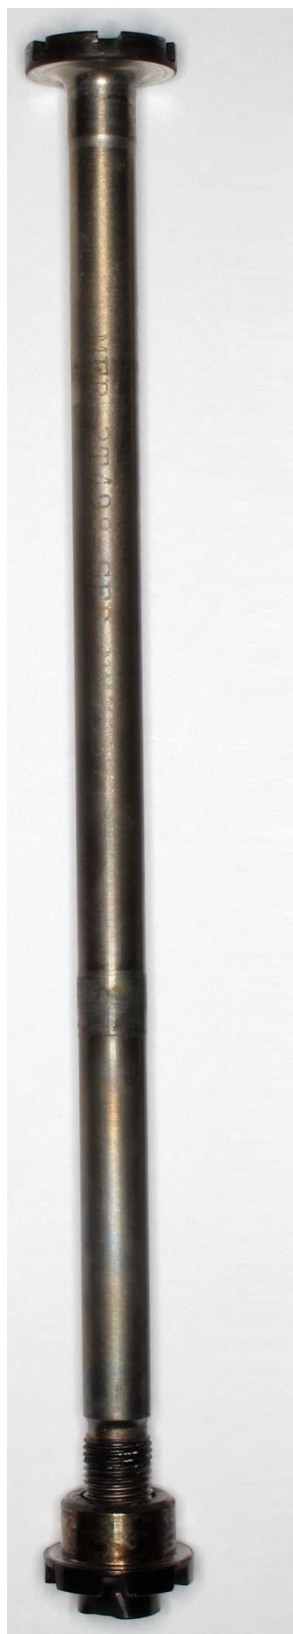
The turbine tie bolt and nut used to clamp the first and second stage turbine wheels are shown in Figure 71. The OD surface of the tie bolt head was damaged as well as the forward portion of the turbine splined adapter splines (Figure 72). Multiple diagonal cracks were also evident on the drive side of the turbine splined adapter splines.

**Figure 71. Photograph of the turbine tie bolt and nut.**

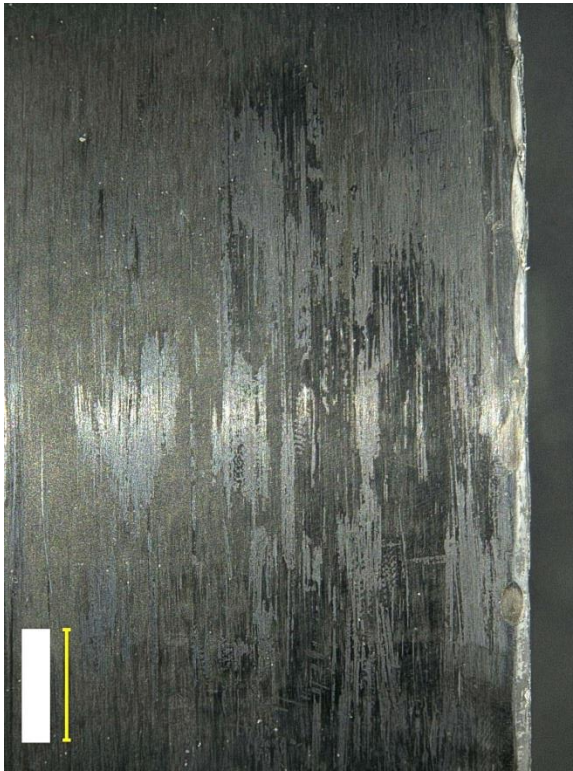
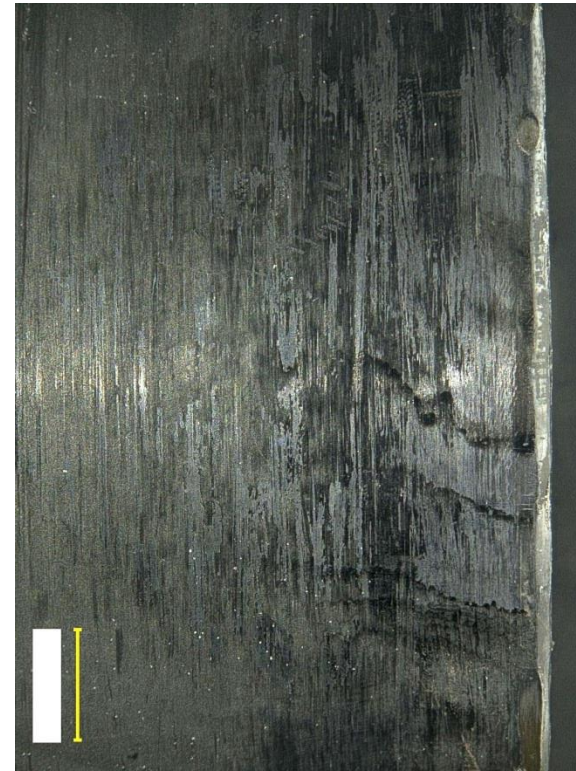
The power turbine inner shaft is shown in Figure 73. A few rub marks were observed on the OD of the shaft. The ID surface of the shaft at the aft end was scored as shown in Figure 74 through Figure 76. No destructive evaluations of the shaft were conducted.

**Figure 76. Photographs showing the damage to the ID surface at the aft end of the power turbine inner shaft (upper image). The lower image shows the condition of the No. 6 bearing inner ring raceway.**

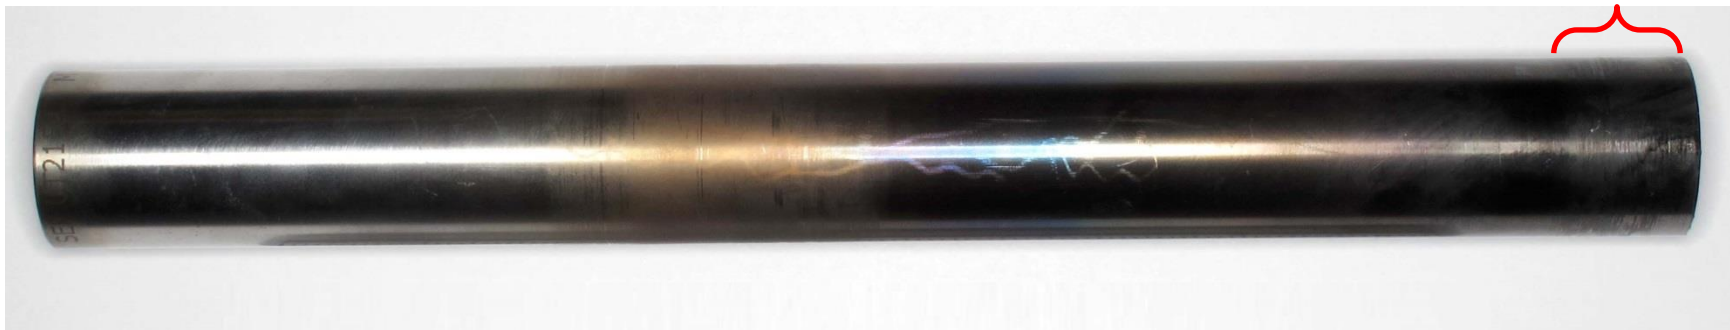
The turbine to compressor coupling is shown in Figure 77. Score marks were observed on the OD surface at the aft end of the shaft and on the aft face. The internal splines showed no evidence of cracking or torsional deformation. No destructive evaluations of the coupling were conducted.

Score marks

Figure 77. Photographs of the turbine to compressor coupling showing the scoring damage on the aft end OD surface.
