# Continental Motors

## ENGINE FIELD INSPECTION REPORT

| AIRCRAFT MAKE & MODEL | Cirrus SR22 |
| FILE NUMBER | 15-638 |

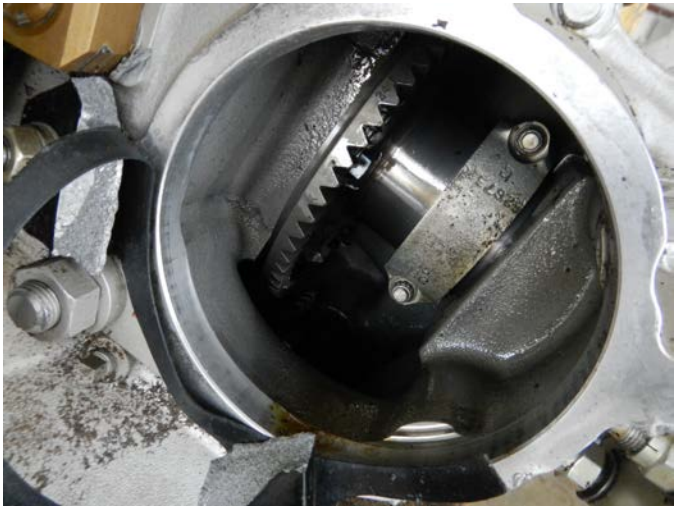
| Condition: | The propeller had separated from the engine. All three blades exhibited chord wise scratches and nicks in the leading edges. Two of the blades were bent and twisted. The propeller governor remained attached to the engine and the control lever was broken from the governor. The governor was removed and the drive turned freely by hand. The gasket screen was free of debris. | | |
