NATIONAL TRANSPORTATION SAFETY BOARD  
Office of Aviation Safety  
Washington, D.C. 20594  
October 17, 2017

## Group Chairman's Factual Report

# STRUCTURES

CEN16FA276

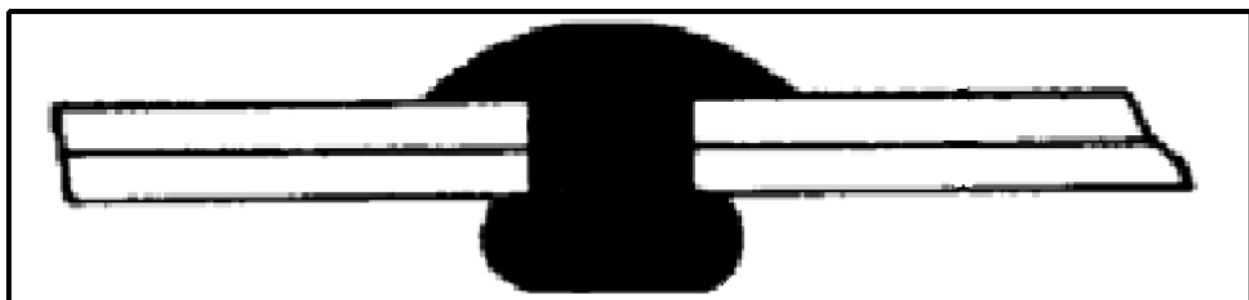
Per the 23560 drawing (reference Figure 17), the fasteners intended to be installed in the concerned holes are AN470AD4-4 rivets, which are classified as solid-shank rivets. Correct installation of these rivets in the assembly is accomplished by slightly expanding the shank while being driven (reference Figure 19).

Figure 19 - Pictorial Depiction of a correctly installed solid-shank rivet
